MEMORANDUM

To: Rob Ferguson and Marie Auyong (NOAA)
From: Ben Wollman, Janelle Veary, Michelle West (HW)
Date: October 26, 2022
Re: Manell-Geus Watershed Inventory – Field Findings
cc: Margaret Aguilar, Guam EPA
Farron Tajeron, The Nature Conservancy
Christine Fejeran, Guam Department of Agriculture

This memorandum summarizes data collection and key findings from a rapid watershed assessment of the Manell and Geus watersheds conducted by HW, Guam EPA, Department of Agriculture, The Nature Conservancy, NOAA, and others the week of August 4 – 9, 2022. The purpose of the assessment was to map drainage infrastructure, identify problem areas (pollution sources, flooding, damage, etc.), and identify potential restoration project opportunities. During this effort, the field team:

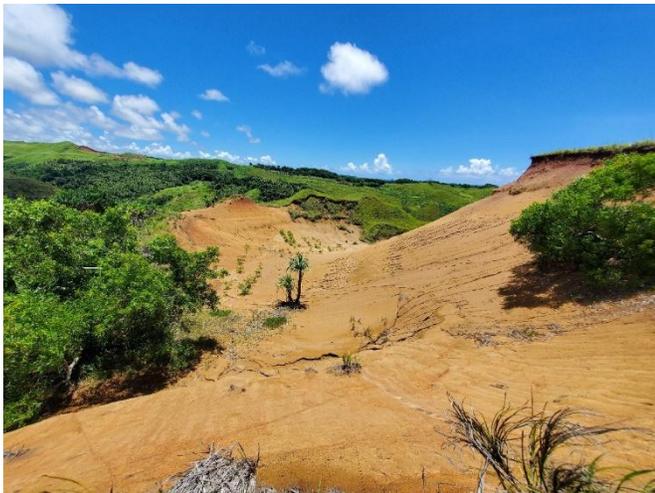
Photo 4 (LEFT). View of a badland area of minimal vegetation near the Asgadao restoration site. Photo 5 (RIGHT). Christine Fejeran, Forestry Chief of the Guam Department of Agriculture, giving the field team a tour of the Quinene reforestation site in the Manell Watershed.

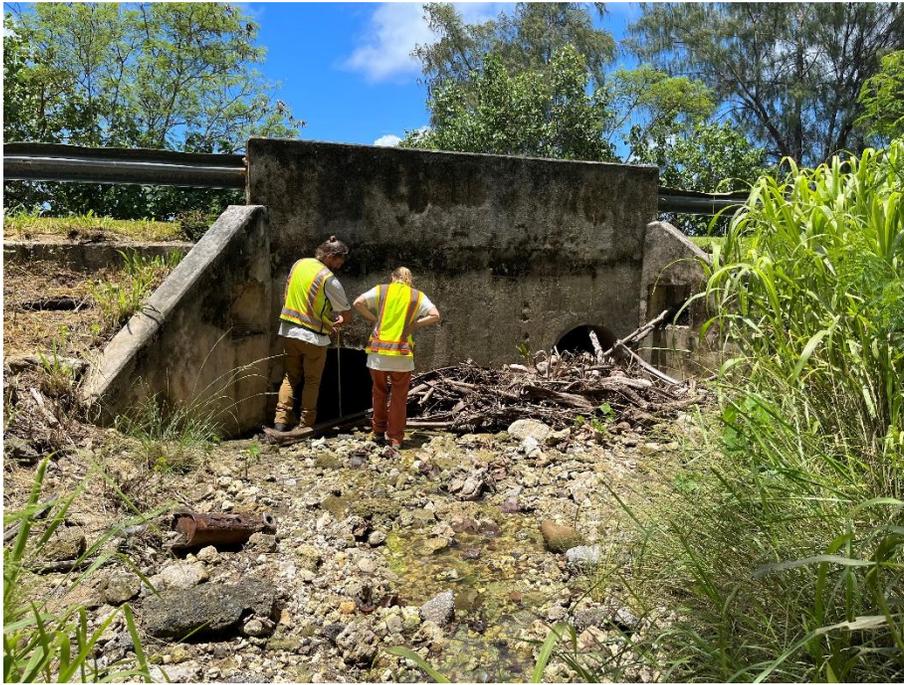
Photo 6. HW field team members collecting data on a culvert section passing under Route 4 at the east end of the Manell Watershed.

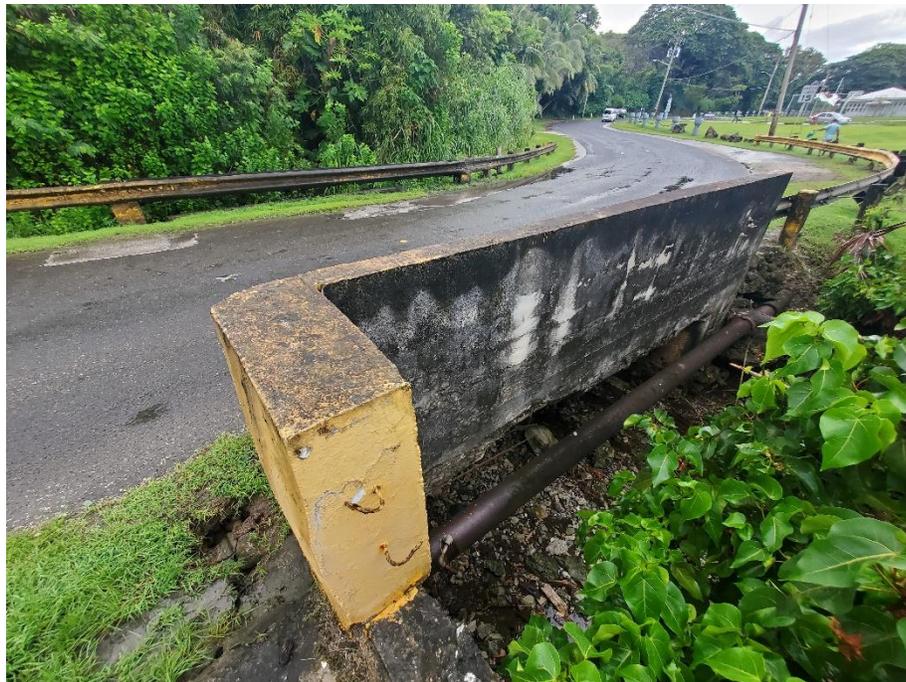
Photo 7. Bridge/culvert infrastructure along Route 4 at the north end of the Merizo Pier Park.

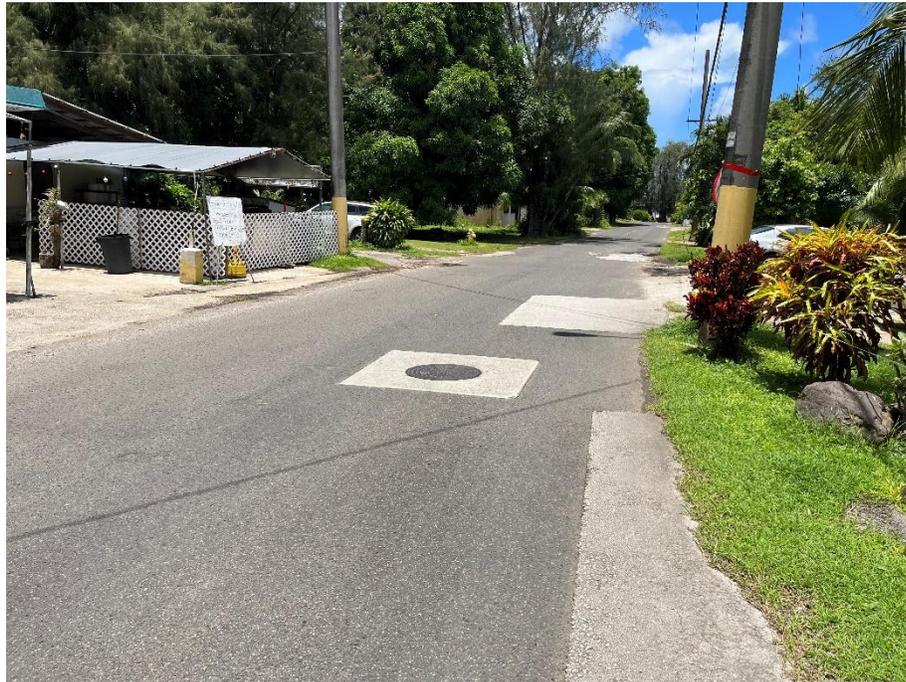
Photo 8. Sewer system located beneath Highway 4 near CJ's. Potential location of SSO.

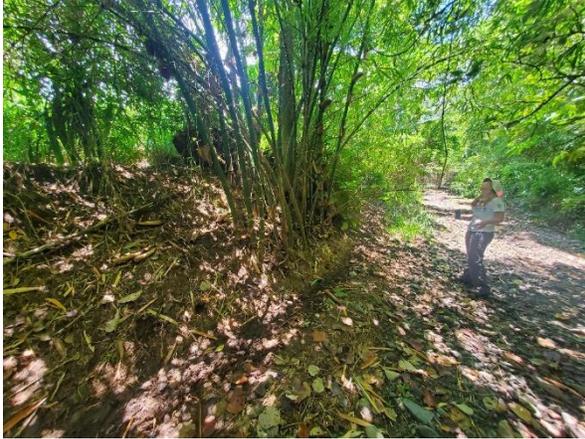
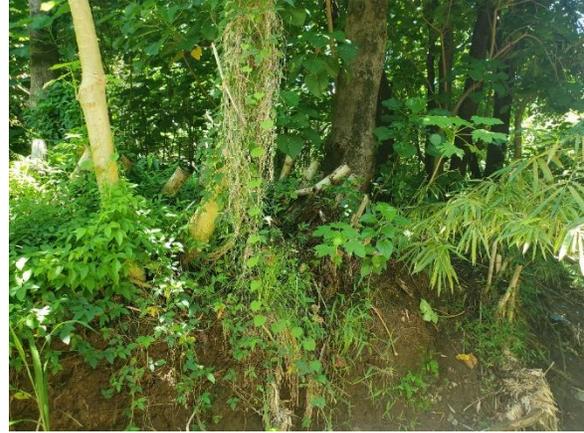
Within the Manell-Geus watersheds, common bamboo (*Bambusa vulgaris*) is the most prevalent and problematic invasive species of concern, as it relates to watershed planning. The bamboo was observed to be growing along the riverbanks throughout the watersheds, in large, mono-specific stands (**Photo 9**). These invasive plant stands cause issues with stream bank erosion/downstream sedimentation, habitat/biodiversity loss, and flooding, as they outcompete and take over areas of native species. Large sections of these bamboo stands often break free from the stream banks or fall across the streams, causing blockages to the stream's flow, which is most problematic within the Manell and Geus River systems. Previous efforts led by Patrick Keeler (Guam Coral Reef Initiative Watershed Coordinator) to remove and manage the bamboo stands in Manell-Geus watersheds have been made with some limited success (**Photo 10**). Increased funding and efforts should be considered for continued progress in removing and managing this invasive species, and reduce downstream flooding, within these watersheds.

Photo 9 (LEFT). Large stands of bamboo growing along the bank of the Manell River, north of Route 4. Photo 10 (RIGHT). Previously treated section of bamboo along the banks of the Manell River.

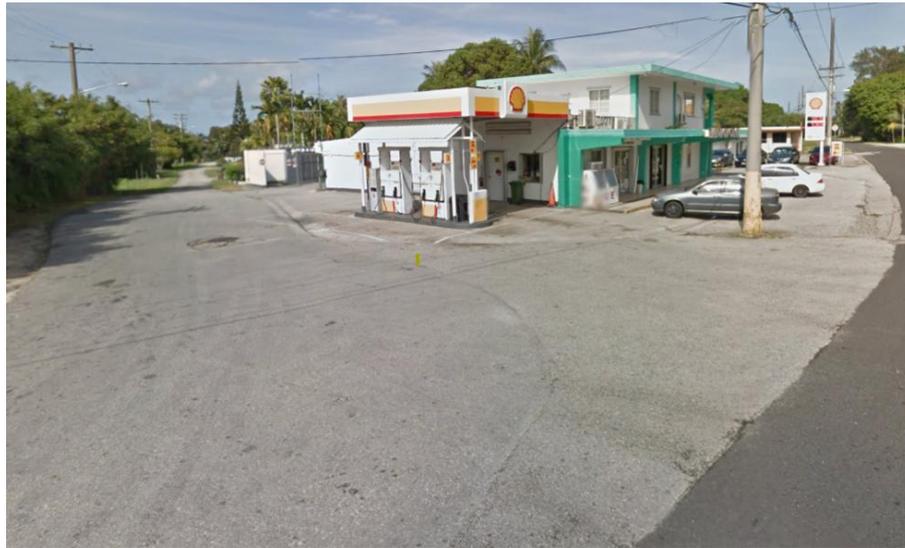
At least one pollution hotspot was observed—where stormwater flows through the Shell gas station located west of Nicholas Reyes Street on Route 4 (**Photo 11**). Stormwater runoff should be managed in this location to prevent pollutant loading from the higher concentration of hydrocarbons and oil present at the gas station property.

Photo 11. Shell gas station hot spot along Highway 4 in the Geus watershed (photo sourced from Google maps).

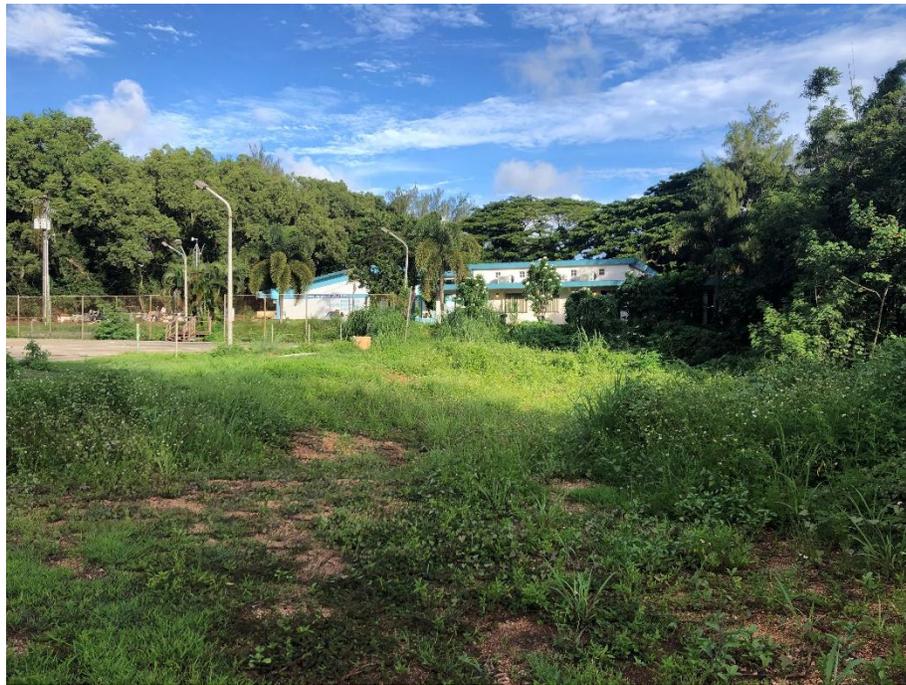
Photo 12. Location for potential on-site stormwater management practice adjacent to the Merizo Mayor's office.

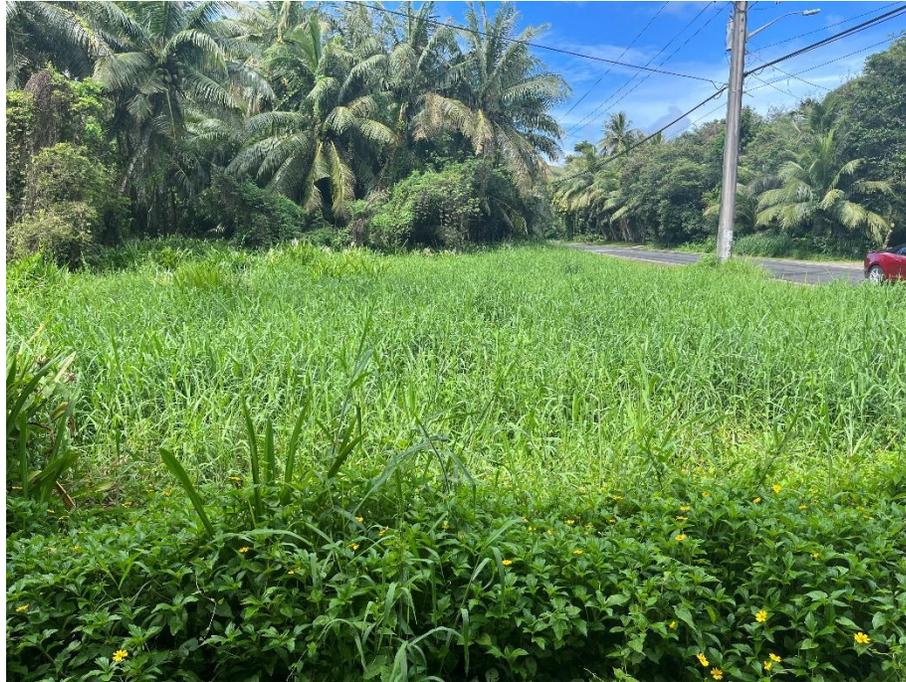
There are some low-lying areas in and around the stream floodplains within the Manell-Geus watersheds which are mapped as (or appear to be supporting) wetlands (**Photo 14**). These wetlands provide ecosystem services that benefit the watersheds, such as nutrient/pollutant filtration, wildlife habitat, and floodwater storage. These services have the potential to be enhanced through restoration or preservation and should be considered as an option in the overall watershed plan.

Photo 14. Wetland area adjacent to Route 4 with potential for enhancement/preservation.

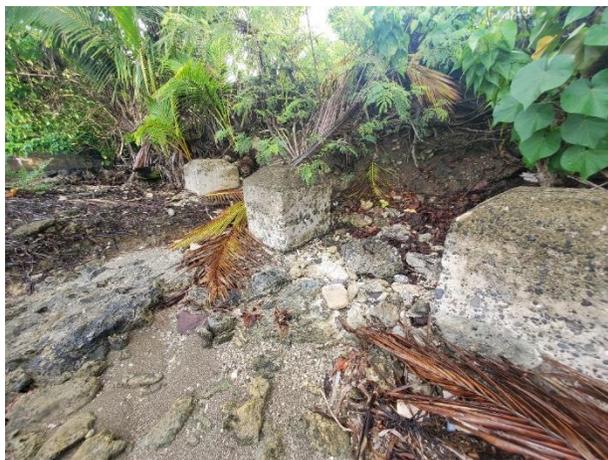
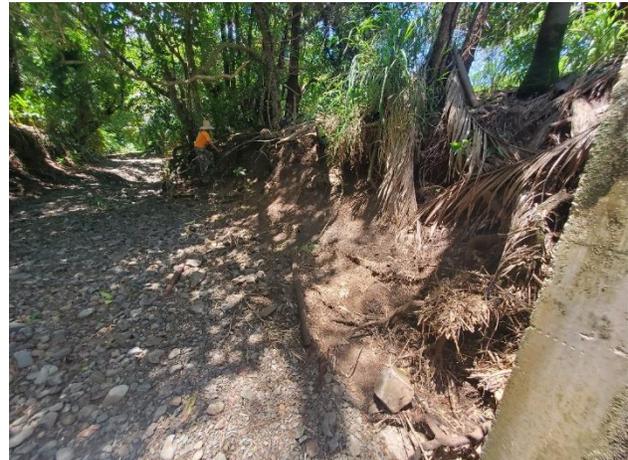
Certain sections of the Manell-Geus watershed coastal shorelines, along the waters of Achang Bay and Cocos Lagoon, as well as sections of stream banks, were observed to be unstable, actively eroding, lacking vegetation or other stabilization structures (e.g., bulkheads, revetments, etc.) (**Photos 15 & 16**). The erosion in these sections causes sedimentation issues in the receiving Achang Bay and Cocos Lagoon waters, but also threatens to compromise roadway infrastructure, as well as other public and private land assets adjacent to the eroding edge. The watersheds would benefit from bank stabilization projects in these areas, which would potentially include mangrove restoration and other bioengineering elements that utilize vegetation as the primary means for long-term stabilization.

Photo 15 (LEFT). Unstable coastal shoreline section near the bridge at the north end of the Merizo Pier Park. Photo 16 (RIGHT). Eroding section of the Manell riverbank, north of concrete channel.

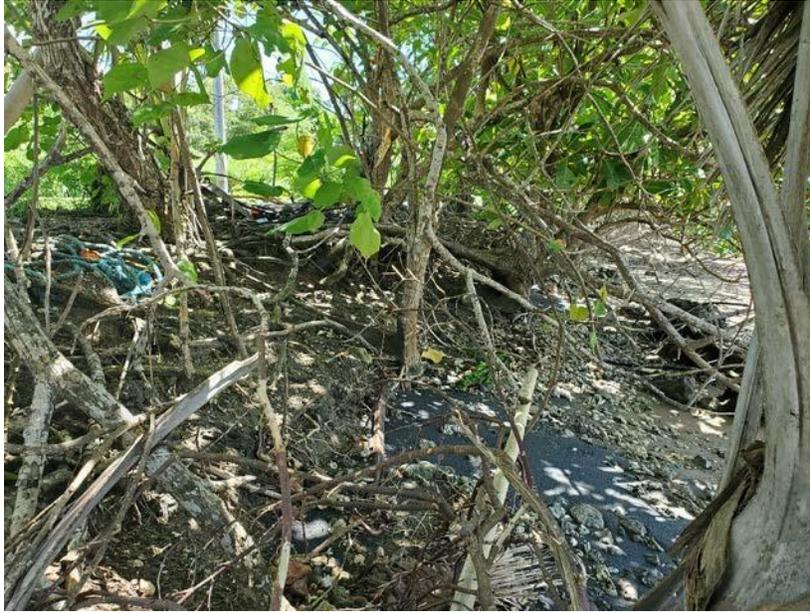
Site Name: Ajayan Bay Shoreline Restoration		ID#: R-01
DESCRIPTION		
Type of Project: Coastal Shoreline Stabilization	Preliminary Ranking: High	
Existing Conditions: Eroding shoreline (some veg), minimal mangrove presence.	Site Location:	
Proposed Solution: Bank stabilization and mangrove restoration

Photo Caption: Existing shoreline is actively eroding, even where vegetation is growing.

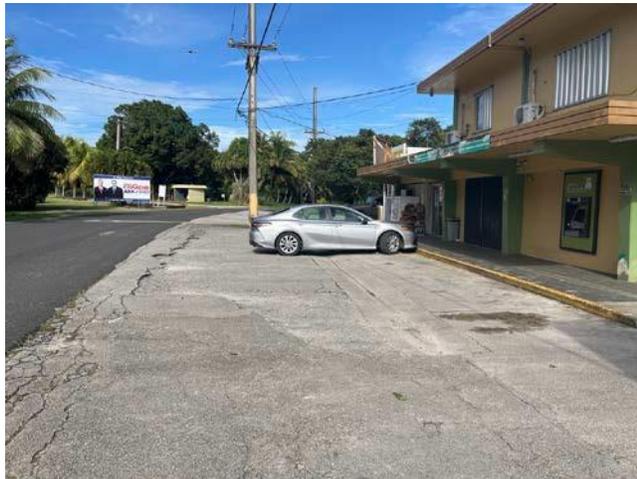
Existing Conditions: This is the only gas station in Merizo as well as a mini mart. Concrete channel carries flows underneath where people park as well as where people get gas. Potential for gas and other hydrocarbons to drip into the drainage channel and flow downstream.

Photo Caption: Parking in front of the mart next to gas station. Stormwater flows toward gas pumps along curb.

Proposed Solution: Proposed solution here is to block the drainage channel and reroute flows around fueling station to prevent leaks from entering stormwater.

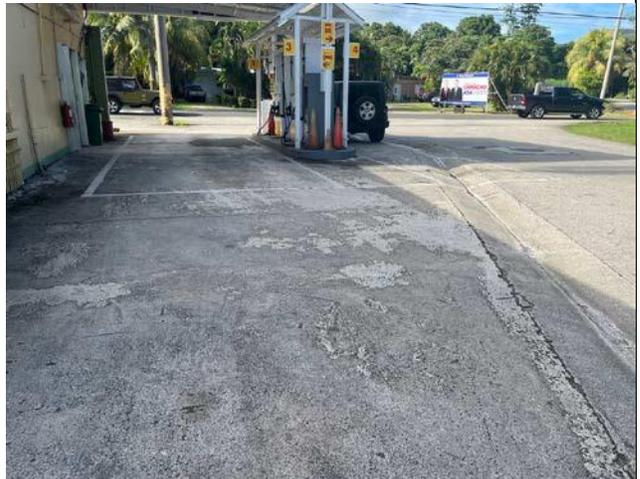
Photo Caption: Stormwater flows in the V-shaped paved channel from front parking area through fueling area. This increases opportunity for runoff to carry spills and leaks downstream toward water.

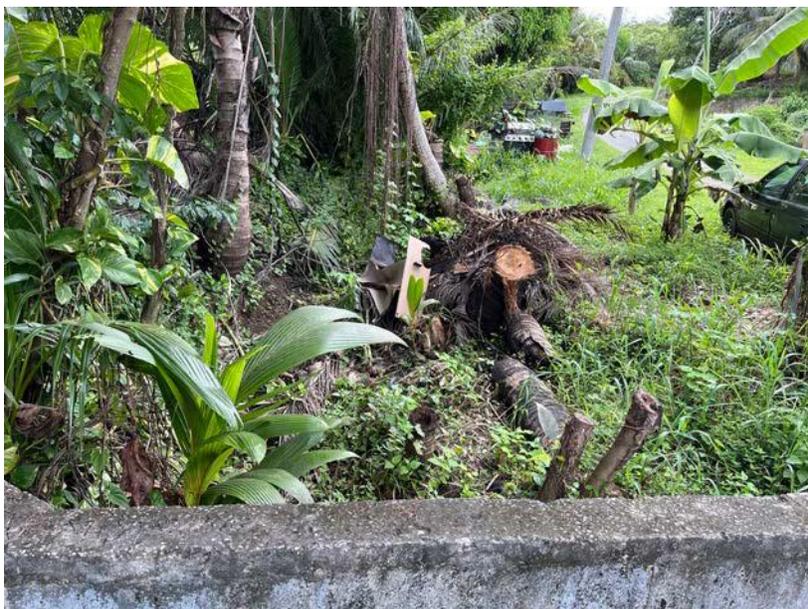
<p>Type of Project: Residential Stewardship</p>	<p>Preliminary Ranking: Medium</p>
<p>Existing Conditions: Tributary stream channel clogged with both vegetative debris and household waste including burn piles. Likely, flows from drainage area are diverted onto road, adding to road flooding issues, due to this clogging.</p>	<p>Site Location:</p>

Photo Caption: Example of drainage flow path (looking upgradient from headwall) clogged with debris.

<p>Proposed Solution: Residential stewardship in this area would be helpful. Work with neighborhood to improve these conditions and make changes on their personal properties to complement a larger roadside project.</p>	
<p>Site Constraints: Private property. Overhead wires. Sewer.</p>	<p>Other Notes:</p>

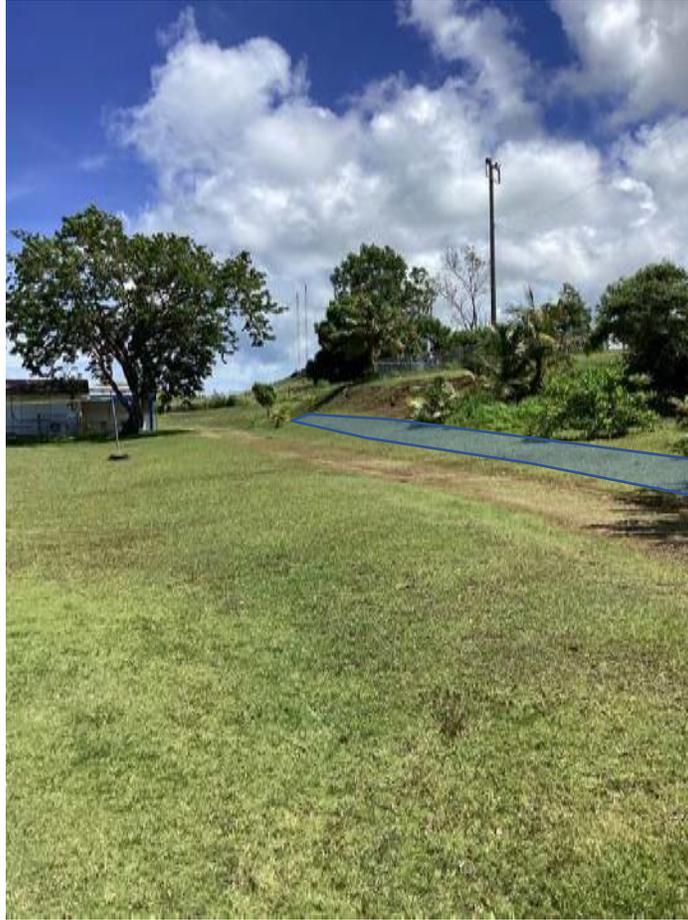
<p>Type of Project: Stormwater Retrofit</p>	<p>Preliminary Ranking: High</p>
<p>Existing Conditions: Staff informed us the field gets soggy and brown water runs off from grassed courtyard into the parking lot and road. Trucks will drive through field, get stuck, making muddy holes.</p>	<p>Site Location:</p>

Photo Caption: Access road along edge of grassy field and steep, eroding slope. Proposed cutoff trench as shown.

<p>Proposed Solution: Install cutoff trench along base of adjacent steep slope to intercept groundwater flowing through this area and divert it to proposed stormwater features for R-20. Stabilize steep slope with vegetation to better hold soil in place.</p>

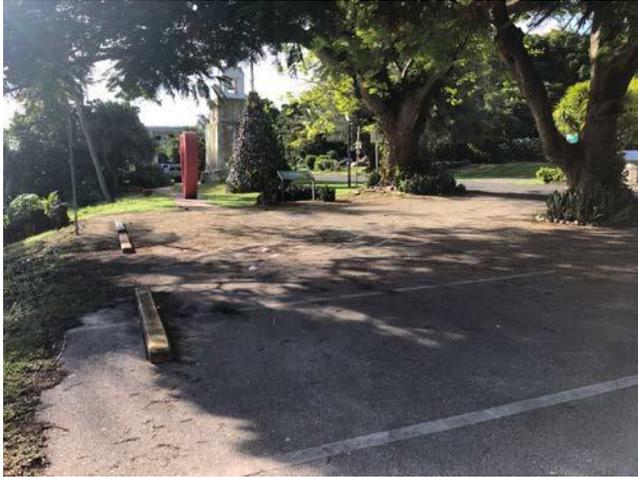
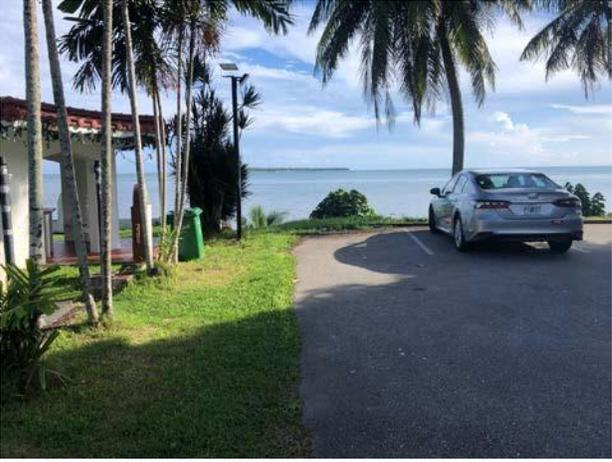
<p>Photo Caption: Parking lot with sediment buildup, staining, and bird droppings visible.</p>	<p>Photo Caption: This edge of the parking lot can be pulled back from the shoreline for a bioretention.</p>

<p>Proposed Solution: Shift parking towards road on east side to line up with road alignment. Add bioretention system to southeast corner of parking lot.</p>	<p>Site Constraints: Coastal bank, utilities</p>	
		<p>Other Notes: Noddy roost in large tree in parking lot. Hundreds of birds roosting here – need to be protected.</p>
PHOTOS/SKETCHES

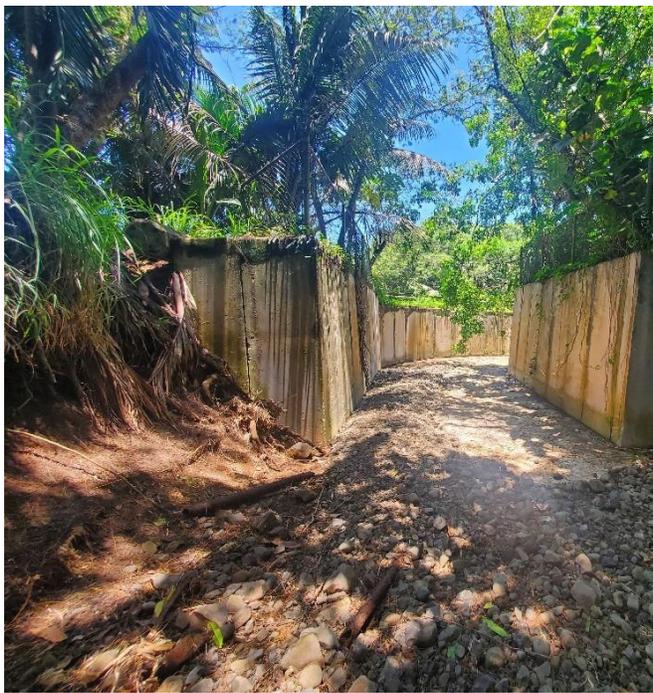
Photo Caption: Standing in river, looking toward 90-degree bend in concrete channel that runs along the road.

<p>Proposed Solution: Restore a more natural river path closer to historic location by constructing a culvert crossing immediately before the upstream 90-degree bent culvert and recreating a naturally shaped channel downstream of Route 4 to the ocean.</p>

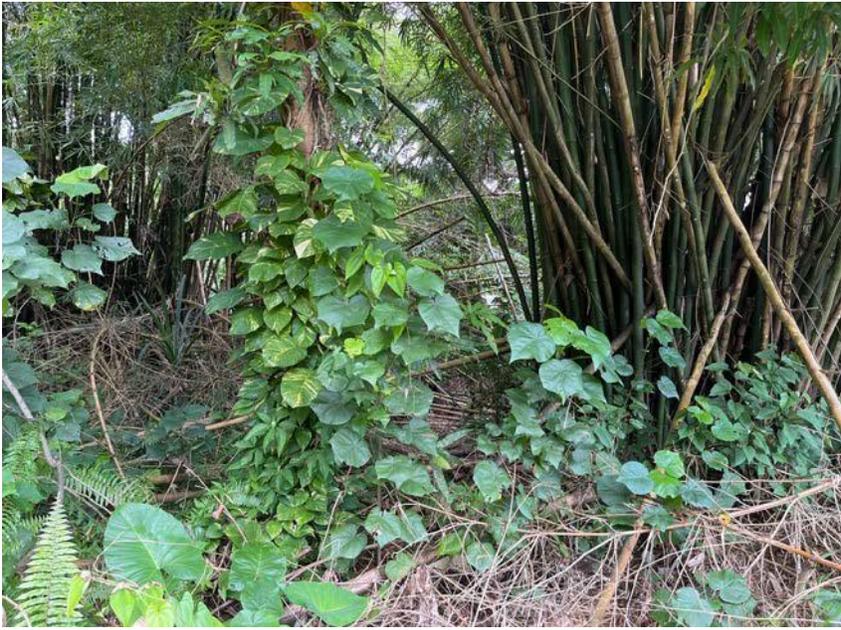
Photo Caption: Large clumps of bamboo on riverbank along Quinene Rd.

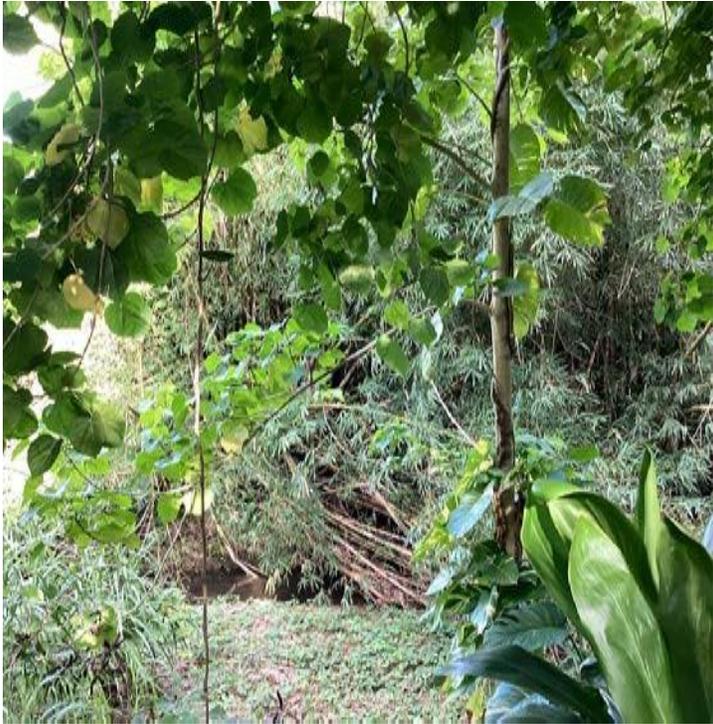
Photo Caption: Collapsed bamboo clump along river.

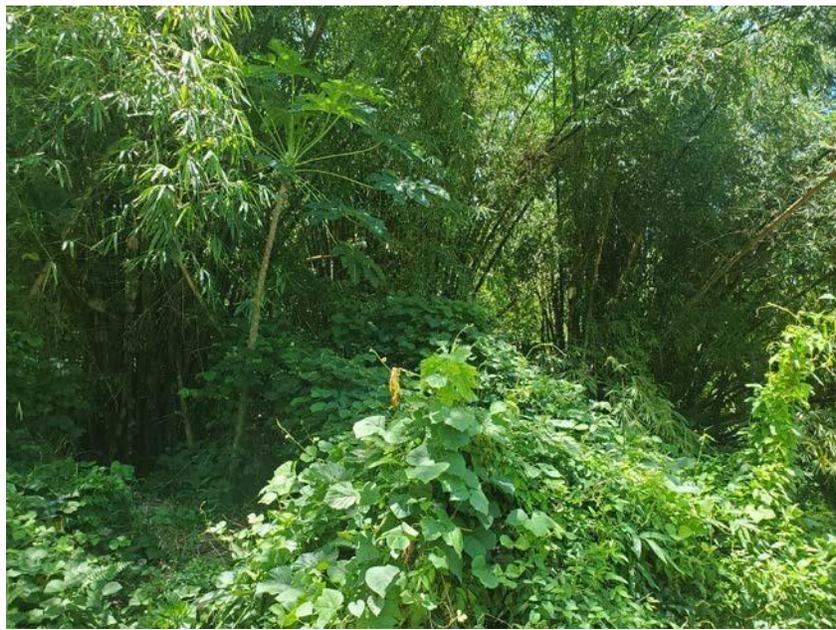
Photo Caption: Large stand of bamboo in area near past bamboo removal site.

Proposed Solution: Continued invasive mgmt, bank stabilization/revegetation	
Site Constraints: Access through private property. Commitment to invasive work.	Other Notes:
