# GUAM COMPREHENSIVE STUDY SHORELINE INVENTORY

#### **GUAM SHORELINE INVENTORY**

U. S. Army Engineer District, Honolulu Building 230. Planning Branch Fort Shafter, Hawaii 96858 Contract No. DACW84-79-C-0024

Sea Engineering Services, Inc./
R. M. Towill Corporation
- A Joint Venture Honolulu, Hawaii

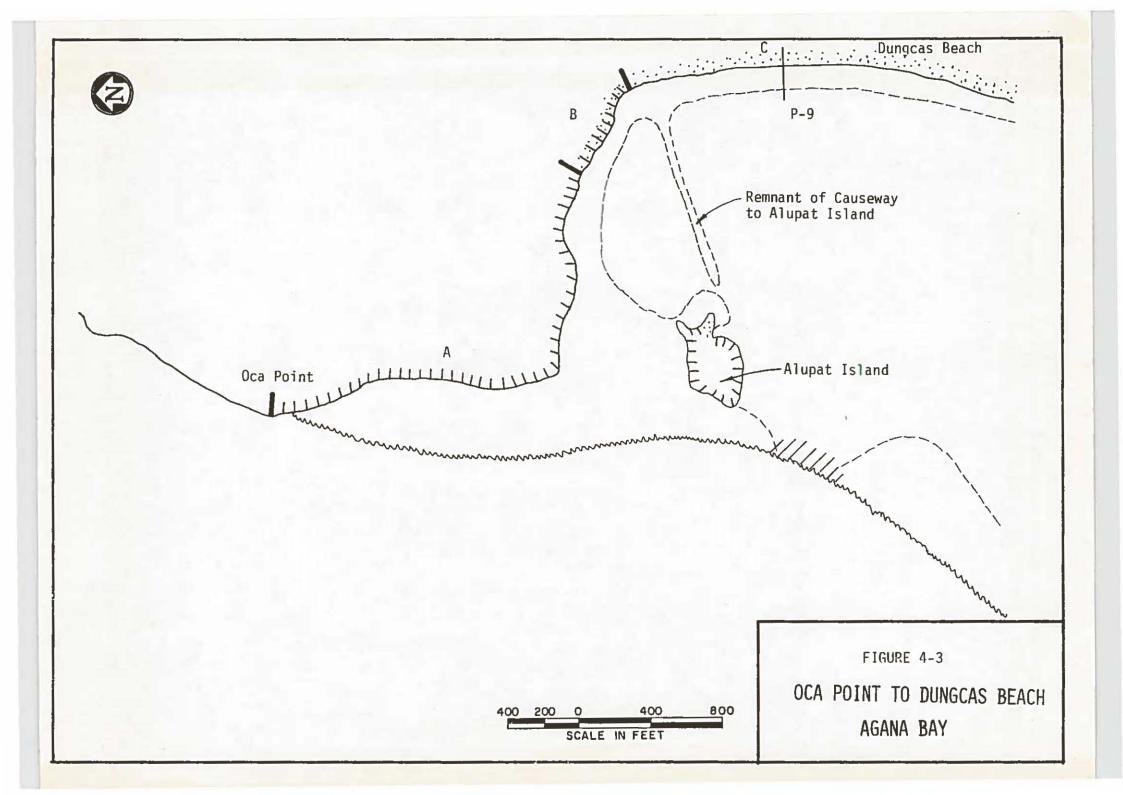
Typical View, Dungcas Beach

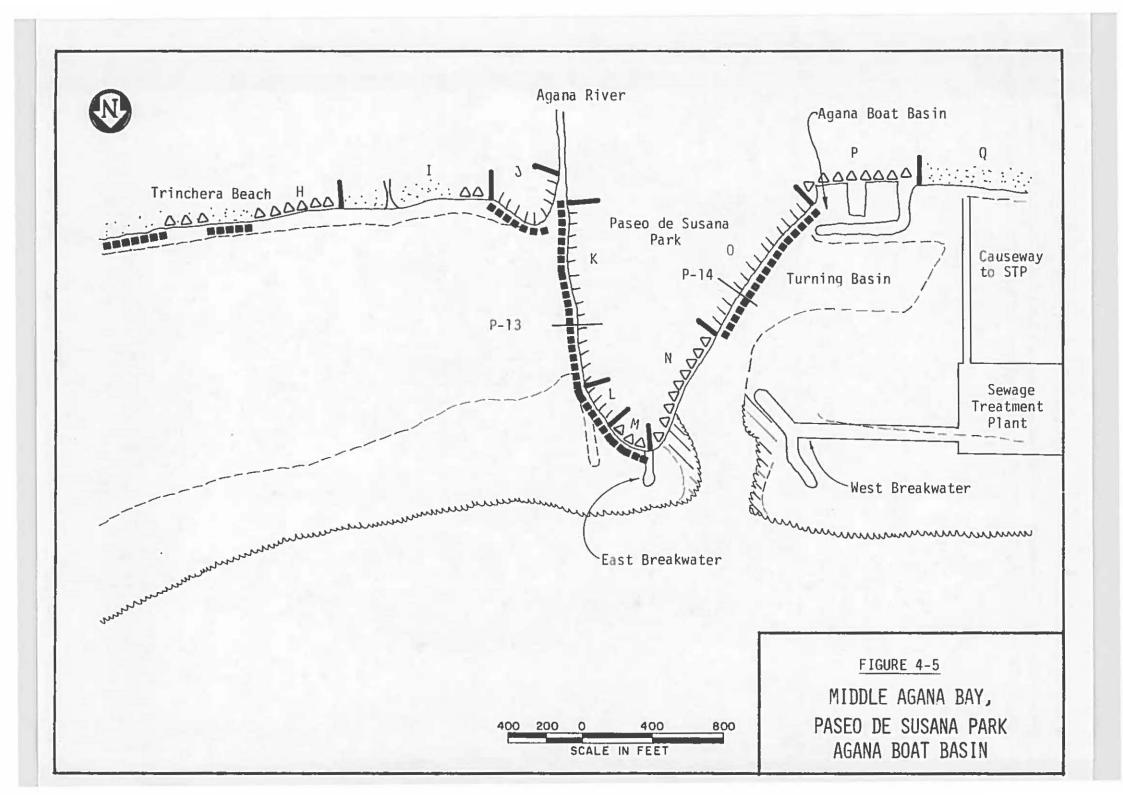
Typical View, Reach I

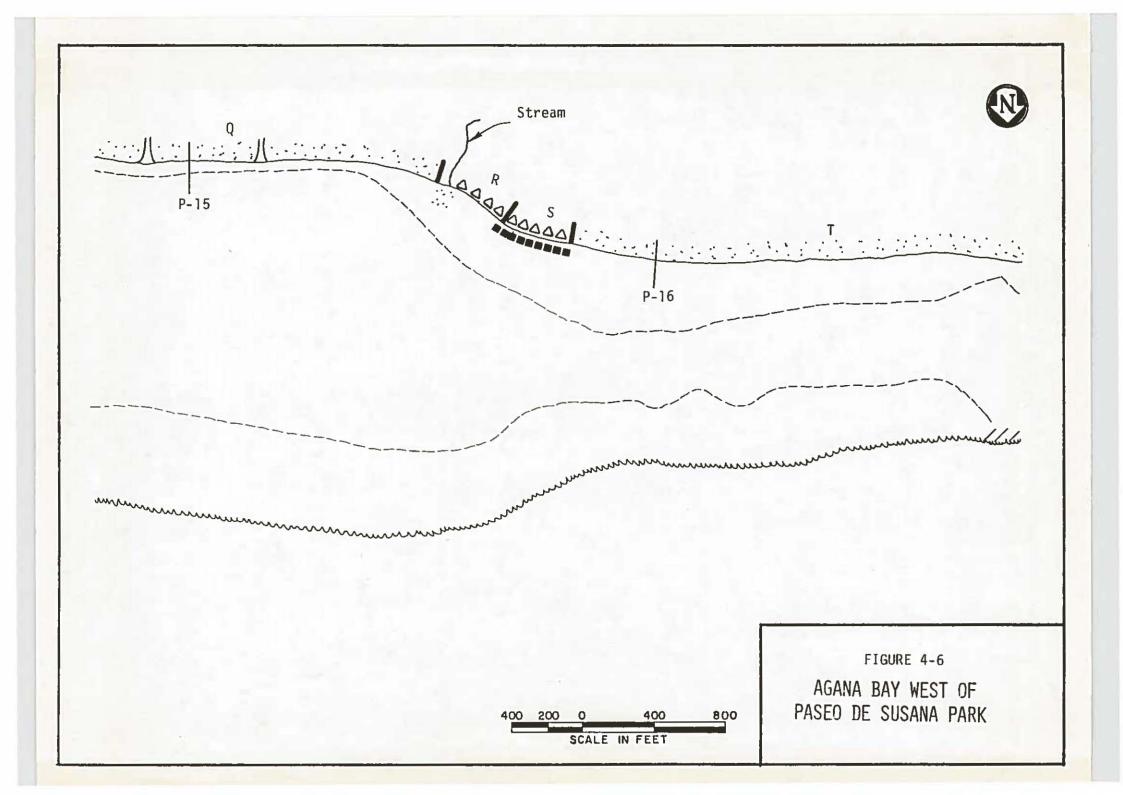
Foreshore, Reach R

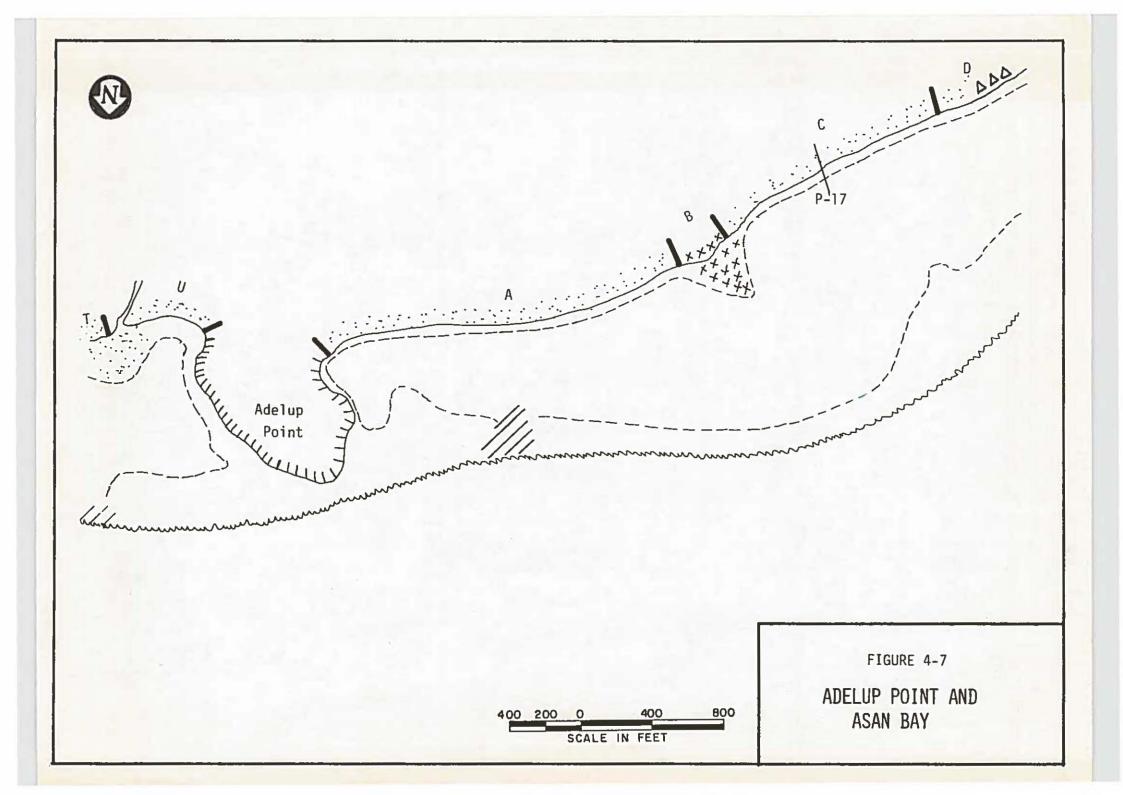
Park Shoreline, Reach U

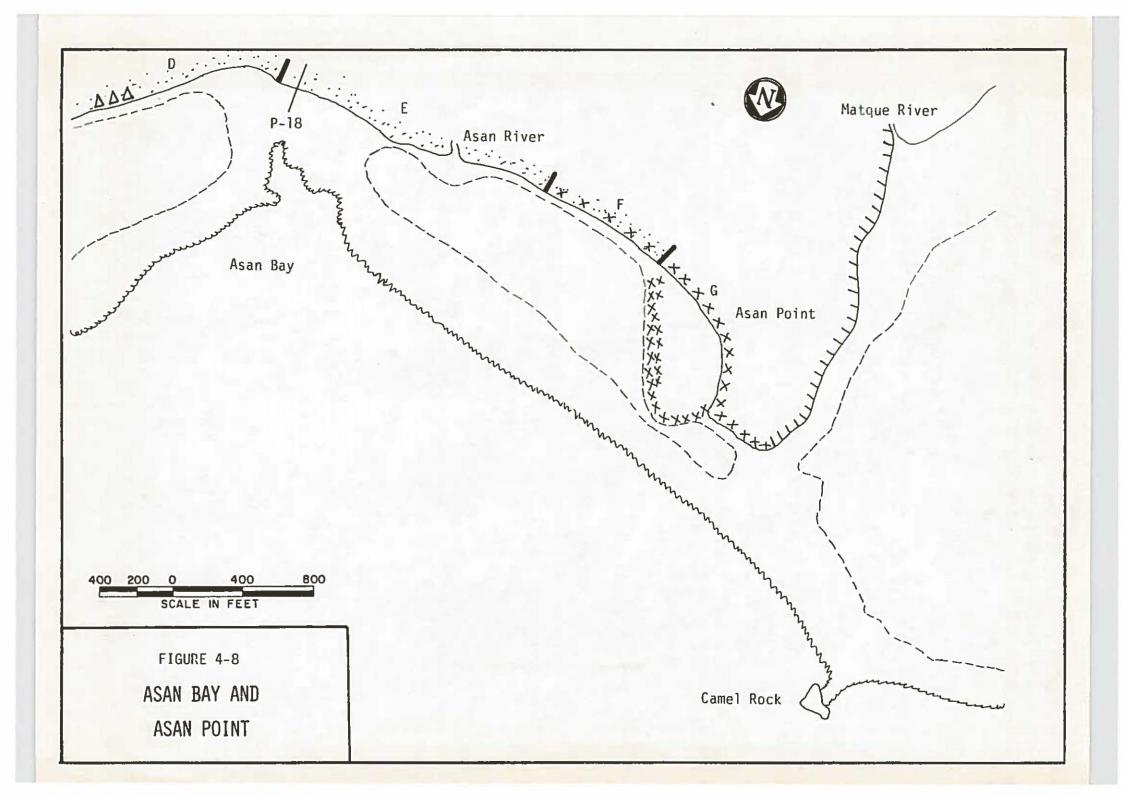
Reach E, West End

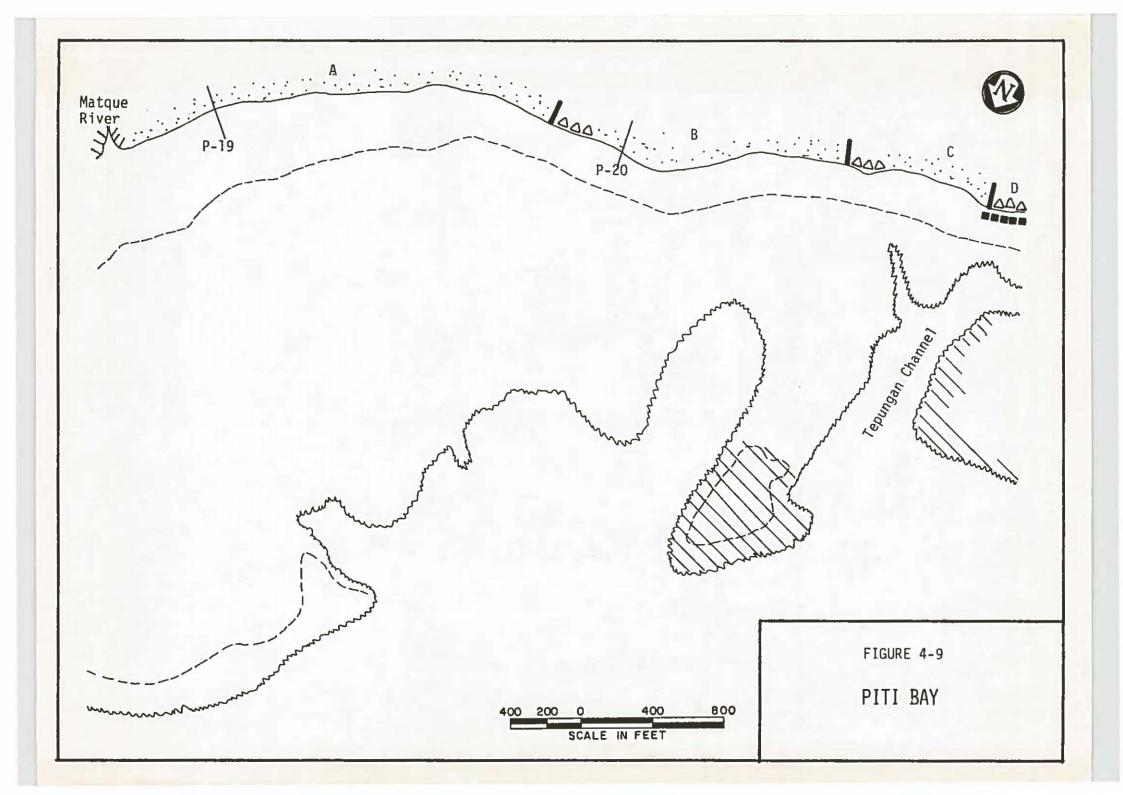
Typical View, Reach B

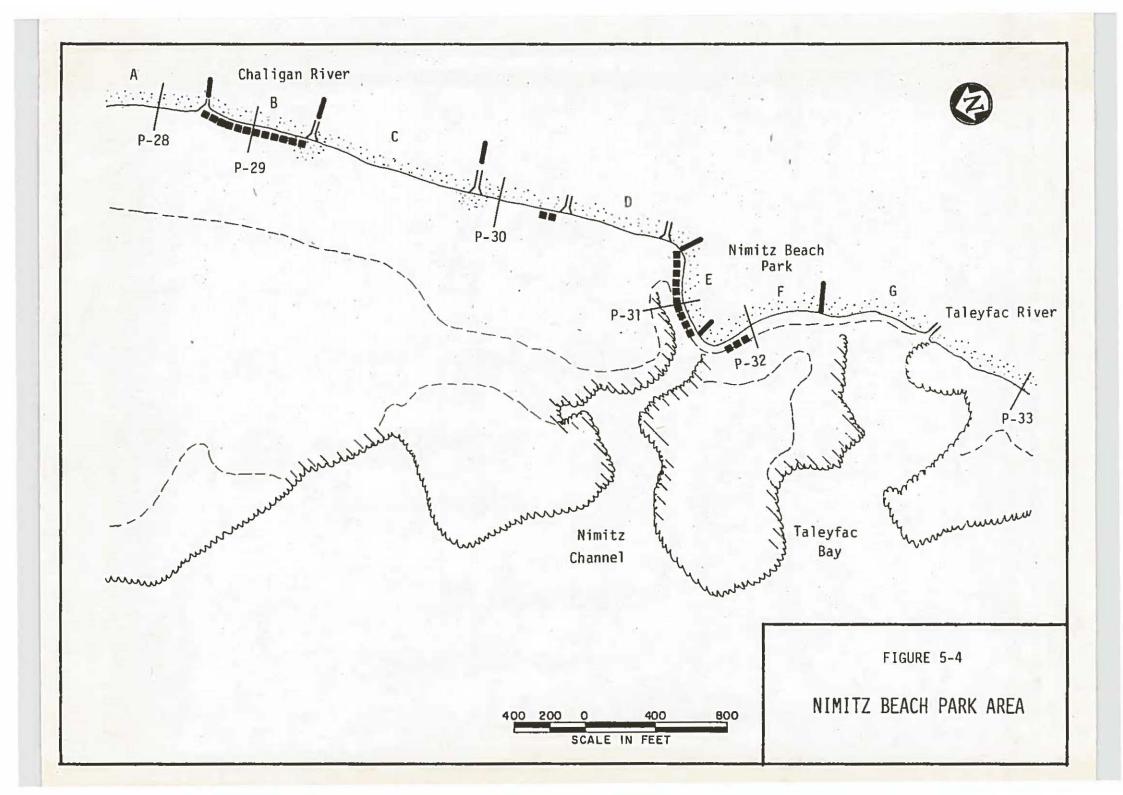
Eroling Shoreline Near Chaligan River

- The backshore along 400 feet of the reach south of the Chaligan River is eroding. Bare earth is exposed and the maximum height of the scarp is 6 feet. Profile 29 shows a typical cross section. At the point of most severe erosion, the scarp is within 32 feet of the highway.
- Classification Intermediate erosion.

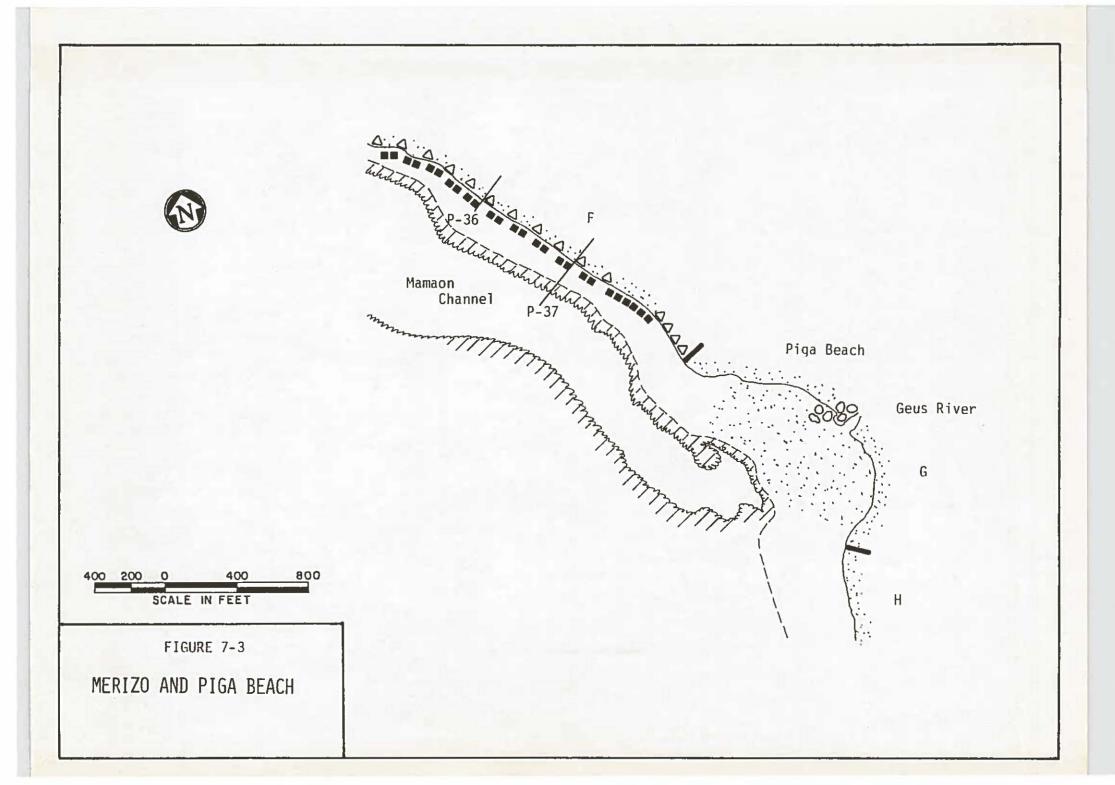
Rubble Seawall, Reach F

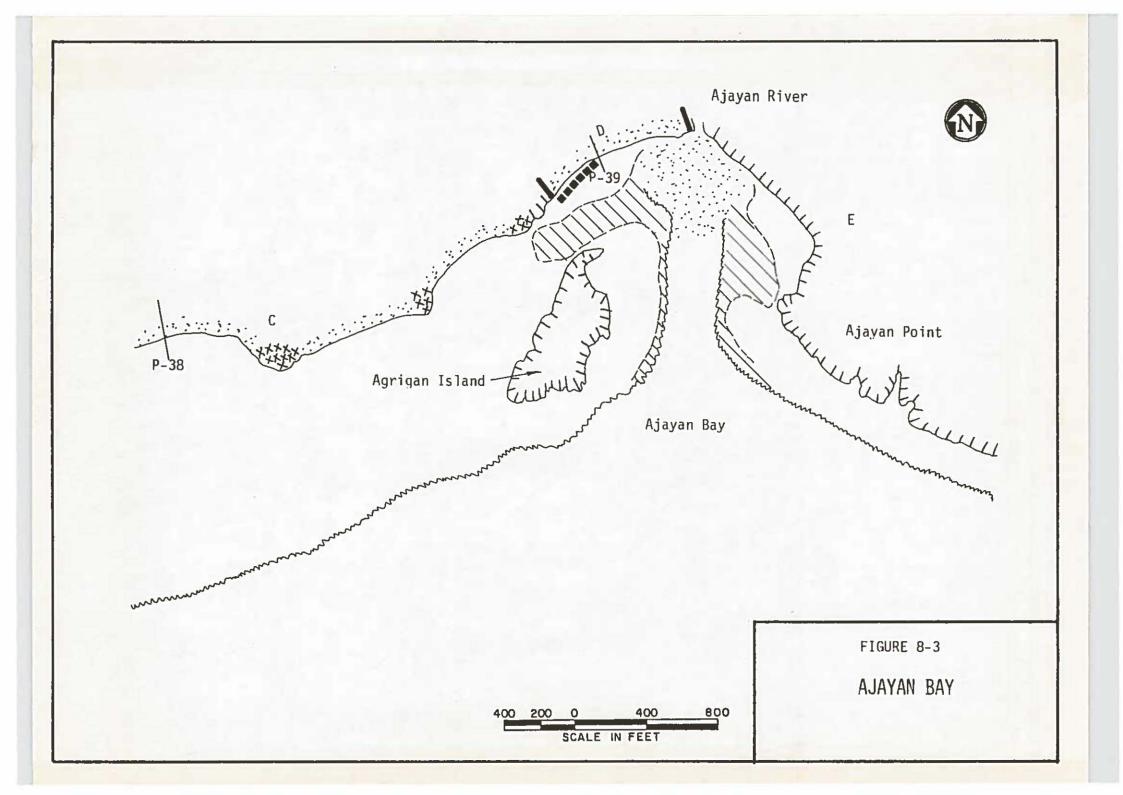
Typical View, Reach C

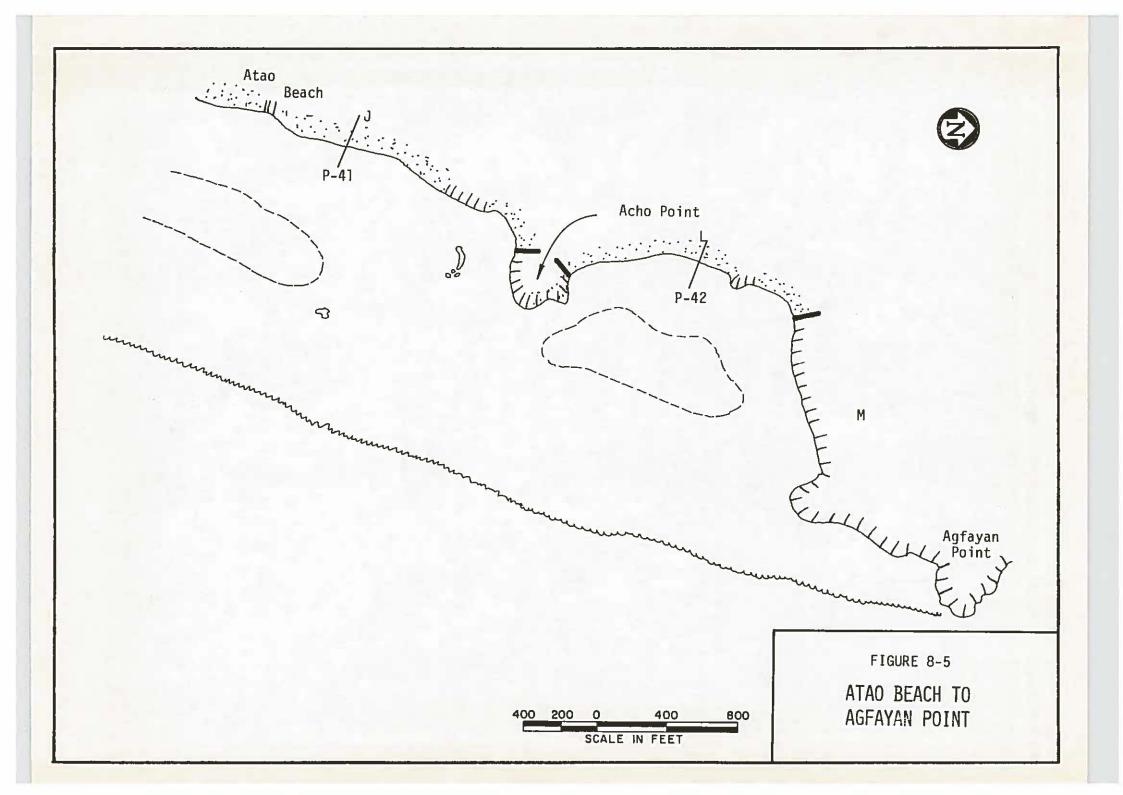
Atao Beach, Reach J

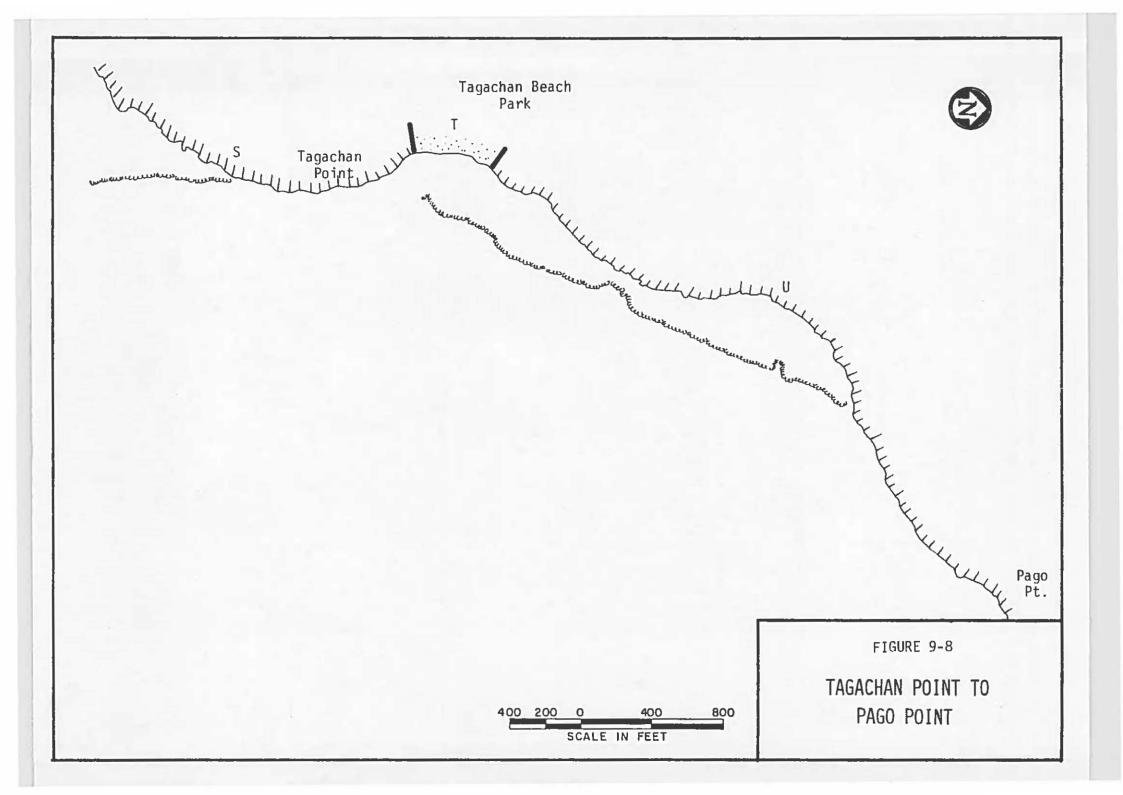
Tagachan Beach Park
