**Non-Jurisdictional Survey of Andersen AFB for  
Prospective Wetland Sites**

**July to 11, August 1995**

**Non-Jurisdictional Survey of Andersen AFB  
for Prospective Wetland Sites  
31 July-11 Aug 95**

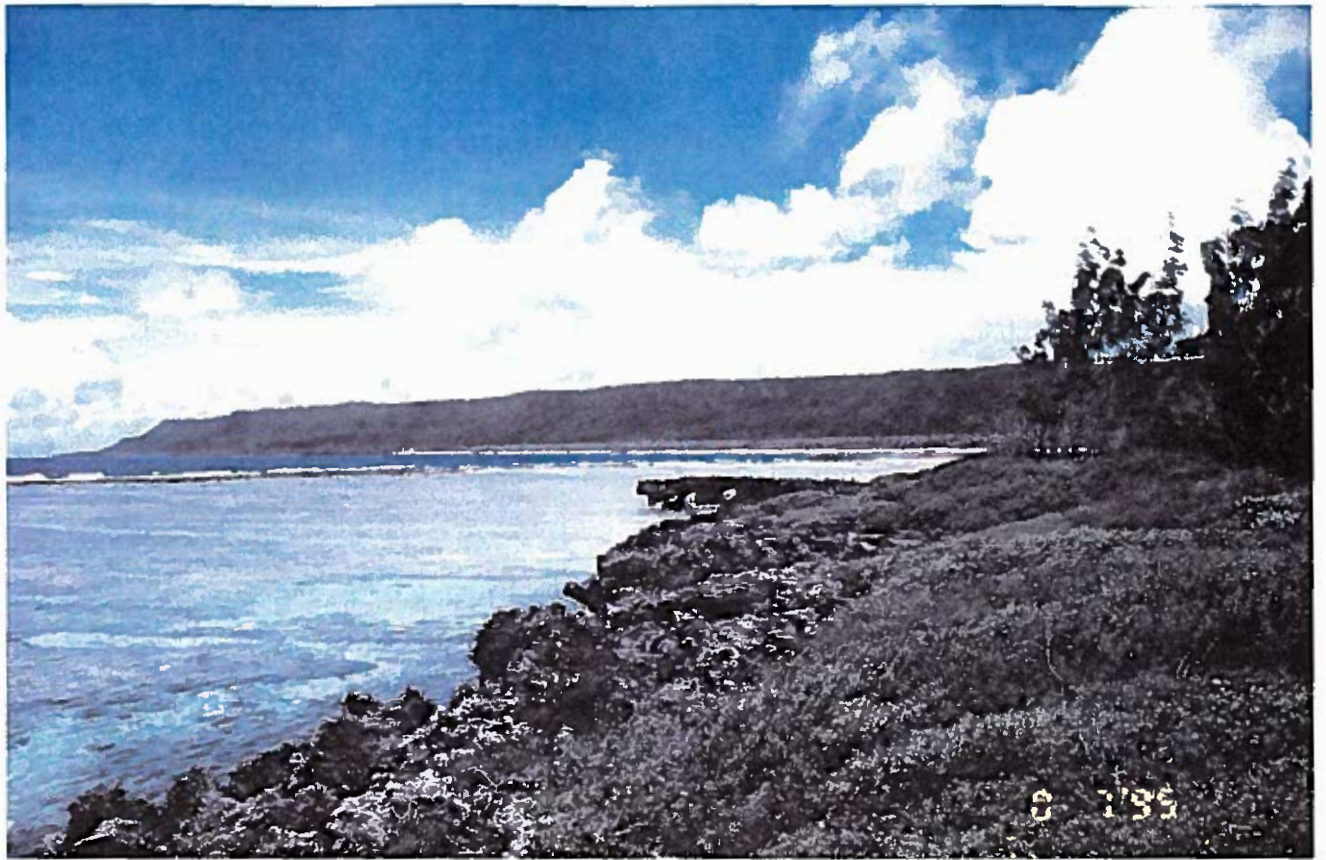
T1. Nigas grows in continuous thicket along Tarague coastline.

When we visited the area, however, we found the vegetation to be a succulent xerophytic-type shrub, Nigas, growing atop the rock, apparently collecting and storing superficial water from storms. Nigas (Pemphis acidula) grows in a continuous band on top and parallel with the reef from the Tarague Recreational Beach area, northeasterly, to and around Pati Point, (Fig. 1). The ground above the platform has no soil developed on it; rather the bedrock here is covered with a layer of well-sorted, medium-grained, white to very light yellow (approximately Munsell 10YR 8/2) carbonate sand. The vegetation here has apparently stabilized the beach sand, and the top 10-15 cm contains abundant dark particulate organic matter (est. app. 15%). There is no evidence of surface inundation or extended saturation of the stabilized surficial sand. In fact, the conspicuous aspect of the terrain here is that the "soil" is well drained. We found no hydrophytic species.

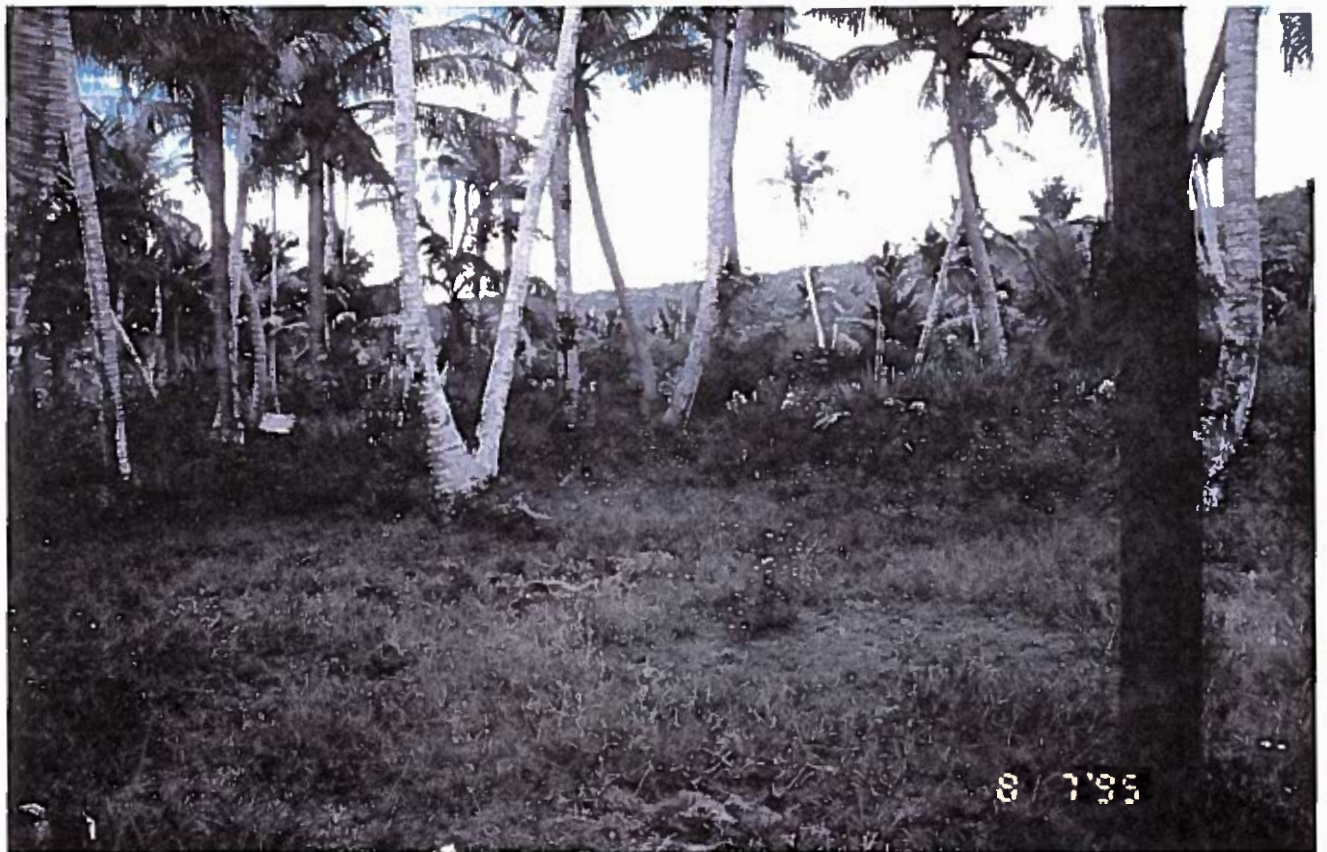
T2. Scuba Cut parking area, showing typical grasses.

T2: Tarague Channel area and nearby abandoned wells: Hydrologic conditions and soil are similar to T1. Some suspect features located on aerial photos near Tarague Channel included dark green vegetation at the base of the slope to the beach. One patch is contiguous with a sink that is intersected by the slope to the beach just above the channel. During the site visit this vegetation was confirmed to be the same xerophytic shrub, Pemphis acidula, growing in the adjacent T1 area. On the terrace just above Scuba Cut, near the parking lot and adjacent areas west and south of Tarague Channel, are abundant patches of Spiderlily (Pancratium littorale, Figures 2 & 3). Dominant plants, grasses, and one sedge found within this stabilized beach sand medium include; Sandbur (Cenchrus echinatus L.), Swollen Fingergrass (Chloris barbata), Beach Wiregrass (Dactyloctenium aegyptium L. Richt.), and Fimbry (Fimbristylis Sp.). The maximum water table elevation here could not rise to higher than about two meters below the surface, and the surface medium was moist but well drained, showing no evidence of saturation or inundation.

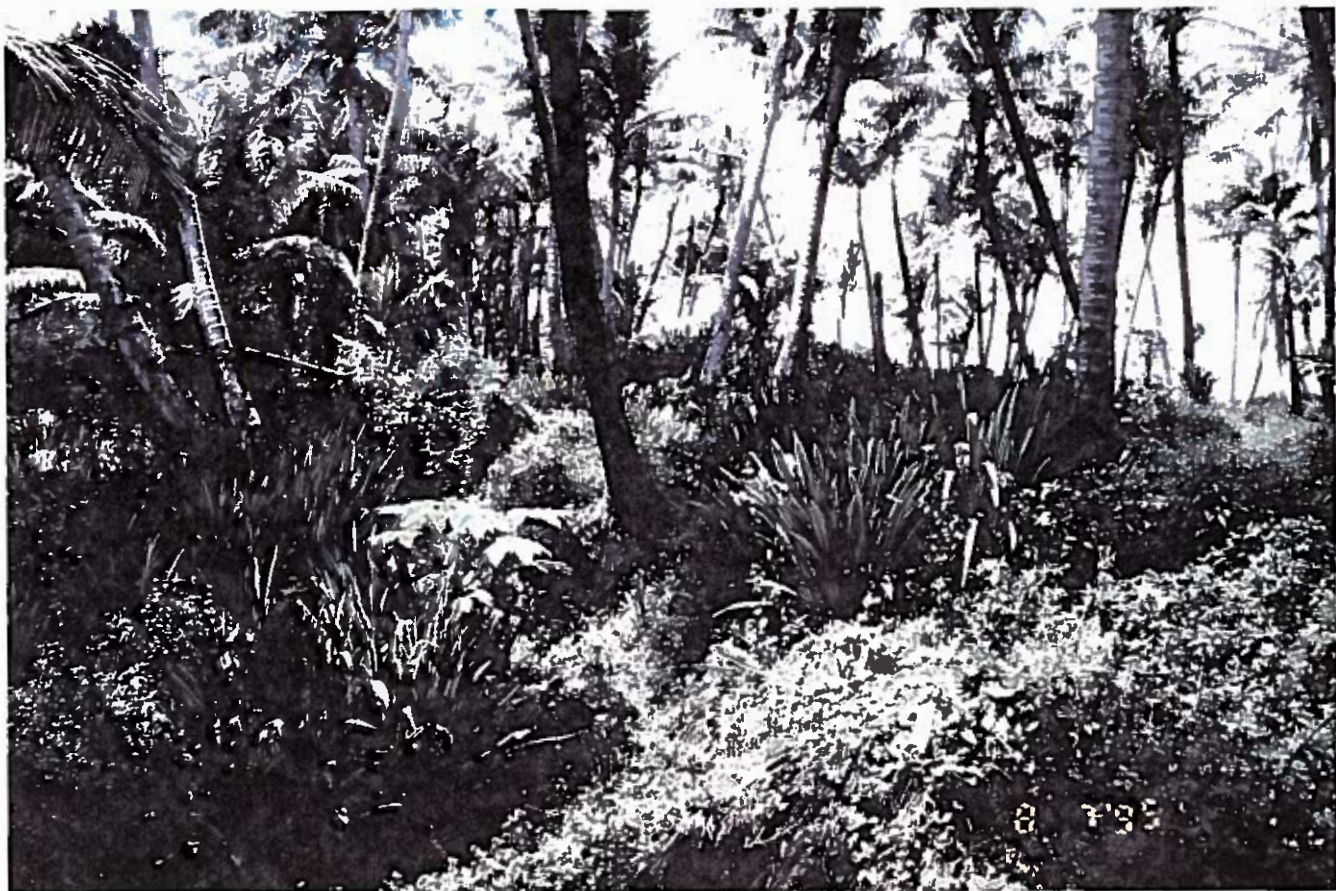
T3. Typical vegetation west of Tarague channel.

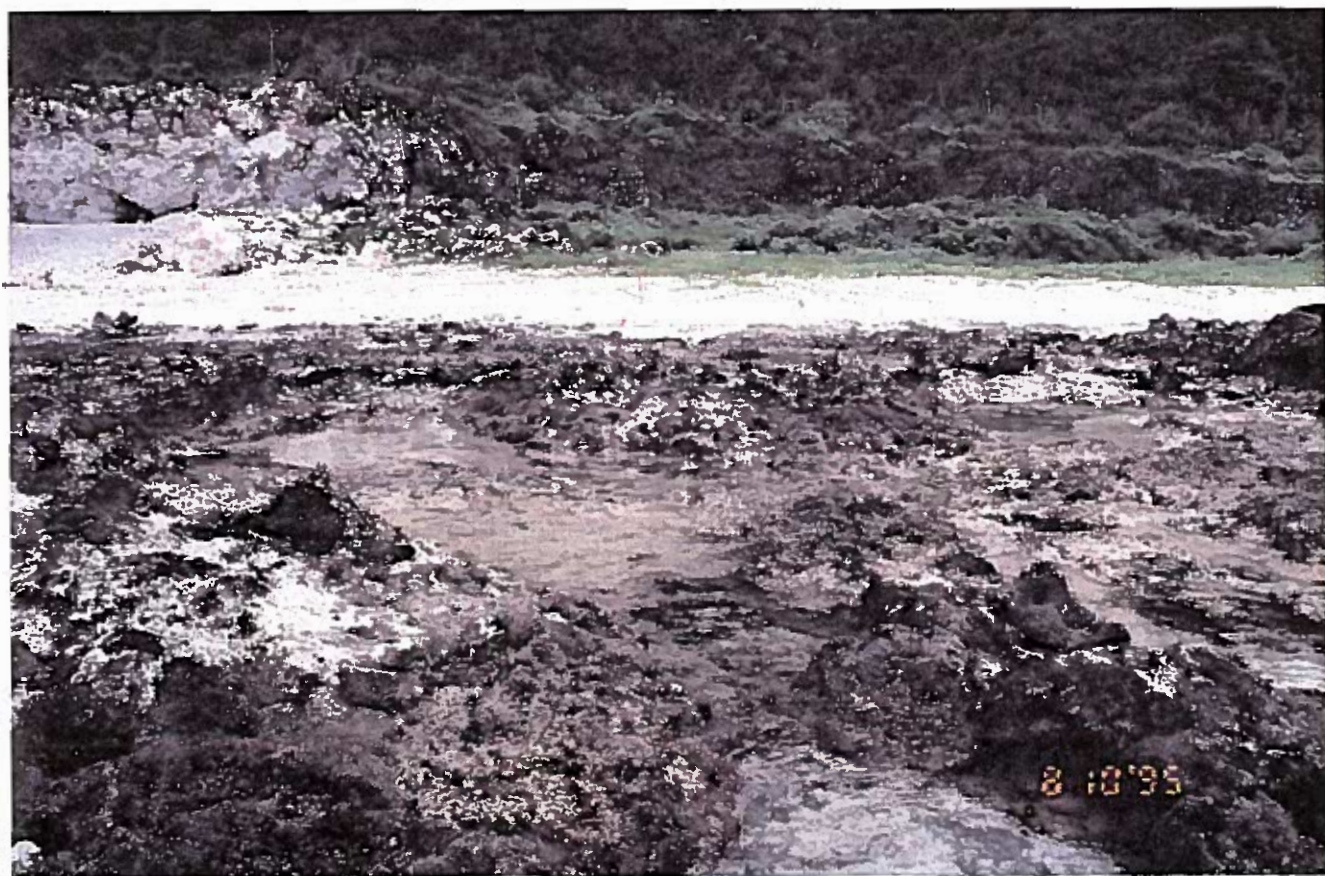
T3: Tarague Beach to Tagua Point: This area is currently used by AAFB as an explosive ordinance disposal (EOD) range. The shoreline consists of modern and eroded Holocene reef platform with an extensive beach behind it. Fresh water rises through the platform on the beach in seeps and springs, and small pools of fresh water abound on the

T4. Coastal fresh water discharge into the shallow pools at EOD Range on platform.

near-shore platform (Fig. 4). Behind the beach, a well-drained, stabilized sand medium supports a well-developed strand community, as in the T1 and T2 areas.

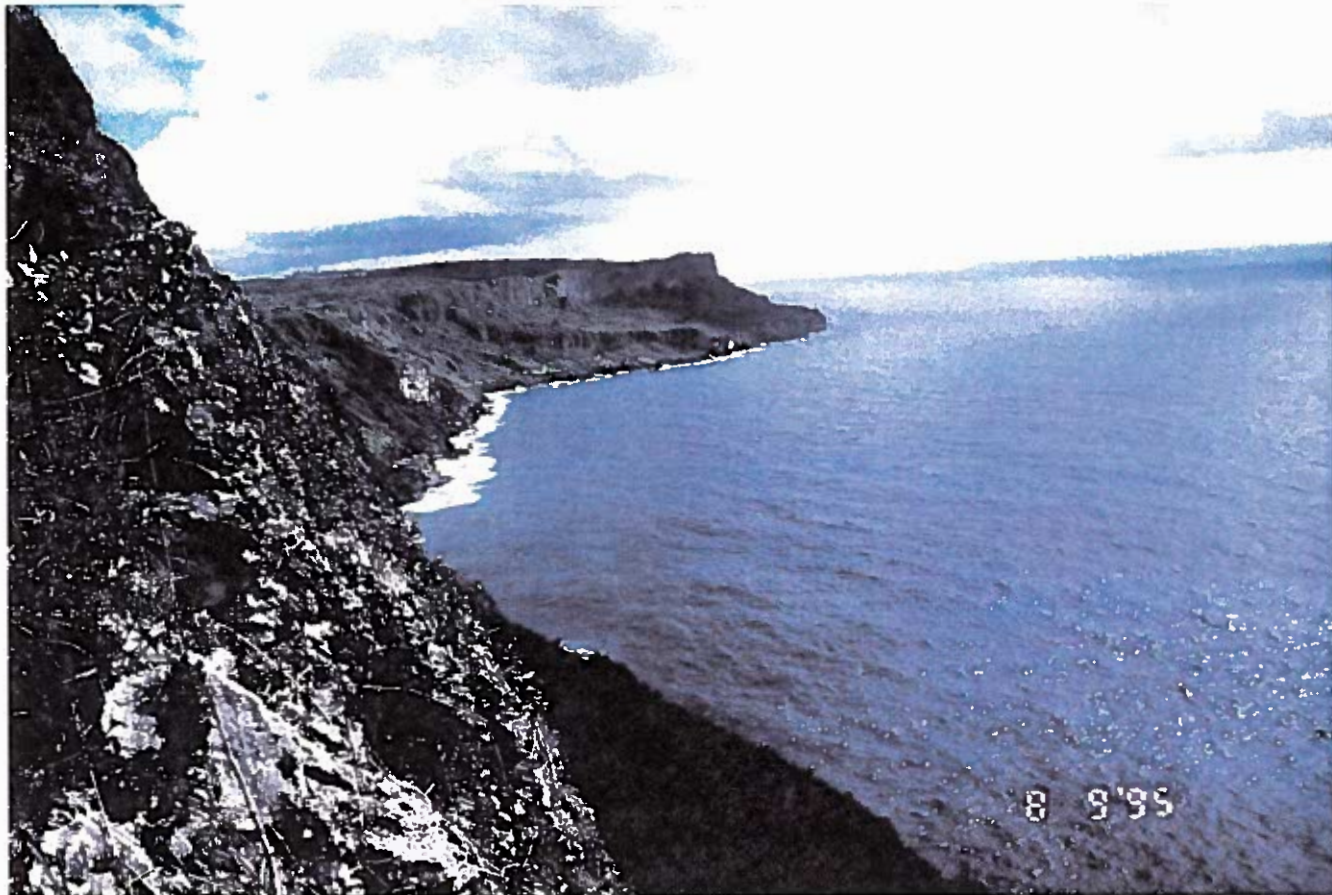
T5: Pati Point to Ahaio Point: In this area shear cliffs descend to narrow platforms that terminate in a rugged, rocky coast without beaches (Fig. 5). The coastal platform is elevated about 1 to 2 meters, so that the terraces are very well drained of surface water and no groundwater intercepts the surface here. An interesting observation here is the presence of the Spiderlily-like plant growing on the cliff face. The plant is known to grow in wet or moist areas but appears capable of growing on this exposed, very well drained, rocky environment as well, (Fig. 6).

T5. Coastline near Anao Pt looking toward Pati Pt, sheer cliffs, rugged coastline, narrow platform.

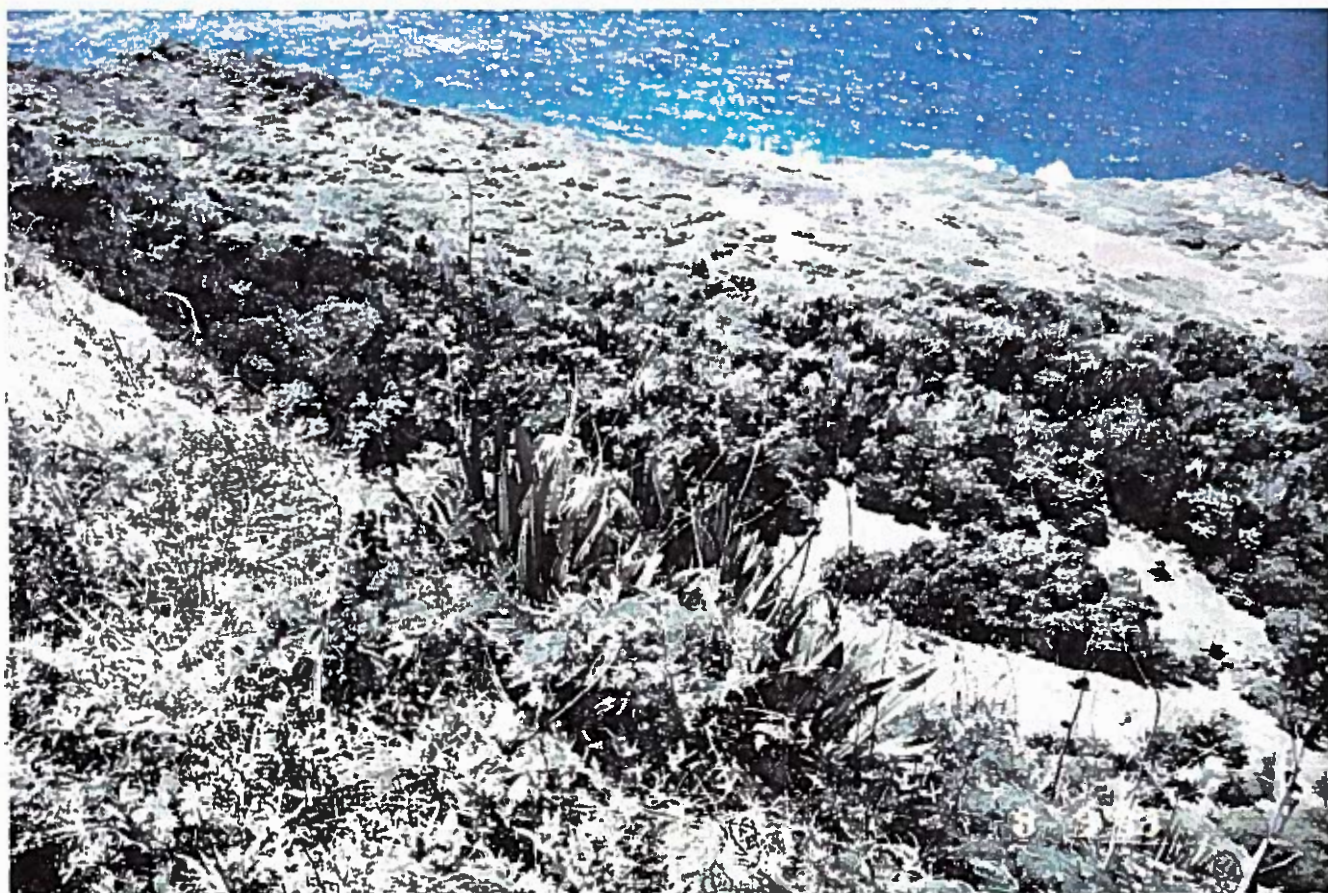
T5. Spiderlily plant growing on cliff top N. of Lafac Pt.

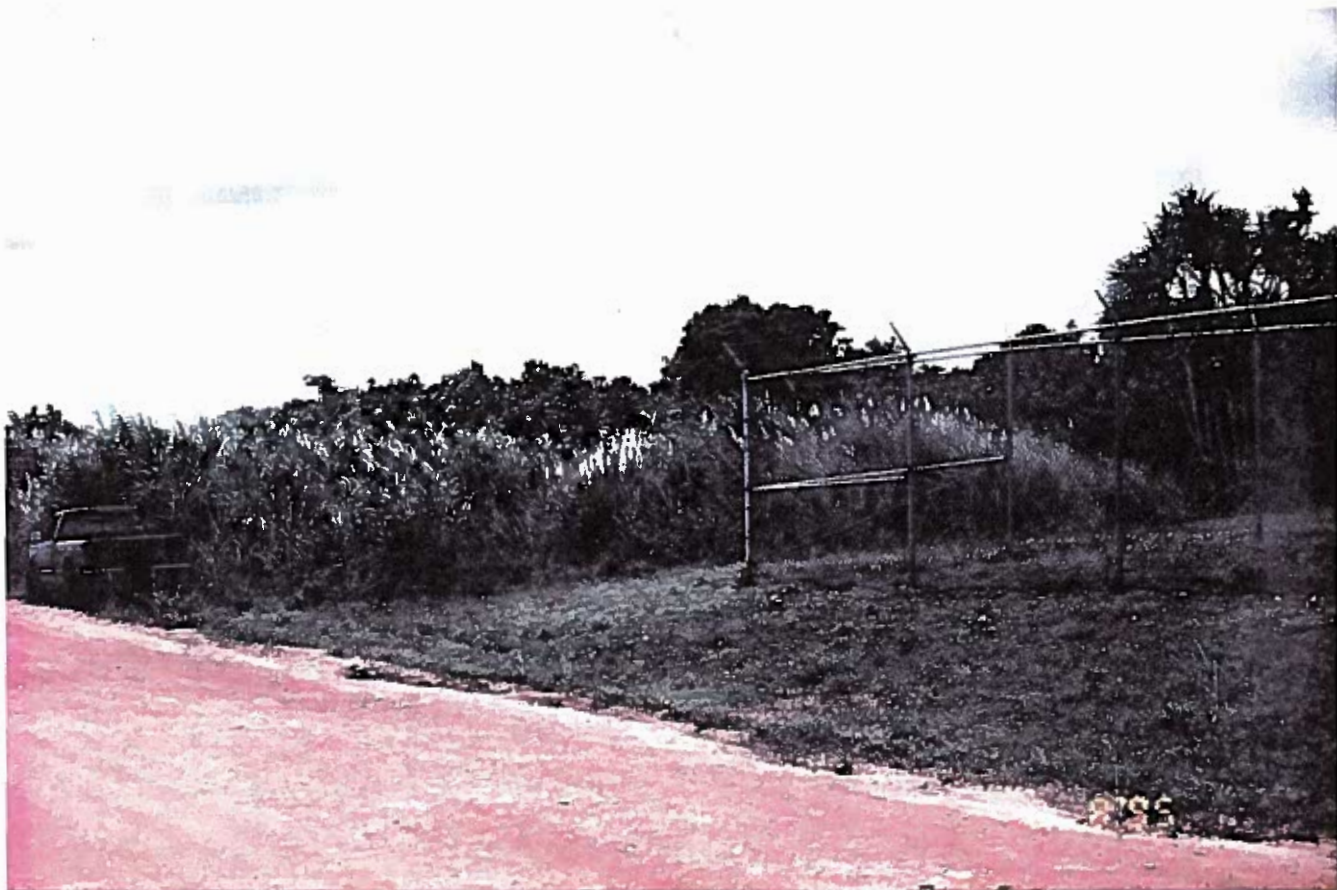
A1: Landfill 5 IRP site. This site is a remediated landfill that has been covered by an impermeable capping material to prevent percolation of water through the landfill. Water shed from the cap is collected by a lined drainage ditch and diverted off the site at the southwest and northeast corners of the structure. The areas into which the water drains support thick stands of Wildcane (*Saccharum spontaneum* L., Fig. 7). There was some ponding of recent storm water along the nearby unpaved roads, (Fig. 8).

A1. S.W. corner of Landfill Cap, water diversion, with wildcane grass in background.

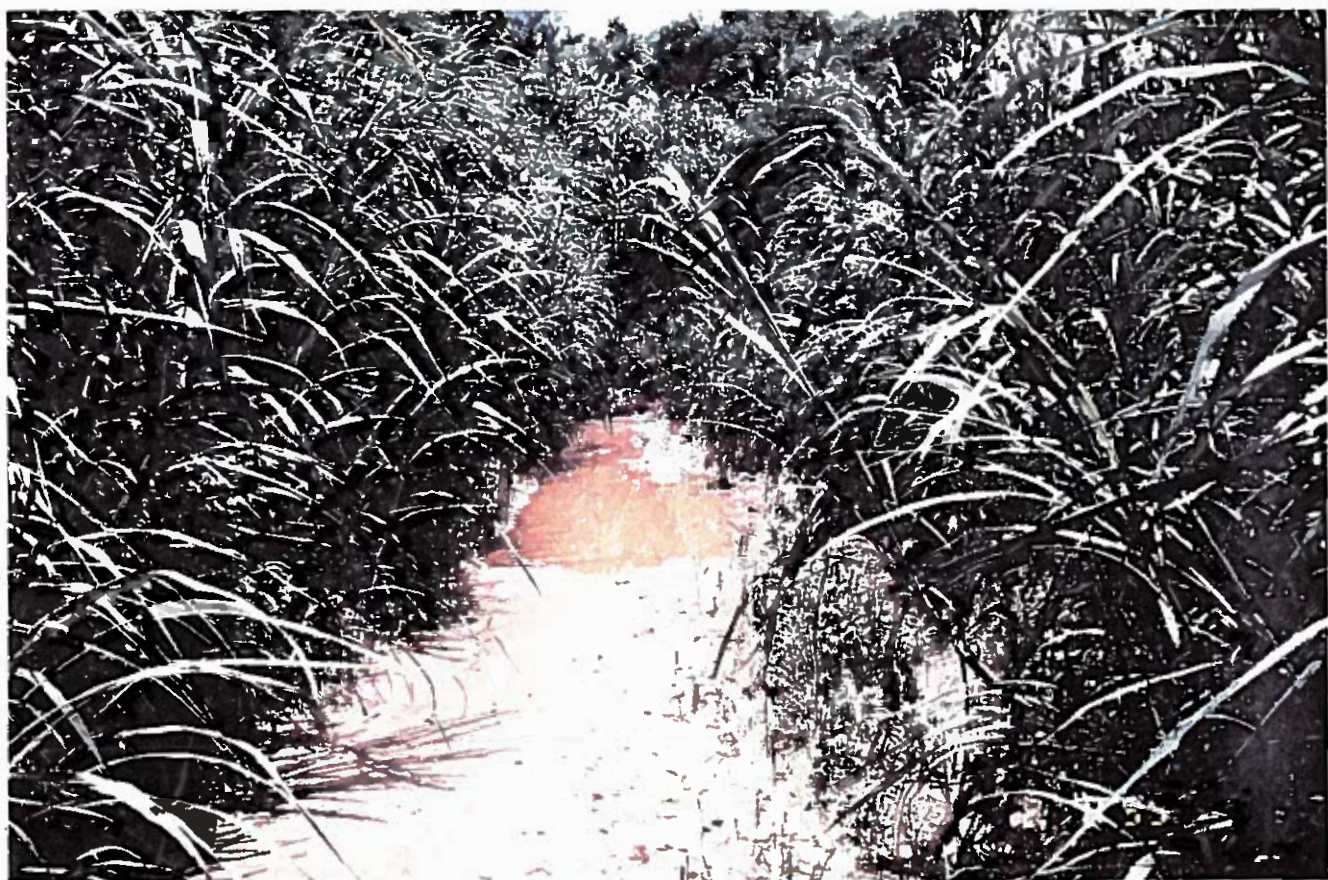
The nature of the thin, silty soil found in the landfill area allows water to pool temporarily, typically less than a few hours depending upon rainfall duration. No area is persistently saturated, and landfill operations constantly alter the vegetation and topography to ensure constant drainage and minimum potential for wetlands establishment.

A1. Localized ponding on road in Landfill area.

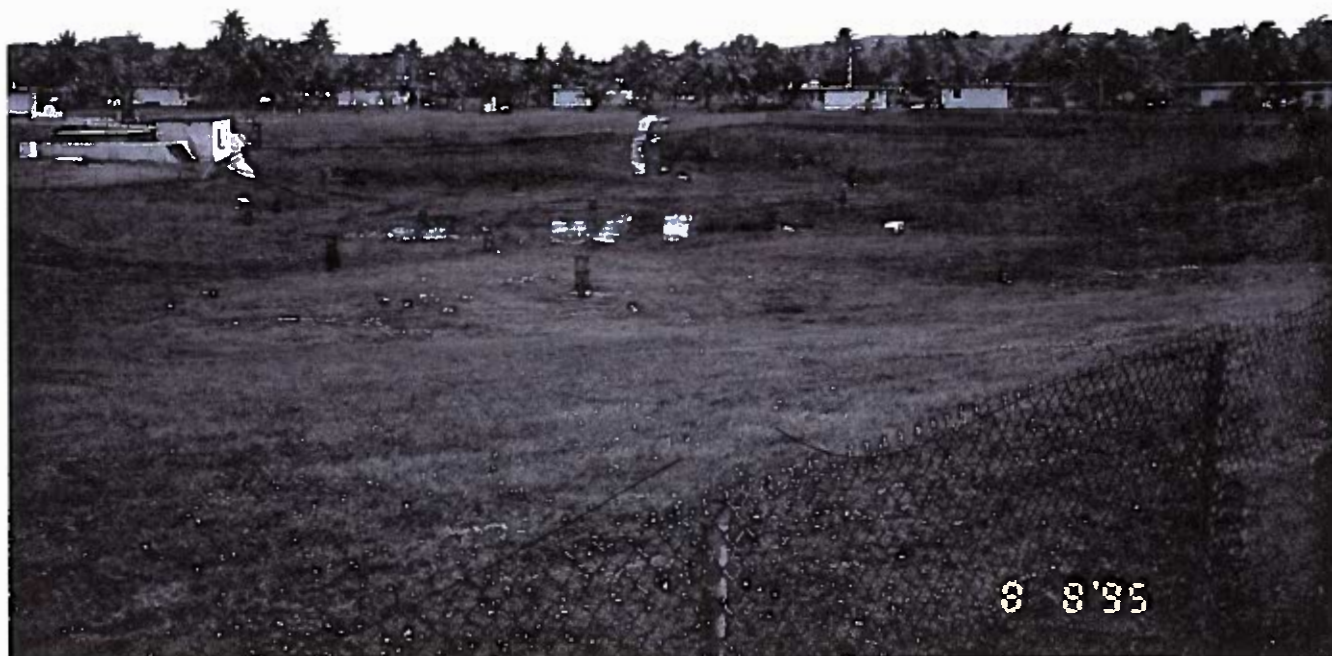
A2: Storm drainage collection site in family housing. A large natural sink in the family housing area at the SE corner of the main base has been developed to accept storm runoff from the housing area. Inflow is fed to the sink by several concrete flumes, and infiltration has been enhanced by the installation of over a dozen drainage wells at the base of sink (Fig. 9). Although inspection of a dry- season aerial photo showed green vegetation at the bottom when the lawn in the housing area were brown, our field visit

A2. Storm water drainage wells in housing area.

confirmed that the sink is sufficiently well drained to preclude colonization by hydrophytic vegetation.

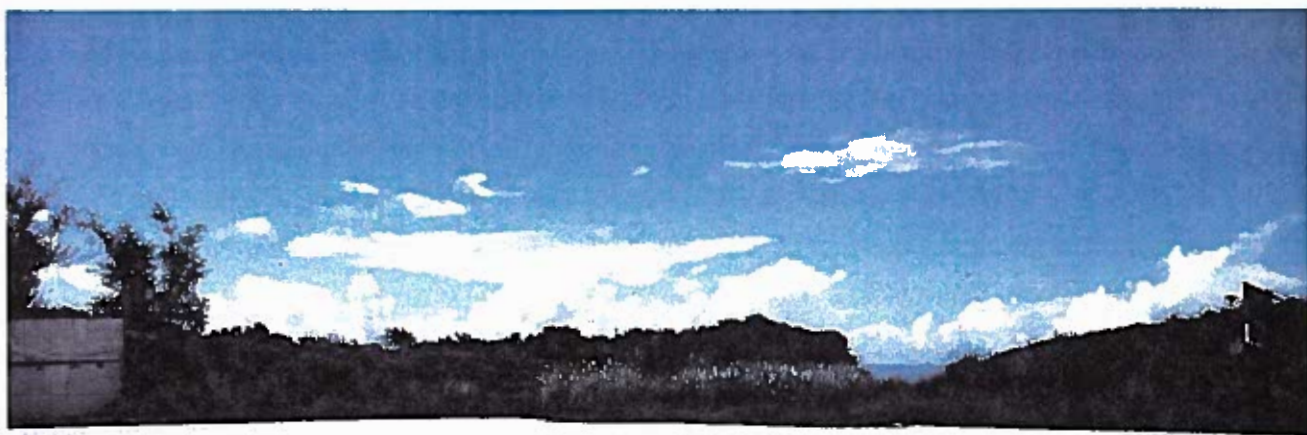
A3. Munitions Maintenance Area showing concrete apron foreground, water diversion and wildcane grass(in background, center.)

A3: Munitions Maintenance Area: Storm drainage from an extensive paved apron on the north side of the building is diverted through a small ravine (Fig. 10) to an adjacent abandoned borrow pit (Fig. 11). There is no ponding of the water here and where soil exists, it is well-drained. Thickets of Wildcane grows where the water is diverted from the apron to the borrow pit.

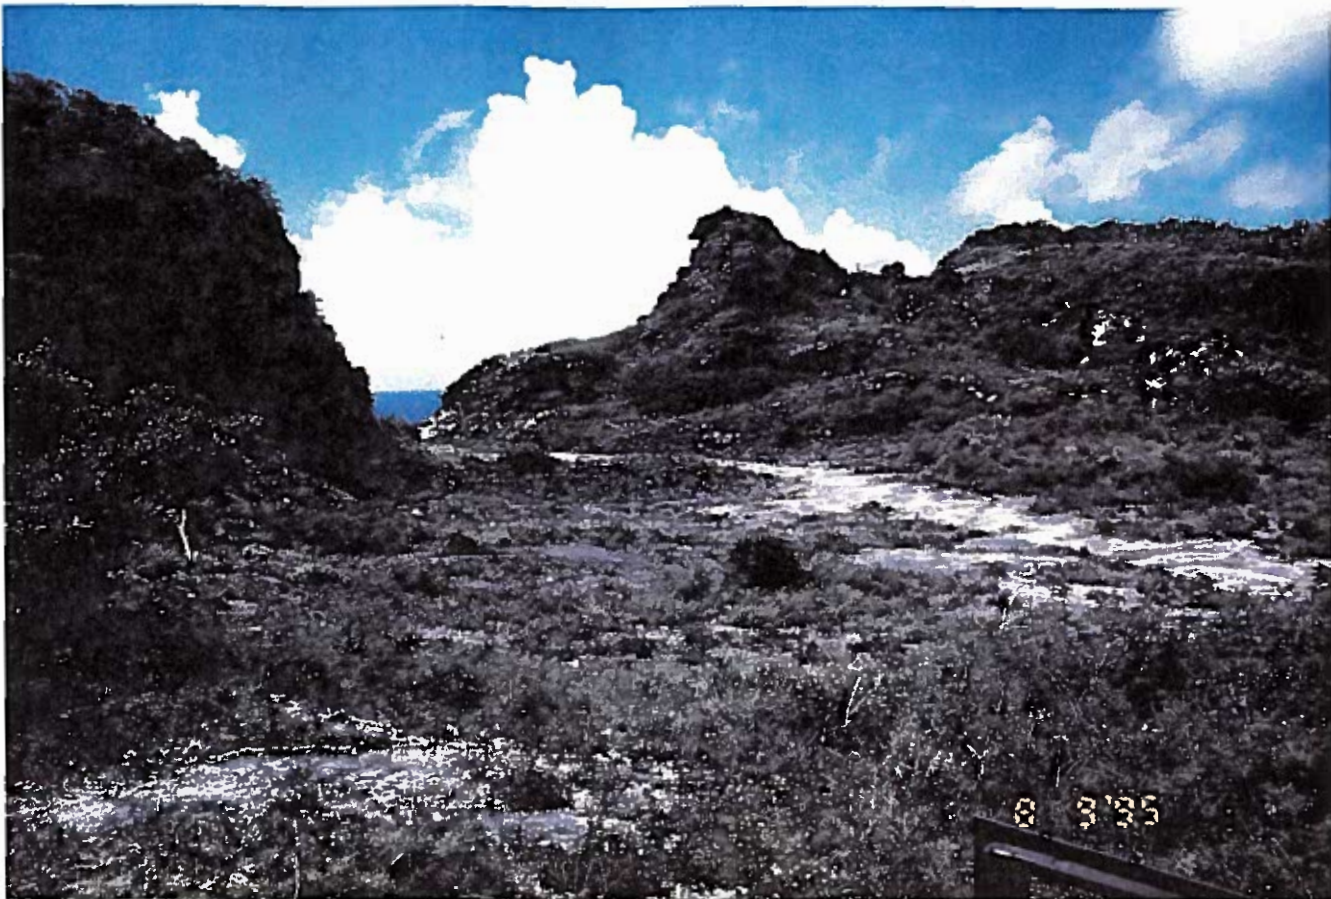
A3. Well drained Borrow Pit at Munitions Maintenance Area.

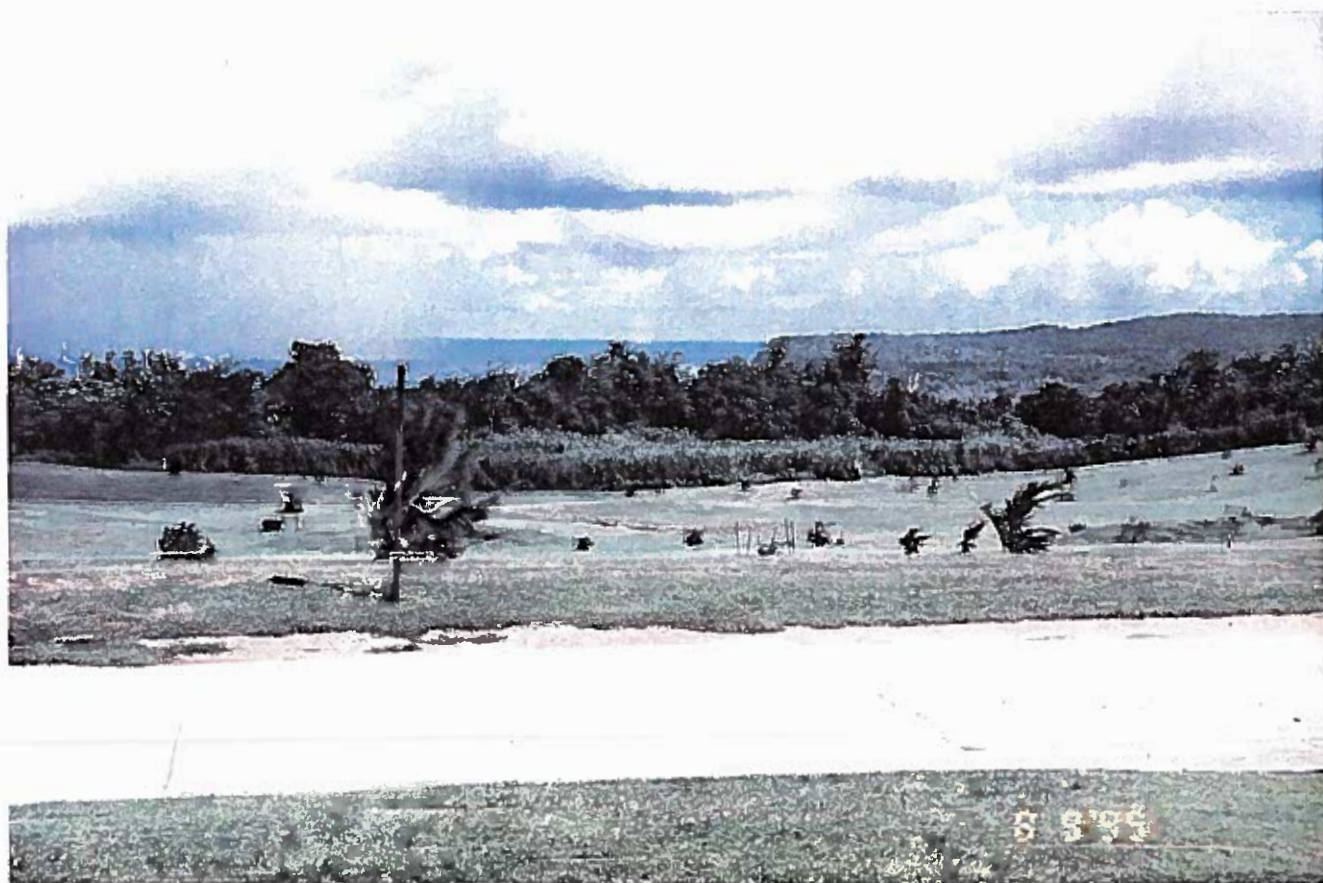
A4: Golf course: A roadside water culvert directs rainwater from the street, across the golf course, and to the edge of the limestone forest where it discharges into the limestone substrate. A stand of Swordgrass (*Miscanthus floridulus*) grows where the culvert terminates, however the area is well drained and does not support hydrophytic plants, (Fig. 12).

A4. Rainwater discharge via culvert on Golf Course.

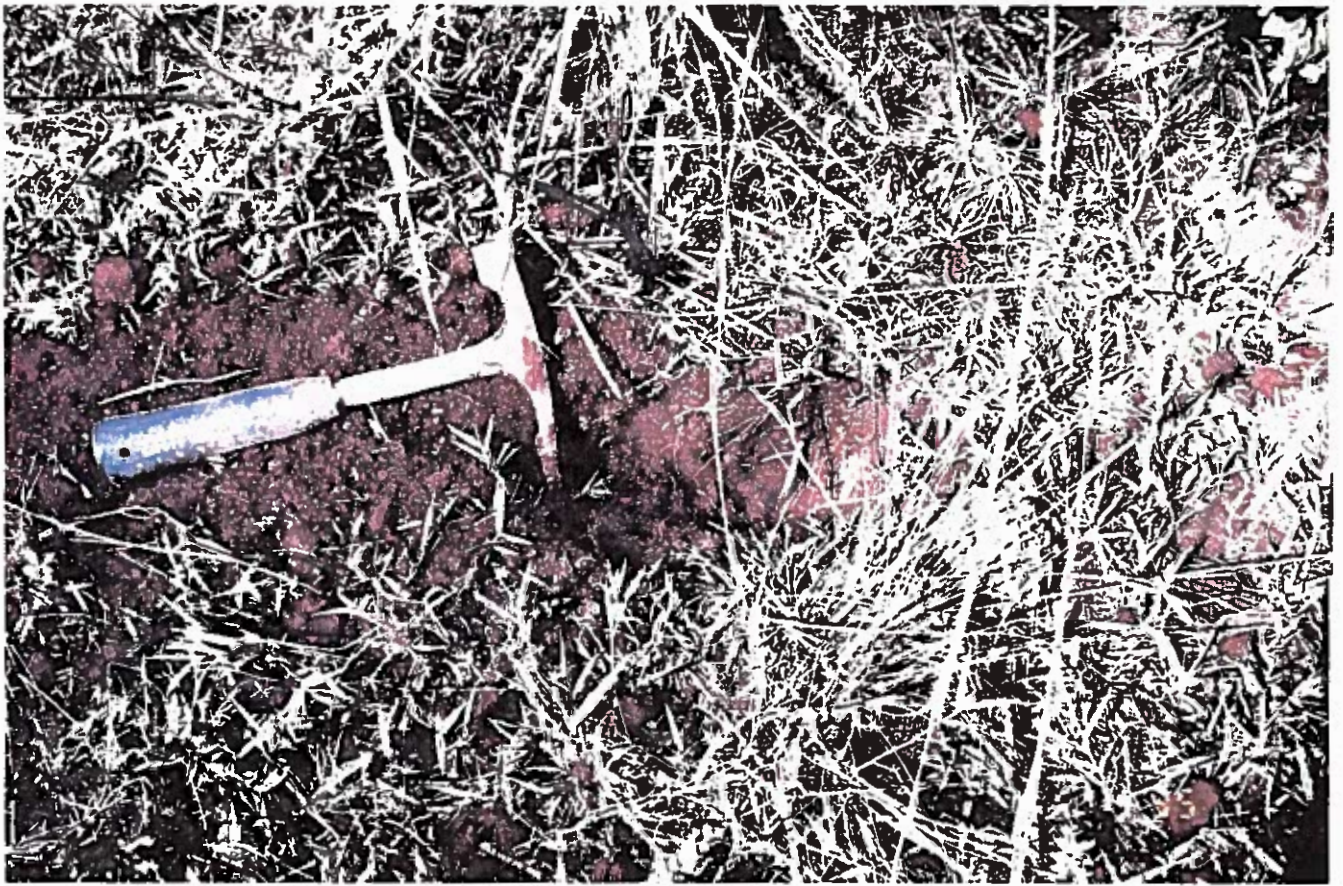
P1: Sinks in Northwest Field, west side: This area is on the highest portion of the karst plateau. The surface topography is formed by extensive, gently-sloping closed depressions, which are filled throughout with limestone forest vegetation. Soil is absent to about 5 cm deep in most places, consisting of reddish-brown to red (Munsell 10R 4/4-4/6) silty sandy carbonate soil (Fig. 13). The area is very well drained in general, with no evidence of ponding, even in areas downslope and adjacent to expansive areas of pavement, which must deposit large concentrations of storm runoff on them. We found no hydrophytic plants other than scattered individuals in associations typical of the recovering to established limestone forest community that occupies this entire area. The high elevation and extremely good infiltration and drainage of this area combine to preclude the development of wetland conditions (Fig. 14)

Pl. Typical soil on Karst Plateau: shallow, silty to sandy, red carbonate.

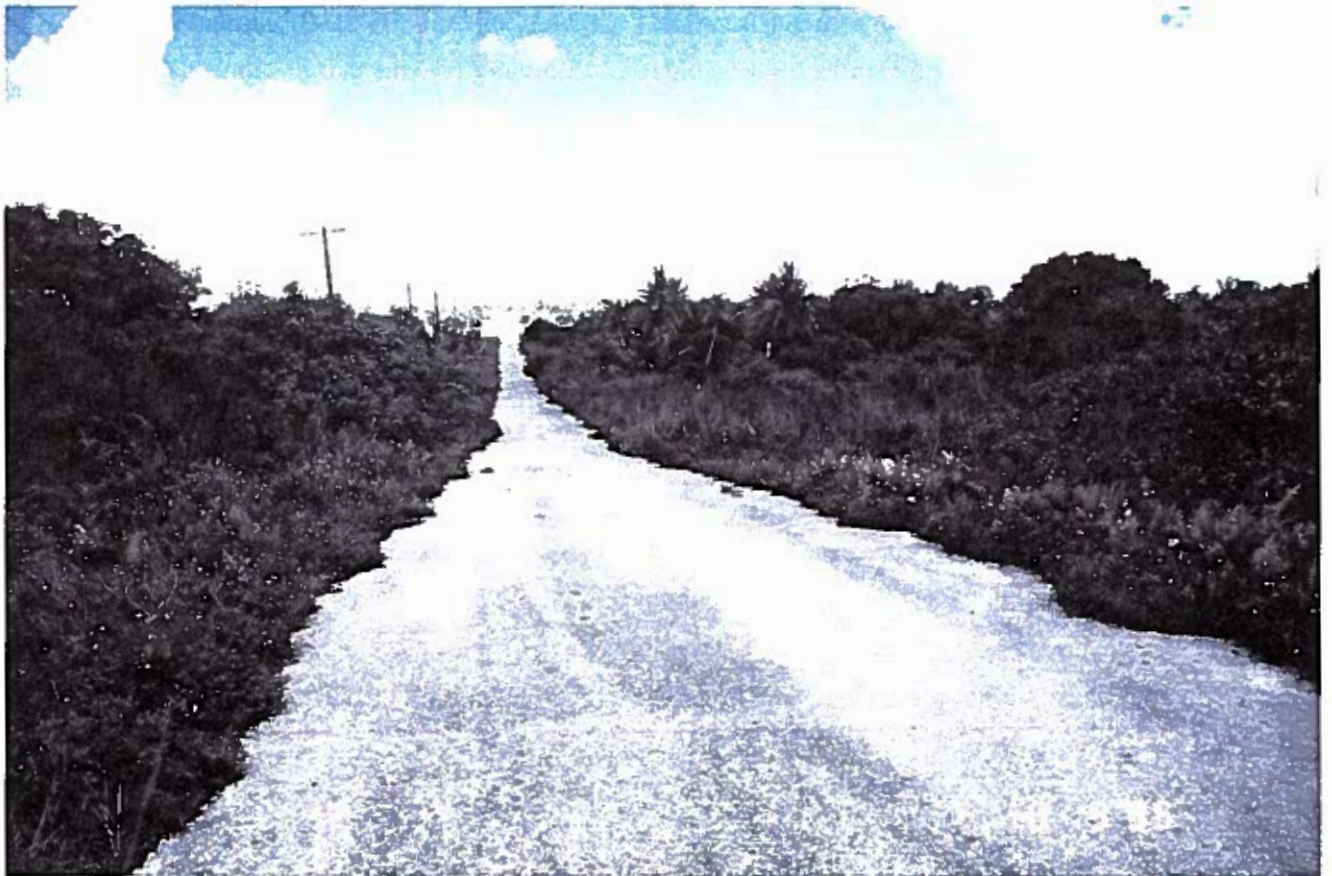
Pl. Topographic low spot at NWF, typical (Ref. Pl on Map 1).

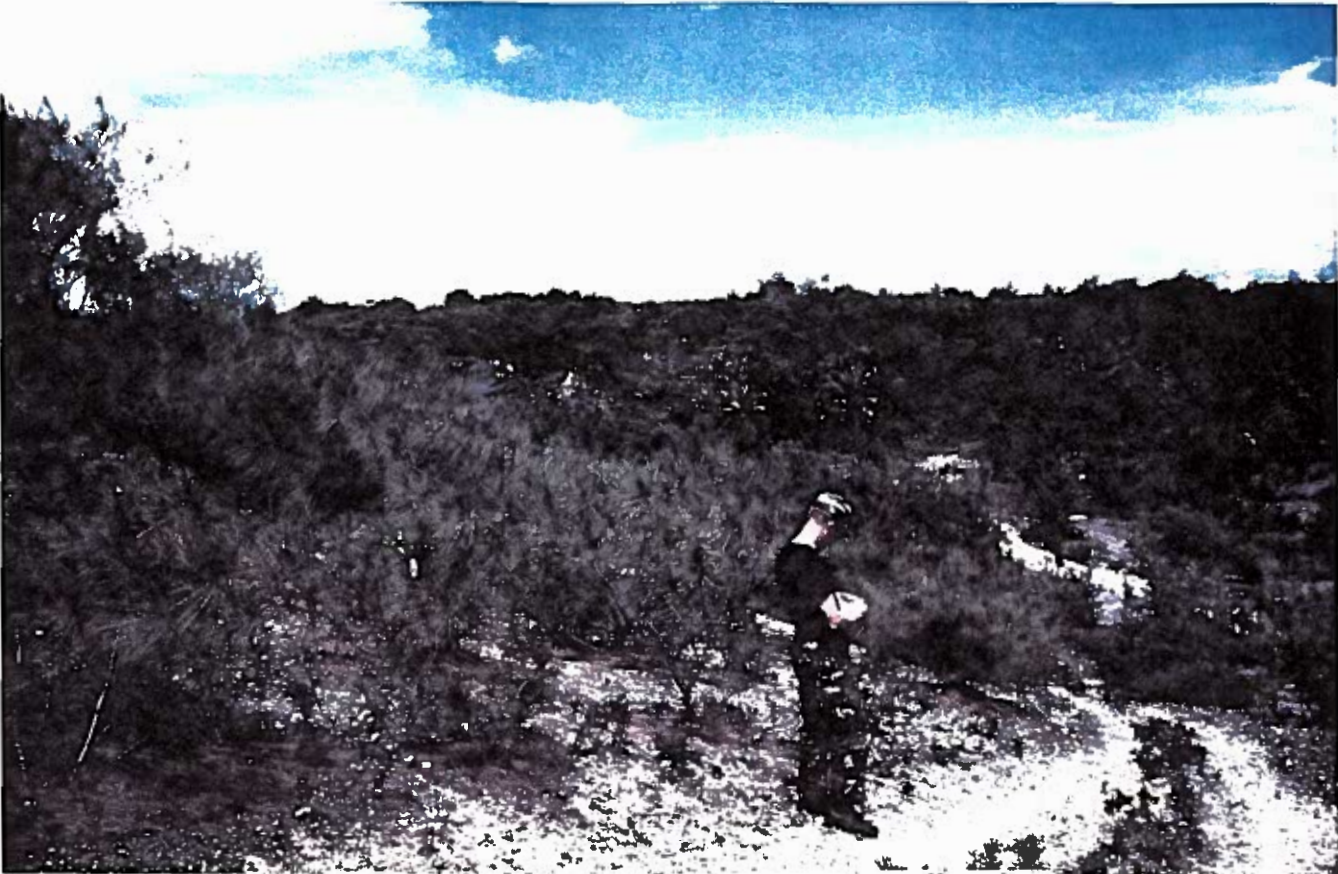
**P3: Sinks between CSA and main base:** Sinks in this area tend to be discrete and localized. In general, they have been heavily exploited as borrow pits, as have many of the other sinks on the base. P3 comprises the past and active landfill areas which have been heavily excavated. These sinks are in the vicinity of a fault zone mapped by Siegrist (personal communication, 1994), which may be a zone of preferential conductivity locally. In any case, the area is high and extremely well drained. Even depressions with bottoms that had been extensively altered by excavation, which might have disrupted natural drainage, showed no evidence of ponding, as shown at P3-1 borrow pit map 1, Fig. 15.

P3. Borrow Pit P3-1, location on Map 1.

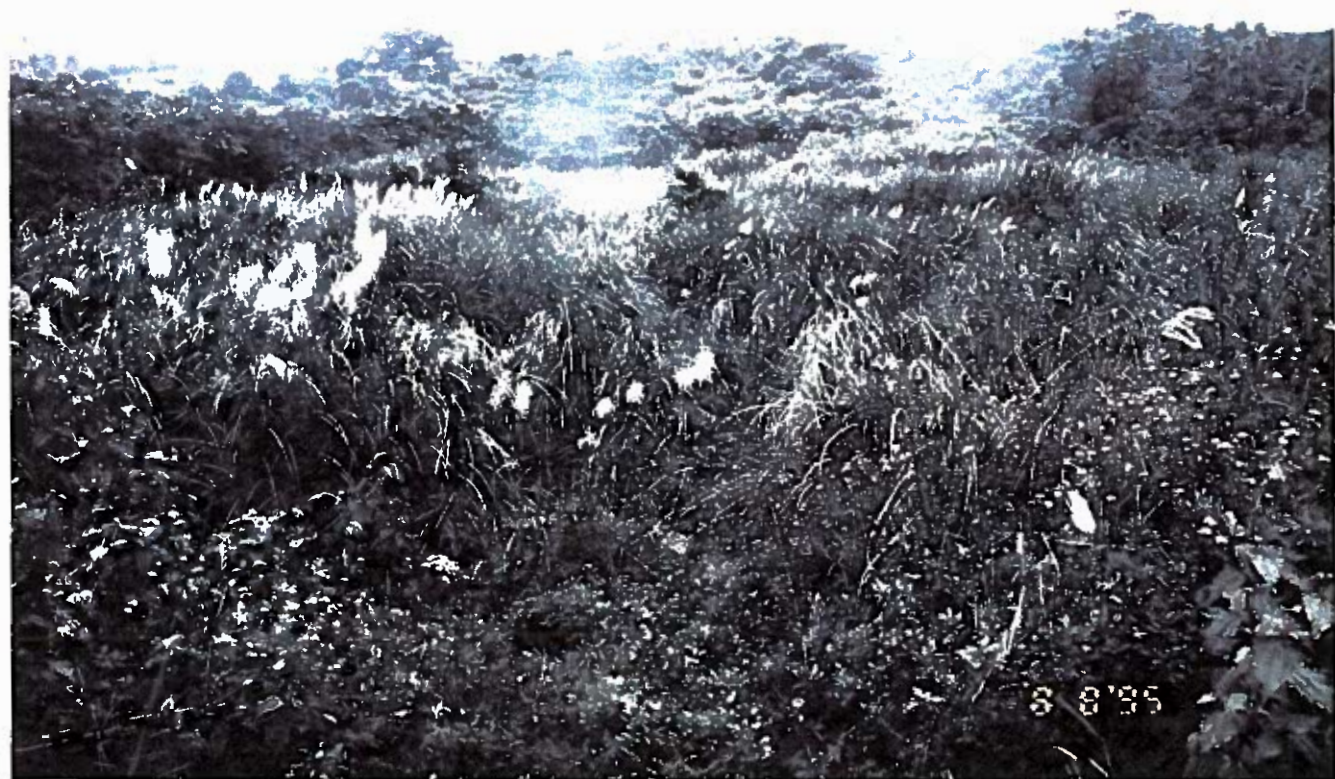
**P4-1: Sink north of runway, mapped as borrow pit on USGS Pati Point quad.** Bottom of sink, about 6-8 m below grade and about 150-200 m diameter, is dominated by tall (1.5-2.5 m) grass. Soil is stony, slightly clayey, red (Munsell 10R 4/8) carbonate soil, probably about 10-20 cm deep in general. The extensive distribution of the relatively thick soil here suggests that this sink might be capable of supporting frequent ponding of significant duration, perhaps a few days, following major storms. Nevertheless, the well oxidized nature of the soil and its hydrostratigraphic location of more than 150 m above water table implies that ponding is necessarily ephemeral. The extent of artificial excavation in the sink is not apparent, but it contains an abandoned concrete structure connected to an 8" steel pipe and an out of service electrical source. This was apparently once used to pump water either into or out of the pit. The extensive distribution of the grass suggested that a more definitive assessment of the hydrophyte population might be appropriate. Consultation and field visit by Mr. Marvin Aguilar, Guam Division of Aquatic and Wildlife Resources staff biologist, confirmed that this and similar communities are not hydrophytic. We identified most all species present as post disturbance, opportunistic, non-hydric, highly competitive plants and grasses, to include: False Verbena, (*Stachytarpheta jamaicensis*), Sandbur (*Cenchrus echinatus* L.), Indian Mulberry (*Morinda citrifolia*), Tangantangan (*Leucaena leucocephala*), Hibiscus (*Hibiscus tiliaceus*),

P4. Borrow Pit P4-1, showing opportunistic vegetation.

Wild Bitter-Melon (*Momordia charantia* L.), Love-in-a-mist (*Passiflora foetida*), and Wildcane (*Saccharum spontaneum* L., Fig. 16).

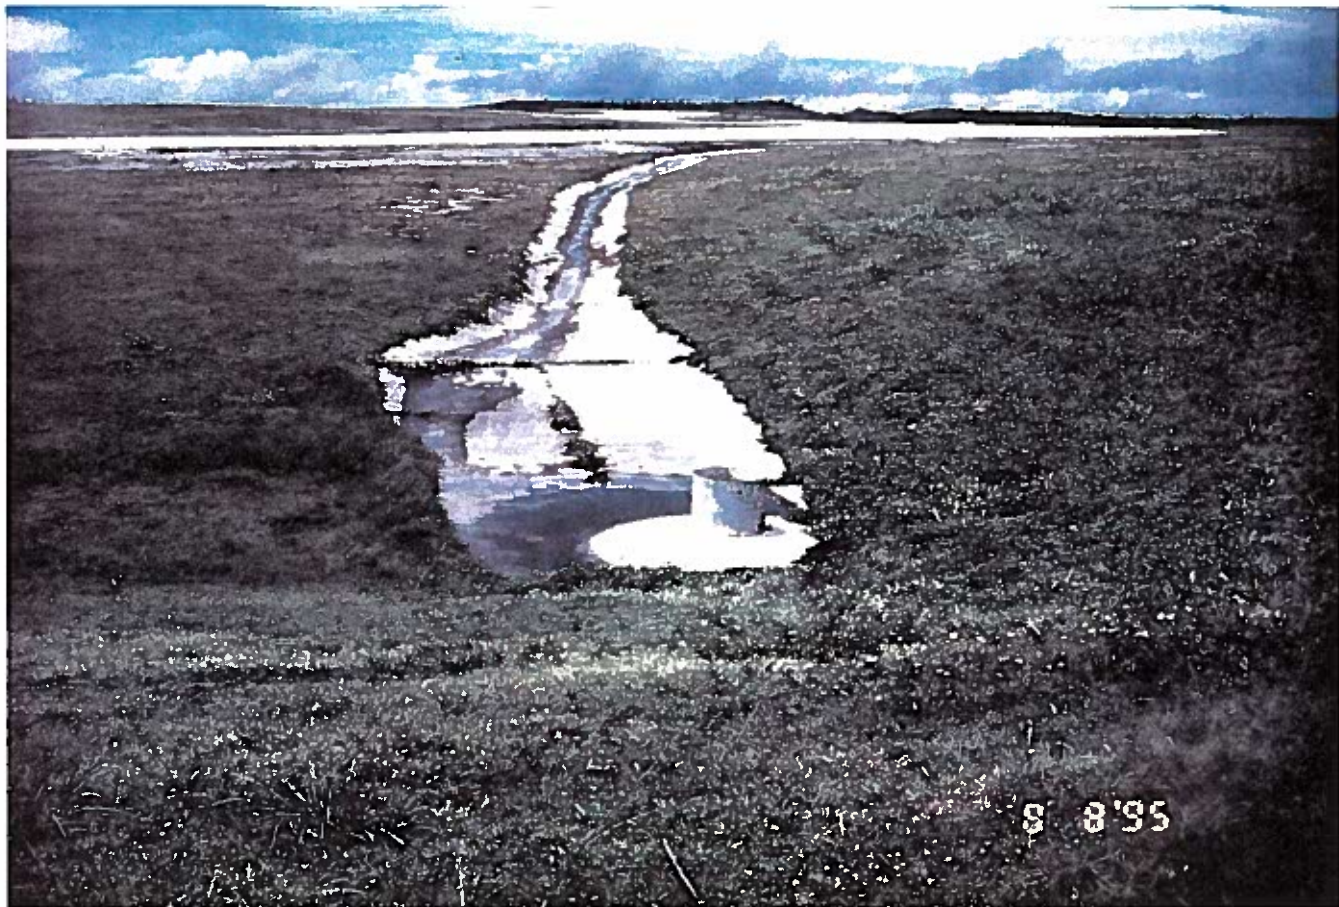
P4. Lowest topographic point at SW end of runways, P4-3.

P4-3: This sink is located at the lowest point at the SW end of the runway, toward which natural stormflow runoff from the runway area would collect, in the absence of the battery of injection wells that have been installed to drain the runway area. There is no evidence that water can collect in sufficient quantity to inundate the area. Vegetation is entirely limestone forest community at the outlet of water diversion directly across perimeter road (Fig. 17).
