**Non-Jurisdictional Survey of Andersen AFB for  
Prospective Wetland Sites**

**July to 11, August 1995**

**Non-Jurisdictional Survey of Andersen AFB  
for Prospective Wetland Sites  
31 July-11 Aug 95**

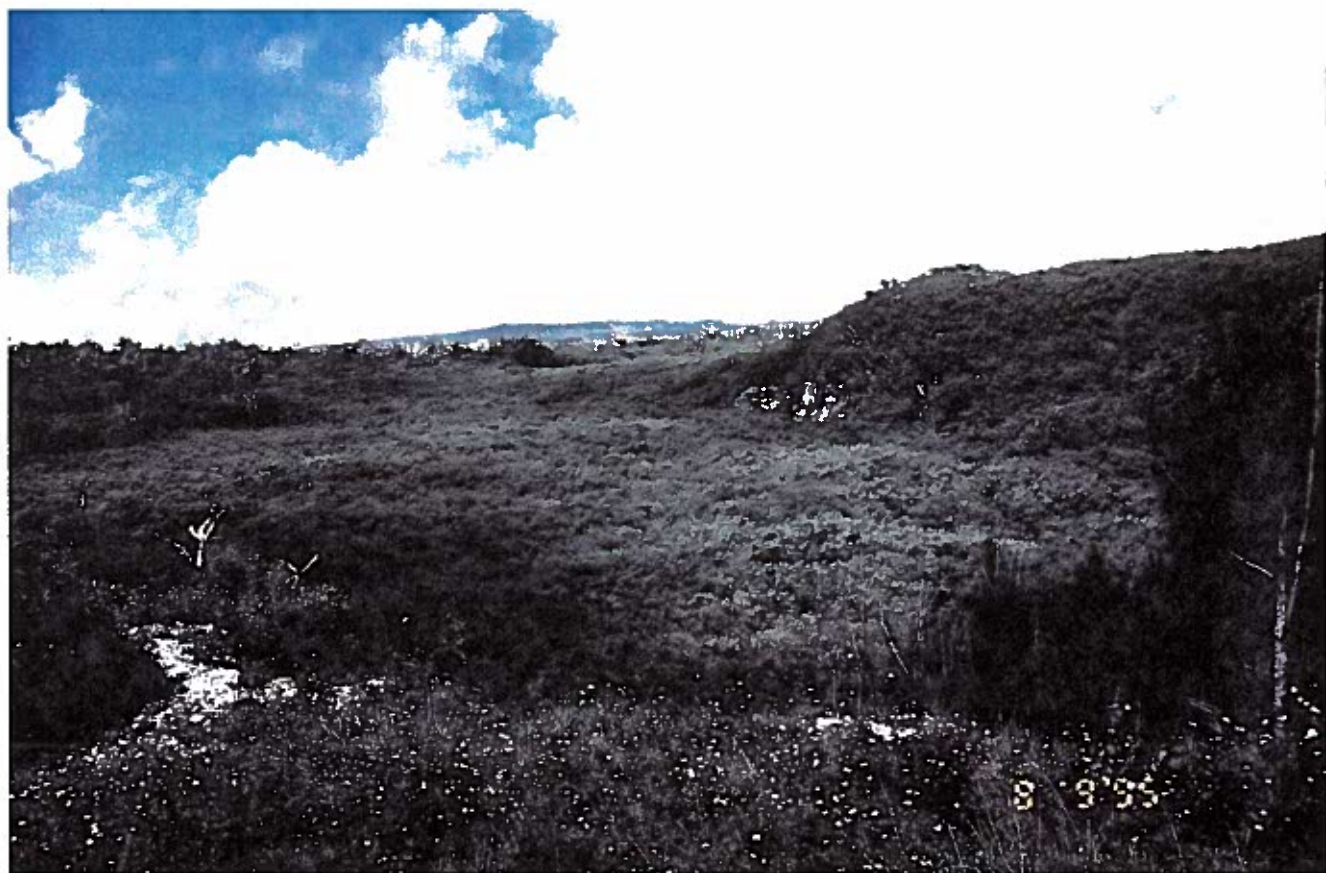
P5. Borrow Pit P5-1 at eastern cliffline, well drained and vegetated completely with Tangintangin.

P5: Sinks along eastern cliff line, P5-1 to P5-5 as indicated on map 1: Eastern cliffline has three marginal sinks and two borrow pits. Cliffline sinks are well vegetated by limestone forest flora. Area is generally well drained, with drainage on the flightline augmenting the natural infiltration. No runoff from runway or undeveloped area around the sink augments drainage. This is probably representative of marginal sinks that have retained natural inflow/discharge conditions. Fig. 18 shows P5-1 borrow pit vegetated strictly with Tangantangan (*Leucaena leucocephala*).
