# **COASTAL ENVIRONMENTAL DAMAGE**

## **A PRELIMINARY SURVEY OF IMPACTS OF TYPHOON CHATA'AN ON GUAM'S NATURAL ENVIRONMENT**

**Coordinated by  
THE GUAM BUREAU OF STATISTICS AND PLANS  
Assisted by  
DEPARTMENT OF LAND MANAGEMENT,  
DEPARTMENT OF AGRICULTURE,  
THE GUAM ENVIRONMENTAL PROTECTION AGENCY,  
and  
THE CHAMORRO LAND TRUST COMMISSION**

**JULY, 2002**

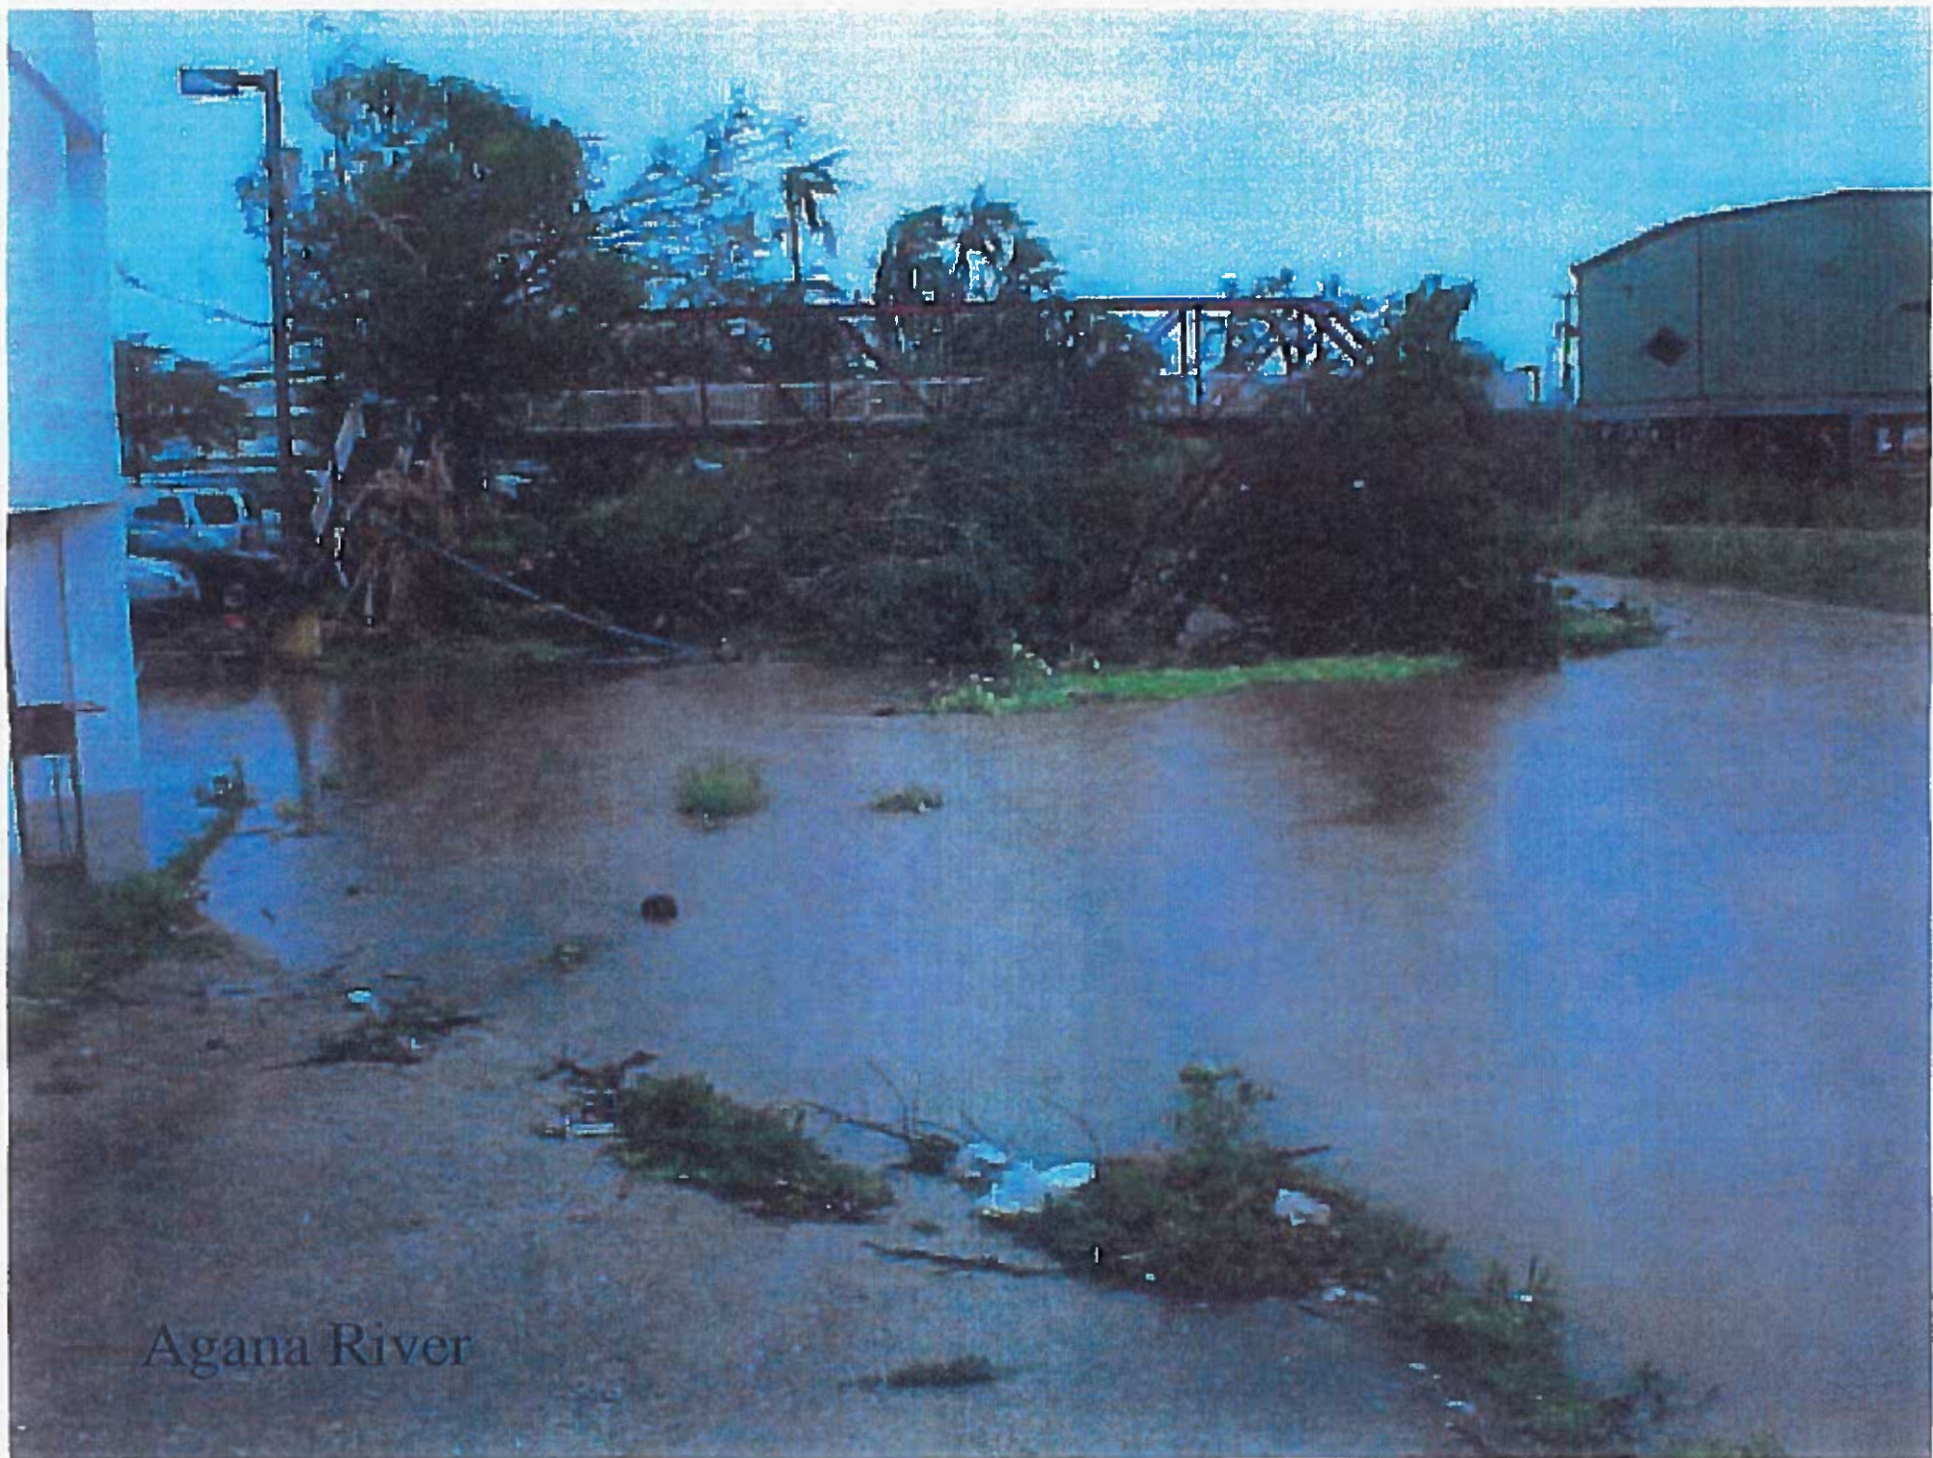
Agana River

Data collected on frequency and level of debris, by municipality, are summarized in Table III. These results indicate that Typhoon Chata'an affected debris accumulation along a general gradient across the island. Although the eye of the typhoon passed over the northern end of Guam, the amounts of coastal debris deposited appeared to be highest in the South East and lowest in the North West. Localized exceptions to this general pattern occurred, but the section of Guam's coasts with the greatest storm debris problems recorded was in Inarajan and Merizo municipalities. Rivers tended to accumulate debris, especially in their lower reaches and river mouths. At bridges, blockage of debris flow down rivers occurred. This jammed debris, blocking river flow and causing flooding and risk of structural damage to bridges. (Please see photo of Agana River, appended.)

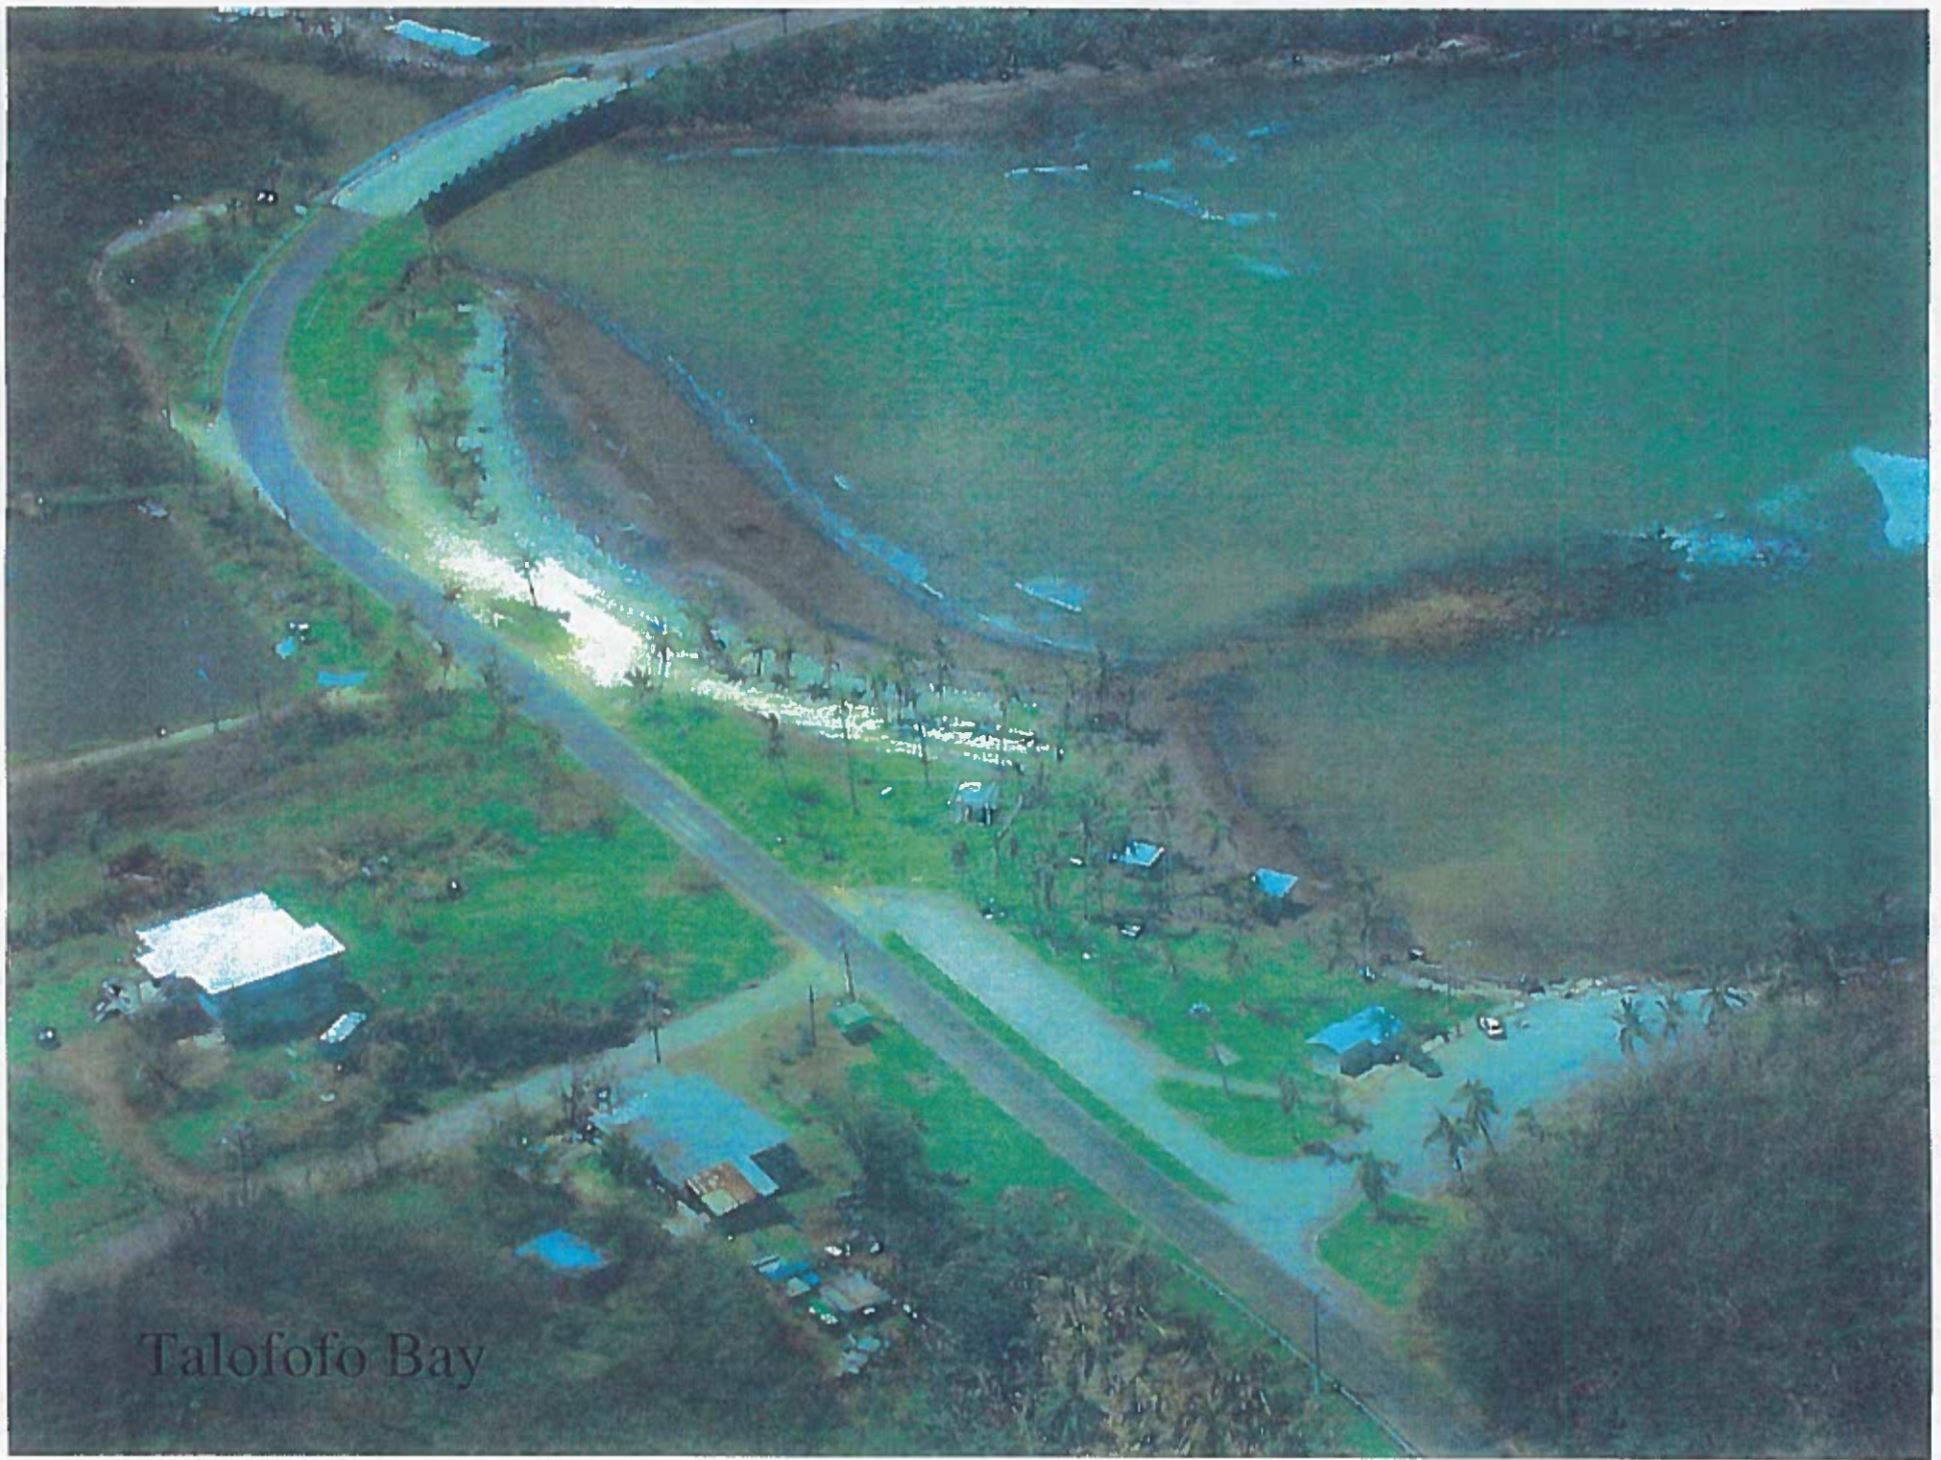
Talofofo Bay

Aerial Assessment: The aerial survey that was done brought back 131 digital photographs of Guam's coastline and river mouths, debris sites and evidence of erosion. Many of the southern river mouths showed low to no turbidity, as shown in appended photo of Talofofo Bay. However, there were indications of erosion up-river and along the riverbanks. The rivers also showed debris around the bridges causing flooding in the vicinity. Evidence of this is in the Village of Merizo where several rivers overflowed their banks and flowed into several residences. It should be noted that the aerial assessment was done on July 16<sup>th</sup>, over ten days after the typhoon. Many riverbanks were cleared and the river mouths and bays had time for particles to settle. The photo of Piti Bay, appended, indicates how quickly clarity had returned to coastal waters by July 16. In contrast, Fena Reservoir remained muddy and turbid as shown in the appended photo.
