**AN EVALUATION OF NEARSHORE SEDIMENT  
CONTAMINATION  
DUNGCA'S BEACH, EAST AGANA BAY, GUAM**

Prepared For  
First Living Service (USA), Inc.

Prepared by  
Pacific Basin Environmental Consultants, Inc.

August 1991

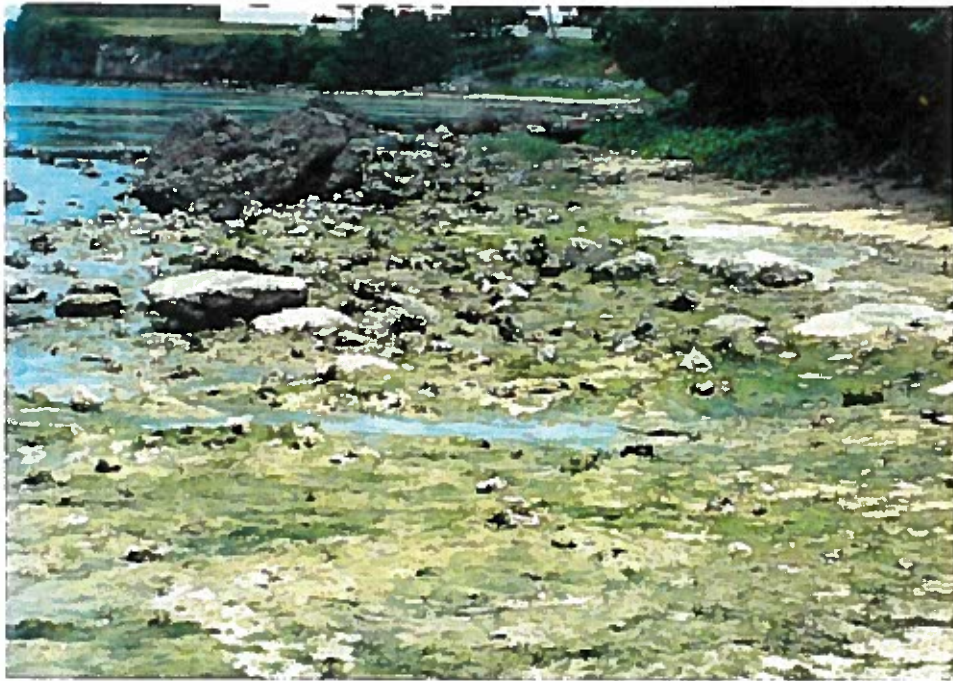
The upper intertidal area of the northern shoreline, which is approximately 24,994ft<sup>2</sup>, is comprised primarily of rocks and rubble (Figure 4, Photo 1). However, algae scum is also present over much of this area, interspersed amongst the rubble (Photo 2). The algae scum consists of Enteromorpha clathrata and Codium sp. Beneath the algae is a layer of black (anaerobic) muck.

Photo 1: Rock and Rubble area along the northern shoreline.

The results of this study indicate that removing sediments along the northern shoreline of the project site is not practical, and an alternative method should be employed to clean up this section of beach, possibly by hand tools such as rakes.

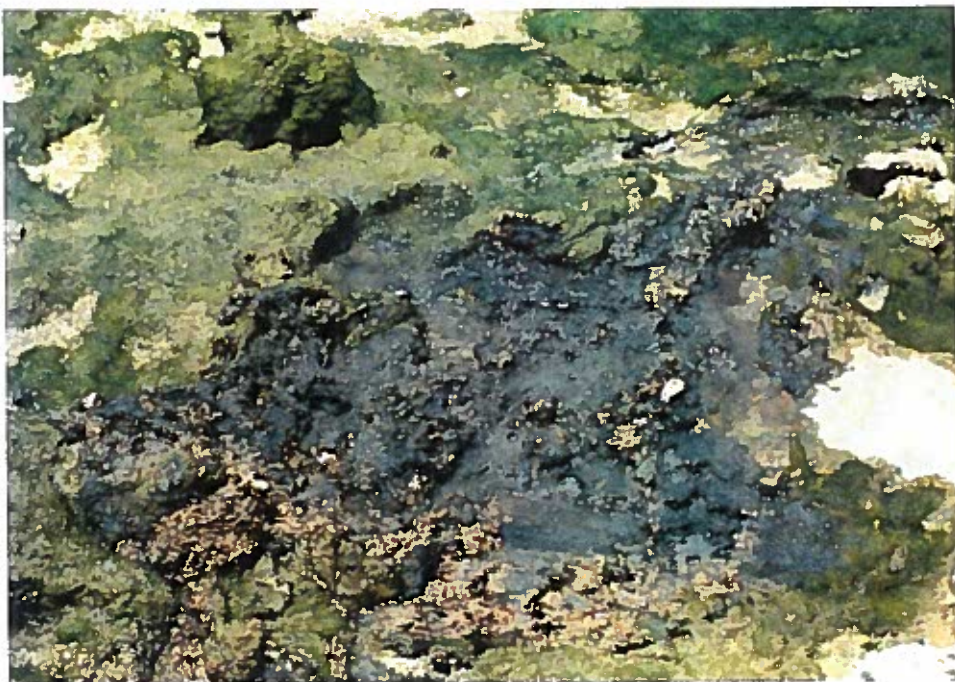
Photo 2: Intertidal algal scum characteristic of the Rock and Rubble area.

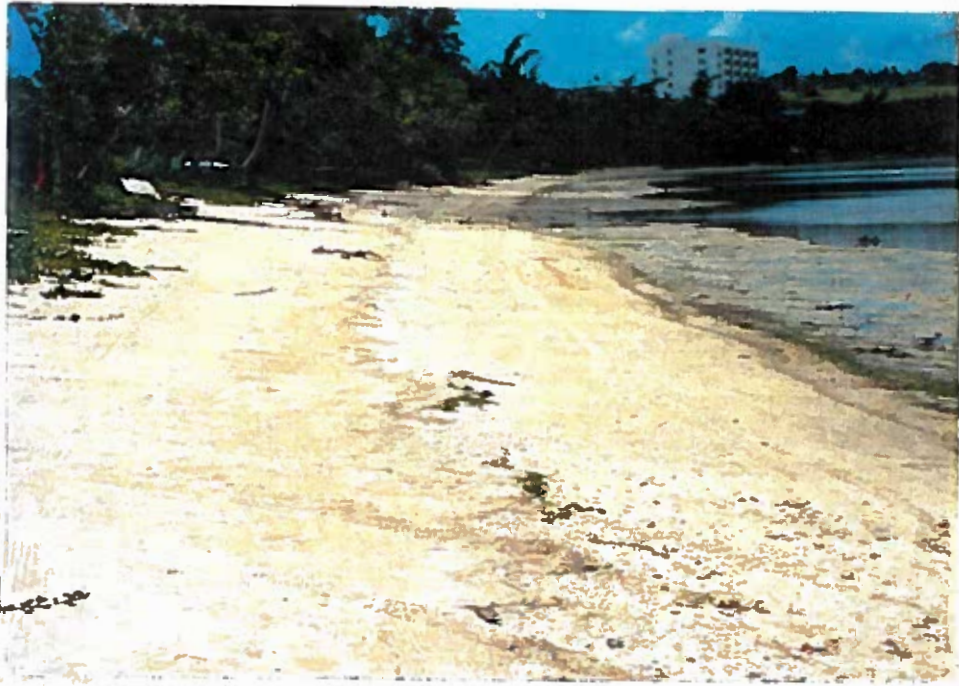
The section of beach directly fronting the Onward Agana Beach Hotel (approximately 8,655ft<sup>2</sup>) contains some rubble, but is mostly coarse beach sand (Figure 4, Photo 3). This sub-area represents the cleanest area along the shoreline.

**Photo 3: Beach sand along eastern Dungca's Beach Shoreline, directly fronting Onward Agana Beach Hotel.**

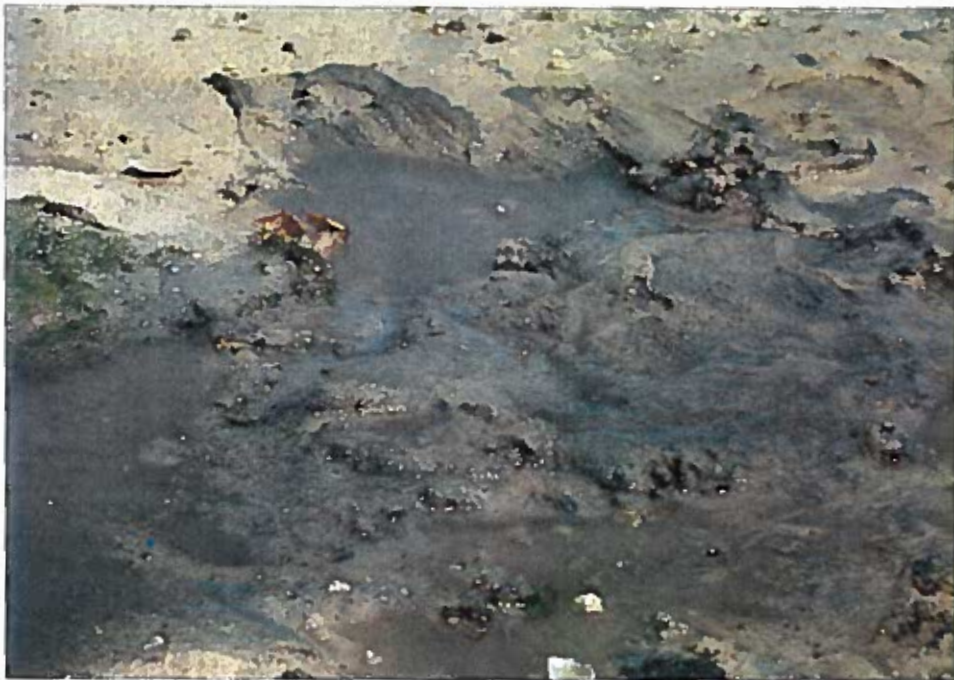
Below the MHW level in the section of lagoon fronting the Onward Agana Beach Hotel, the substrate is predominantly a black, silty fine anaerobic muck (Figure 4, Photo 4). The upper subtidal zone in this area is also composed of black muck covered by a thin layer of sand (total area approximately 55,193ft<sup>2</sup>) (Photo 5). Sediment samples of this intertidal muck revealed an unidentified organism, possibly a nematode, which thrives in this area. Enteromorpha clathrata was also found scattered throughout this area. This sub-area represents the most polluted area in the study site.

**Photo 4 Black muck sediment representative of intertidal area along the eastern shoreline.**

The methodology to remove the polluted sediment along the remainder of the shoreline is not clearly defined at this time. However, the present dredging methodology (suction dredge) will not be employed for two reasons: first and primary is that the suction dredging requires at least three feet of water to float. Because water depth is very shallow in this area, it will not be possible to maneuver the rig close enough to shore to perform the work. Secondly, the removal of contaminated sediments for this project requires a methodology that scrapes off only inches of a thin top layer. The suction dredge rig would cut too deep. At this time we feel the appropriate methodology will involve smaller mechanical means such as a frontend loader, sweepers and hand tools. The appropriate methodology will be studied and determined at the time a contractor is chosen. This methodology will include the use of silt curtains and will be explained in the Environmental Protection Plan.

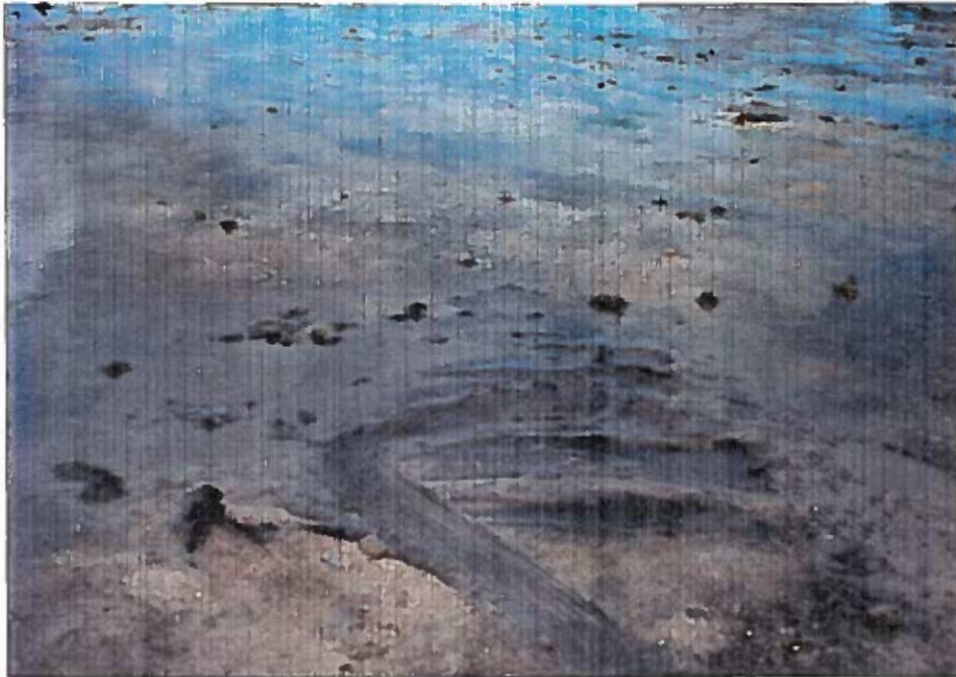
**Photo 5:** Thin sand layer over black muck. Characteristic of upper subtidal area of eastern shoreline.

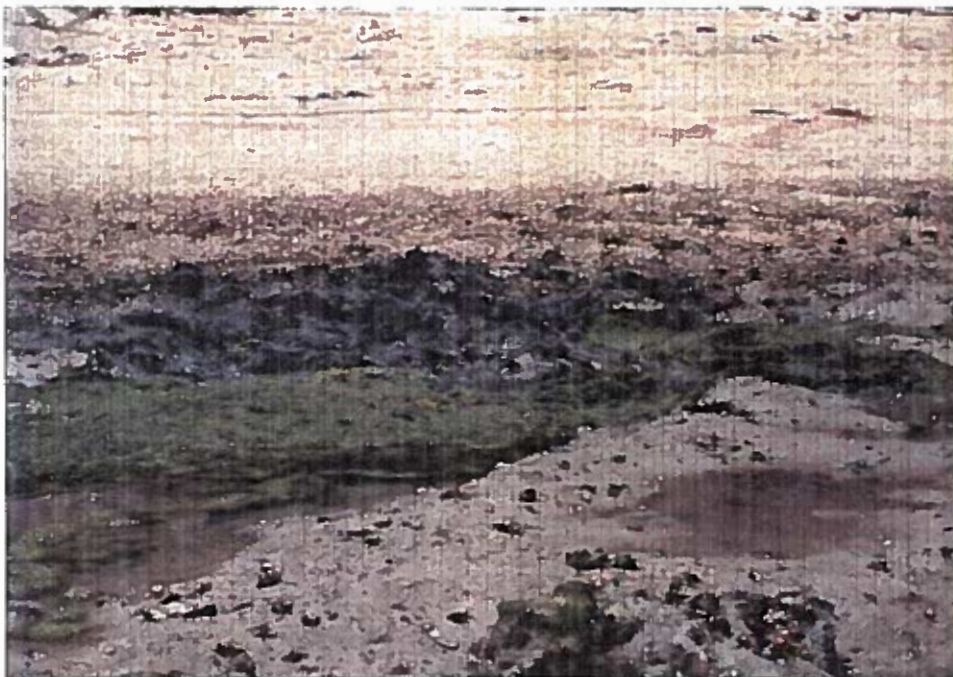
**Photo 6:** Intertidal area of beach directly fronting Onward Agana Beach Hotel.
