**AN EVALUATION OF NEARSHORE SEDIMENT  
CONTAMINATION  
DUNGCA'S BEACH, EAST AGANA BAY, GUAM**

Prepared For  
First Living Service (USA), Inc.

Prepared by  
Pacific Basin Environmental Consultants, Inc.

August 1991

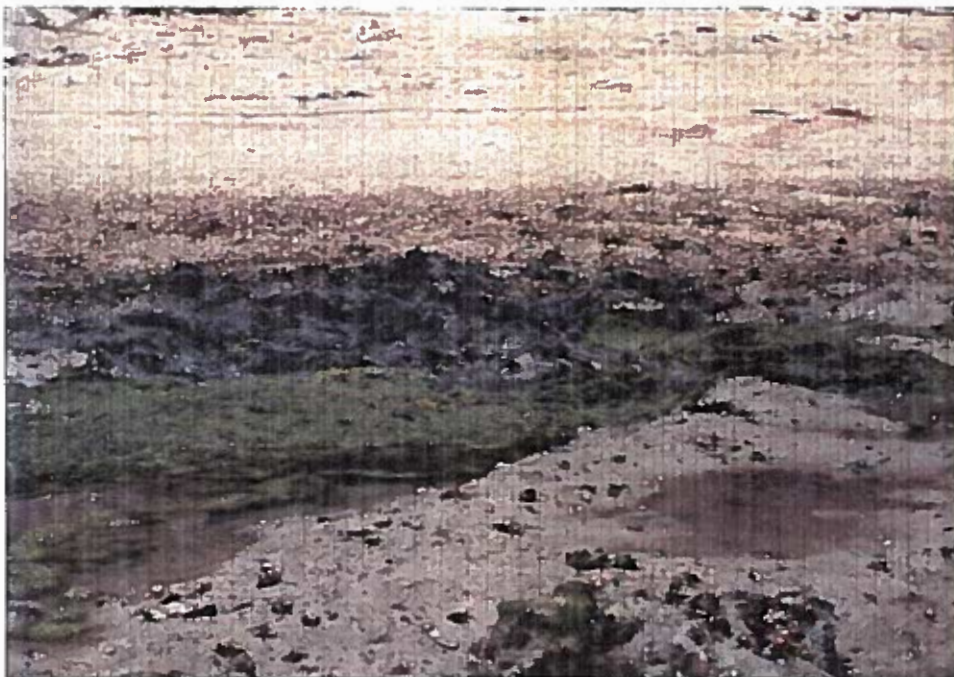
**Photo 6:** Intertidal area of beach directly fronting Onward Agana Beach Hotel.
