**GUAM COASTAL MANAGEMENT PROGRAM  
FEDERAL CONSISTENCY FORM APPLICATION:  
JAPAN-GUAM-AUSTRALIA SOUTH CABLE LANDING  
PITI, GUAM**

**Subject: CZMA Federal Consistency Certification for Japan-Guam-Australia South Submarine Cable Landing, Tepungan, Piti, Guam.**

**Benthic cover and ESA coral surveys for the proposed Hong Kong-Guam, Japan-Guam-Australia North, and Japan-Guam-Australia South cable systems landings in Piti, Guam**

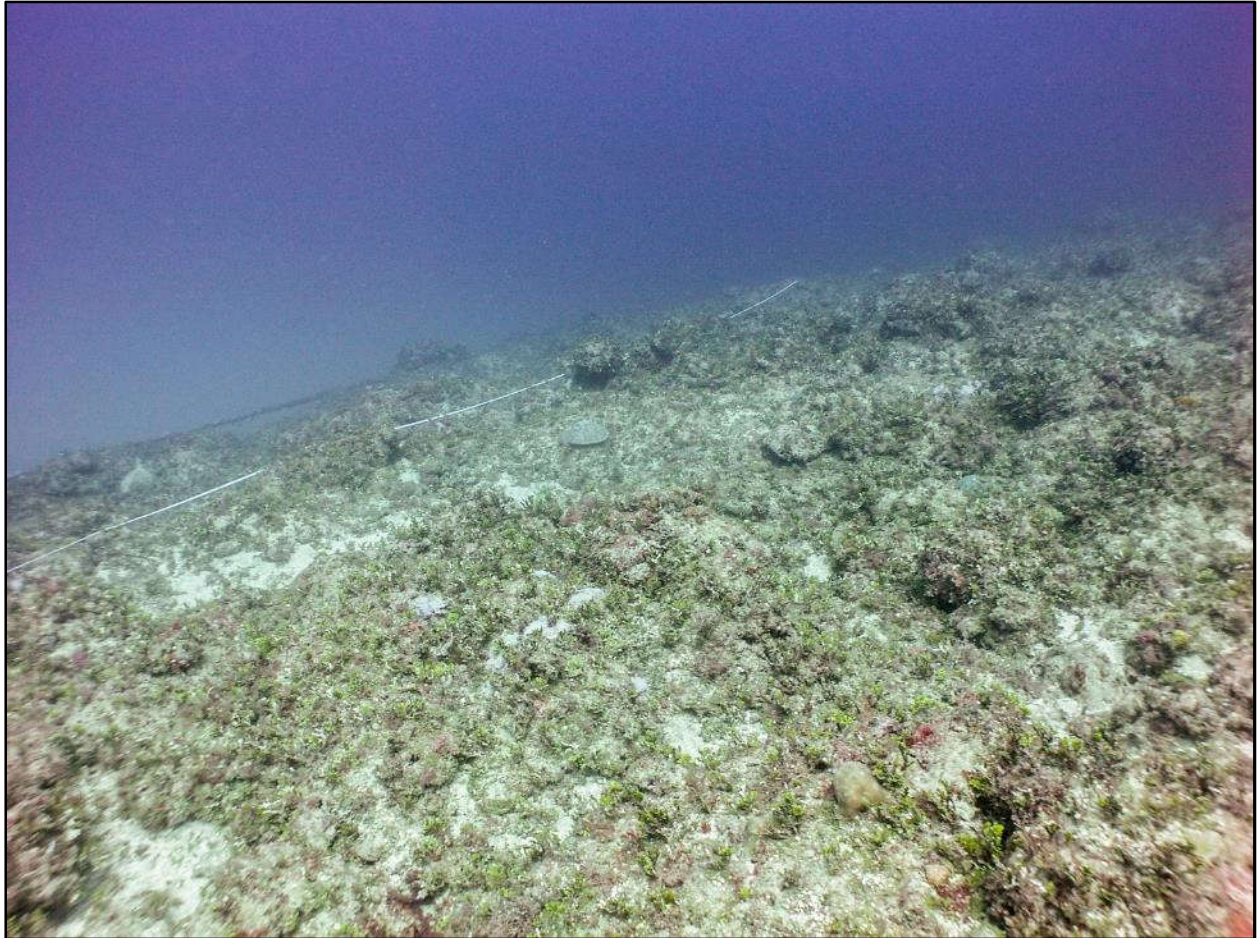
**Figure 5.** A low-relief, low coral cover, high algal cover benthic community representative of that observed at Site A between depths of approximately 30.5 m (100 ft) and 18 m (60 ft). The Tata cable (without articulated pipe) can be seen in the upper-left quadrant of the image, beyond the white transect tape.

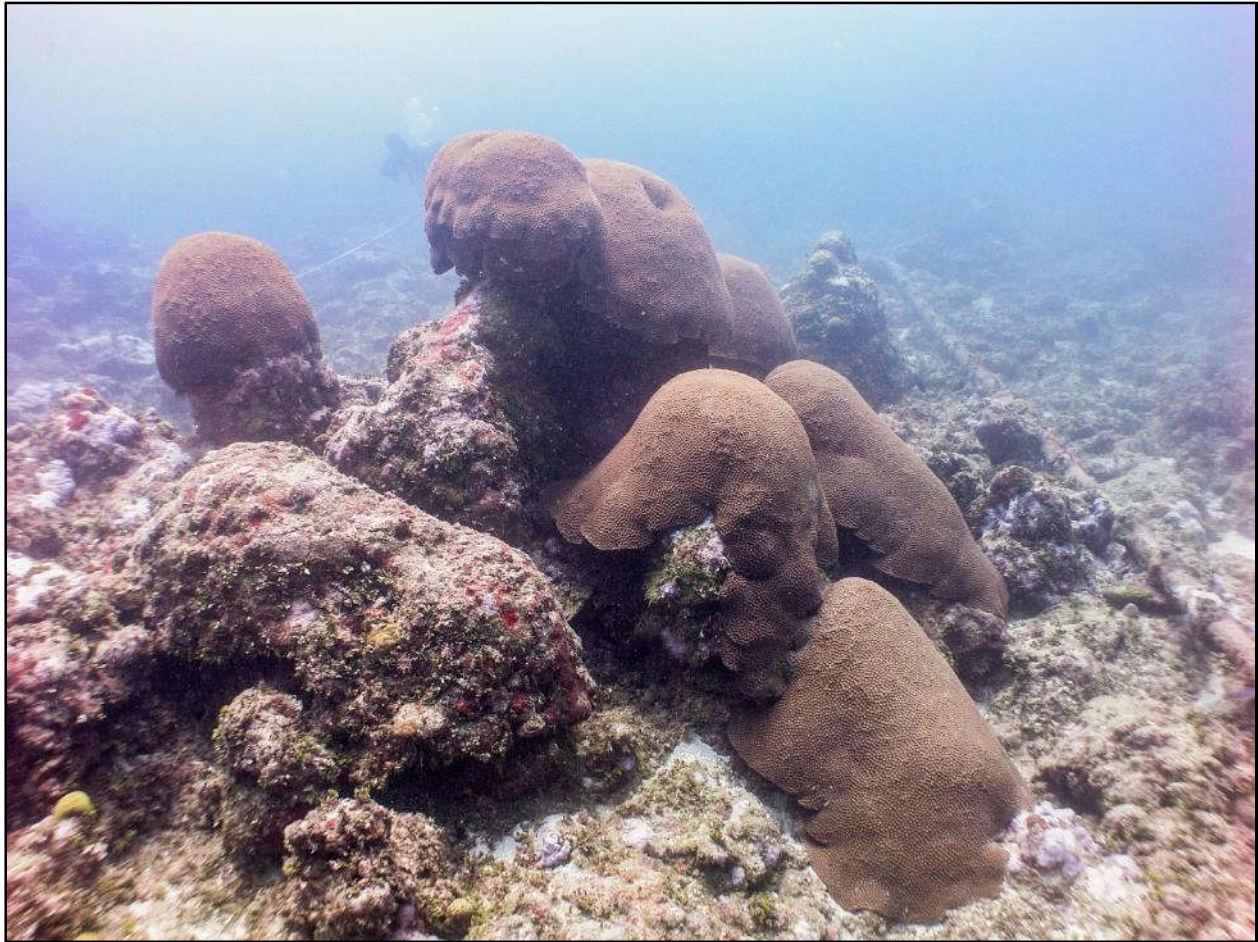
**Figure 6.** Large colonies of the coral, *Diploastrea heliopora*, within the deeper portion of Site A. While coral cover along the deeper half of Site A was generally low, several large *D. heliopora* colonies were observed in this area, including the aggregation of colonies pictured here. The above colonies occur within the center of Site A (Transect 2). The Tata cable with articulated pipe can be observed immediately to the right (southwest) of the colonies.

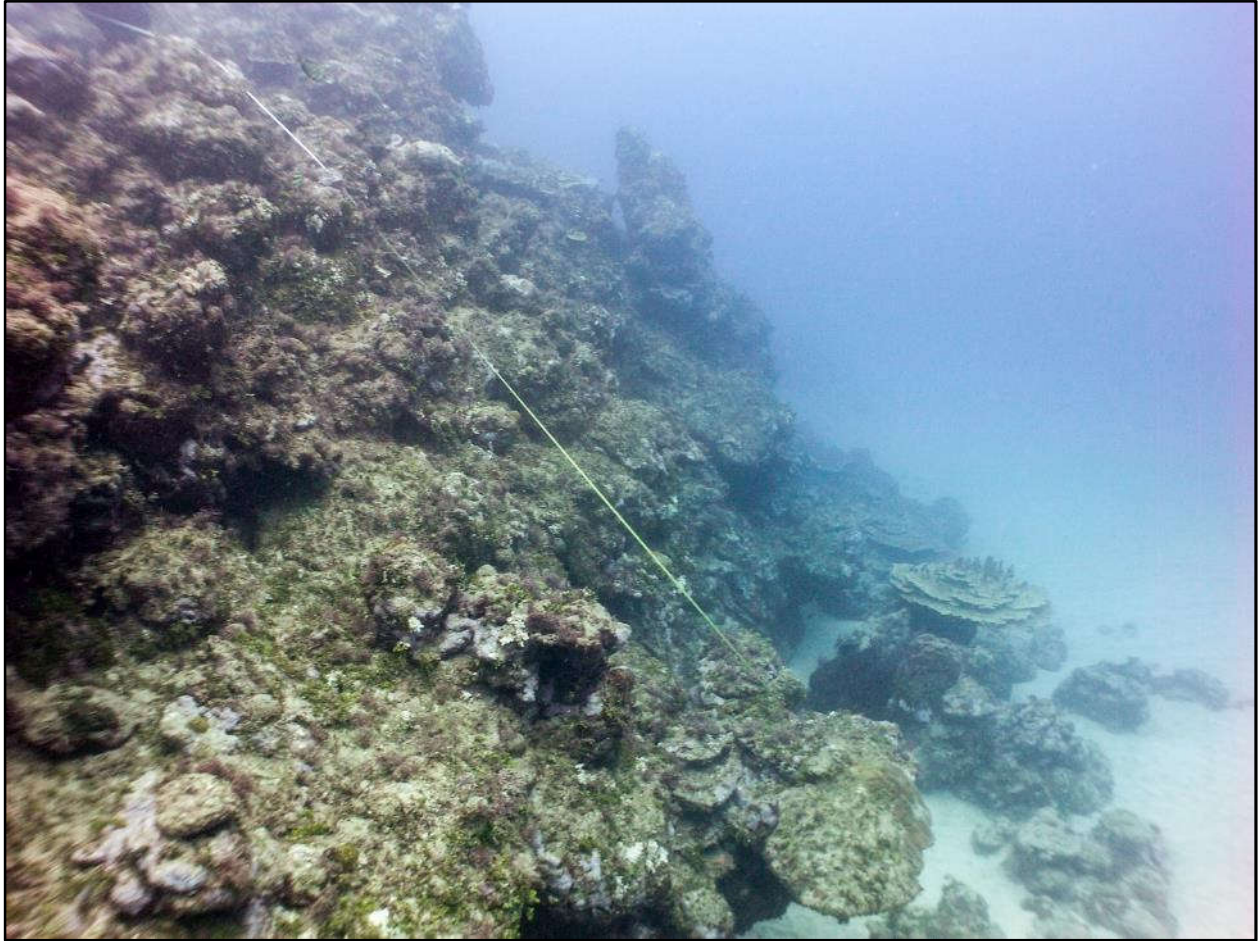
**Figure 11.** A steep slope at deep end of Site C. The steep hardbottom slope rises from a sand flat at a depth of approximately 22 m (72 ft) to a depth of approximately 15 m (50 ft).

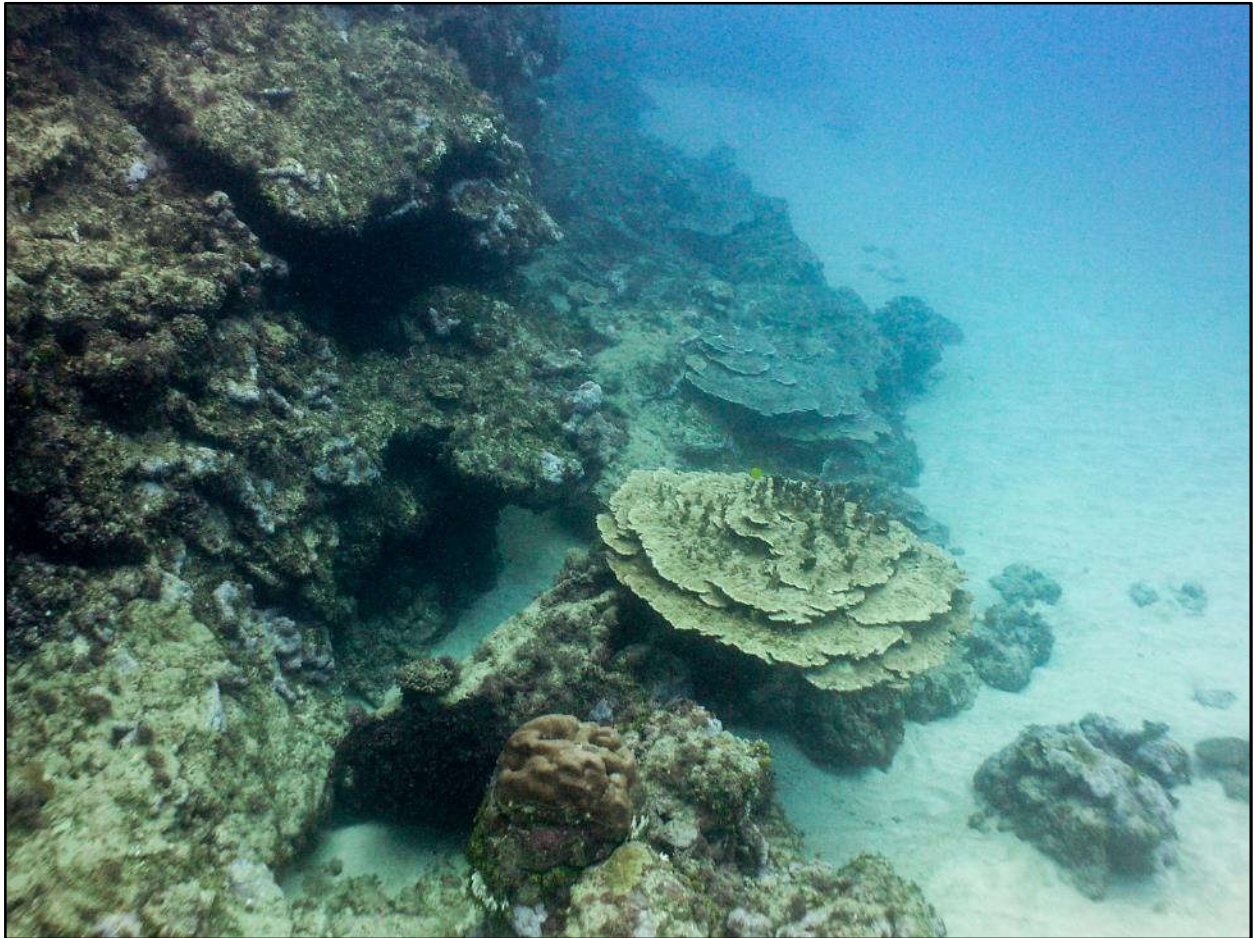
**Figure 12.** A plate-and-pillar coral, *Porites rus*, along the base of the steep slope of Site C pictured in Figure 11. While coral cover is relatively low along the steep slope of Site C some notable coral colonies, such as the *P. rus* colony pictured above, are present along the slope. Colonies such as this one are relatively fragile and would be highly susceptible to physical damage if care is not taken to avoid them.

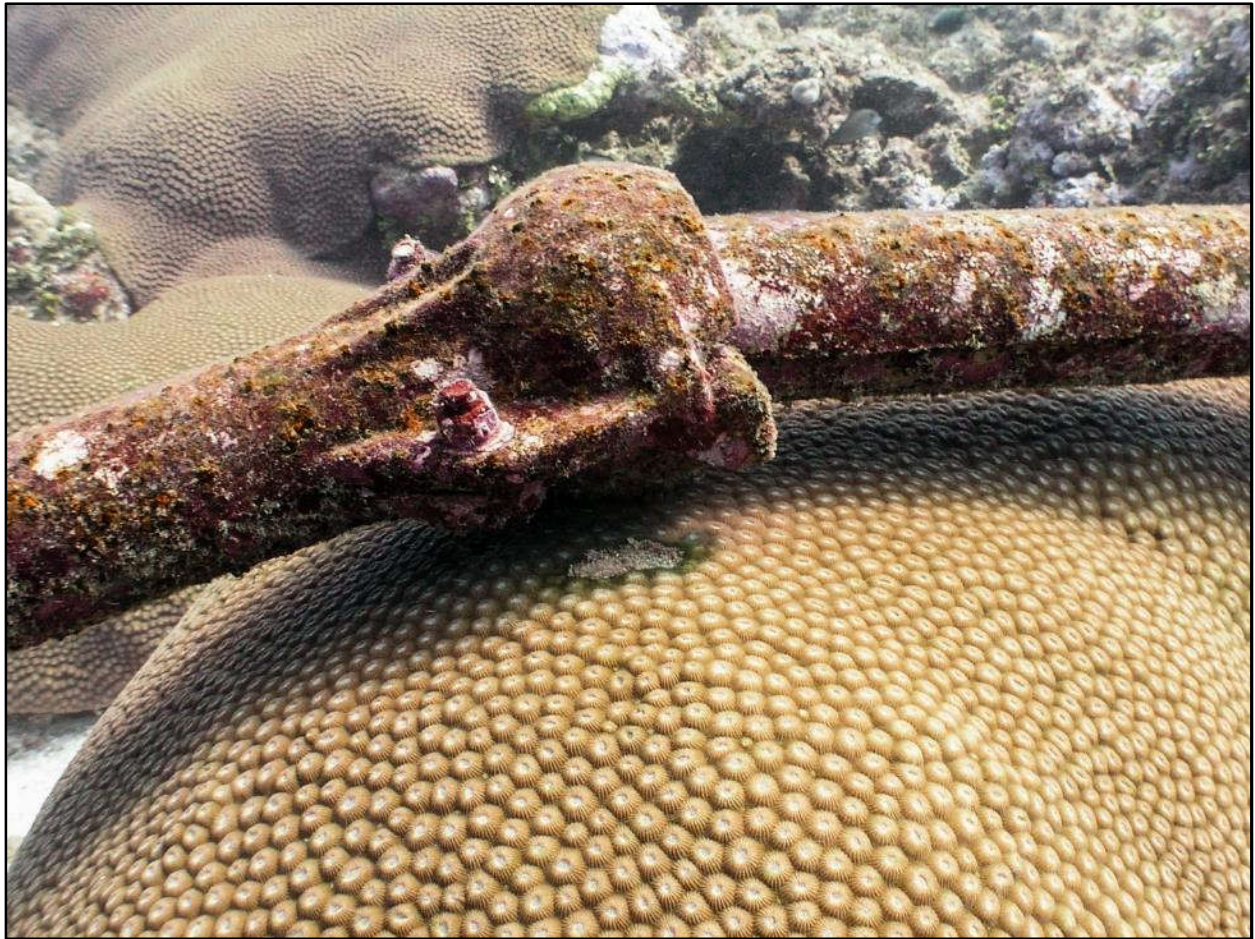
**Figure 41.** The ATISA Cable resting on the surface of a large *Diploastrea heliopora* colony. The small area of dead tissue may be an area of the colony where the cable had previously rested.

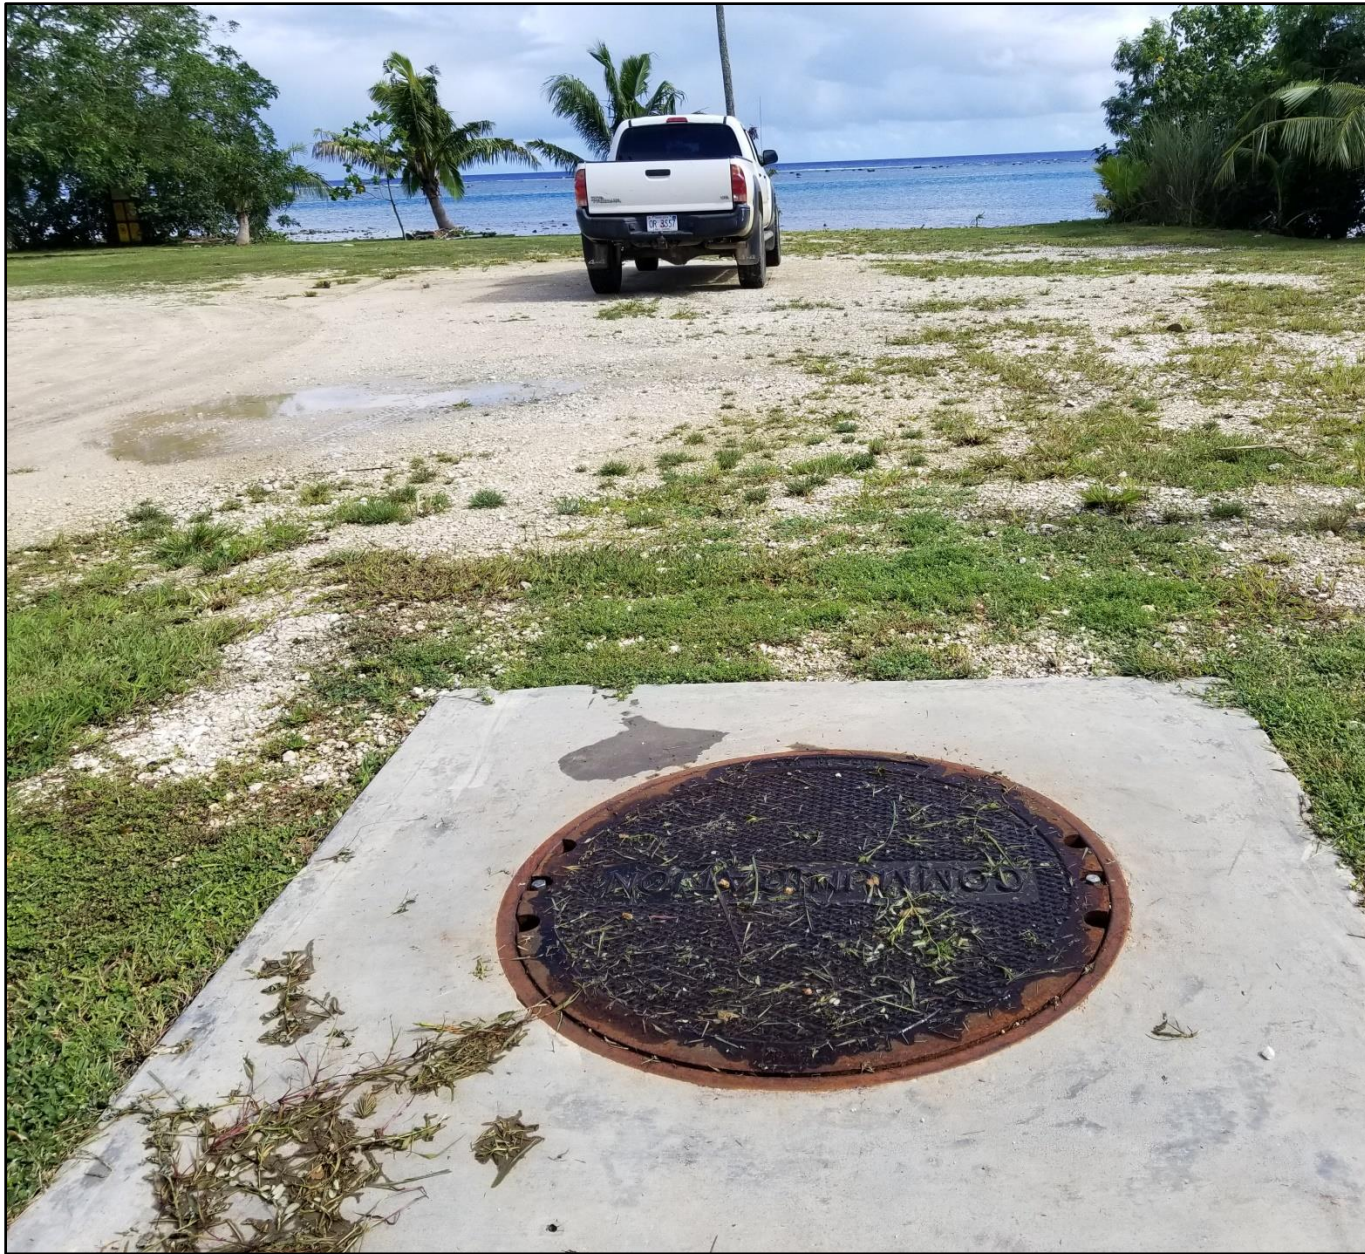
Photo 2. GTA Beach Manhole installed in 2017 located within Santos Park, facing north.

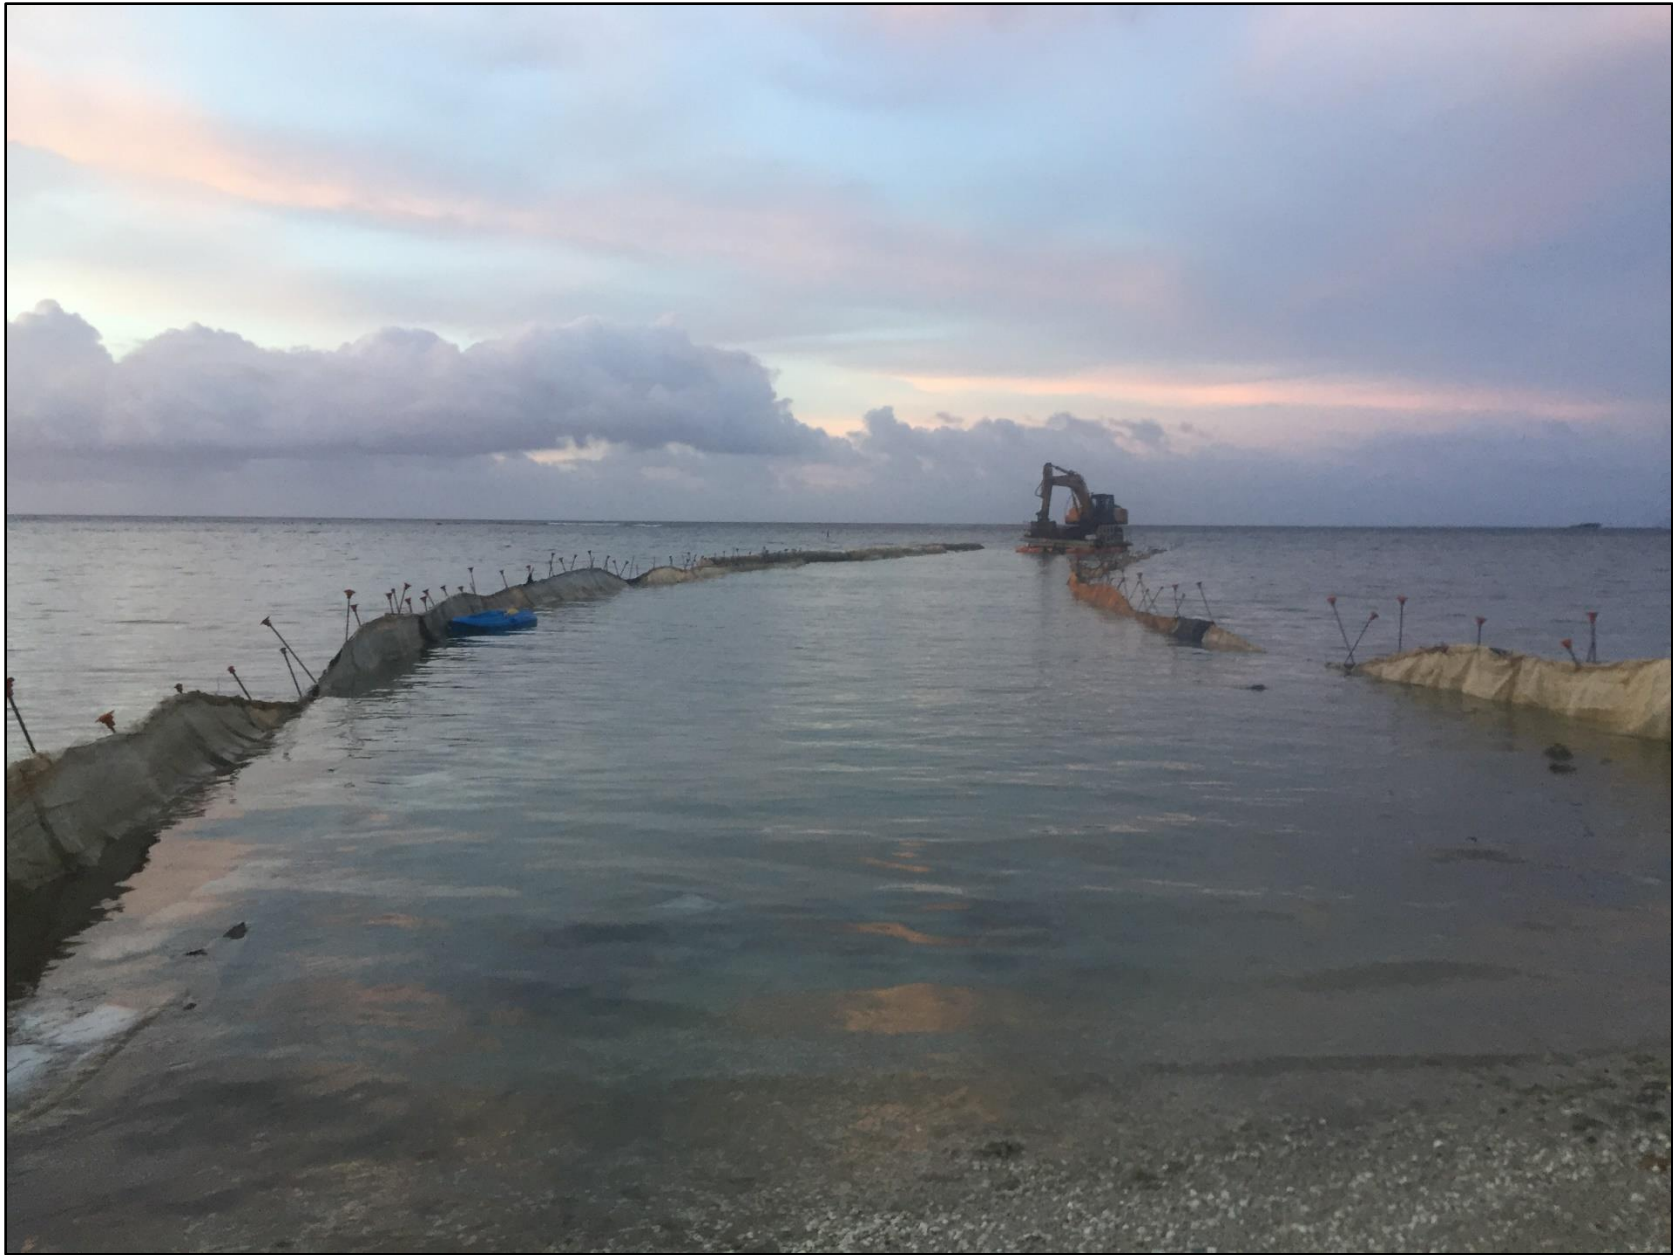
Photo 3. GTA conduit raceway construction corridor. The entrance corridor to allow for small support vessels and pedestrian access would be located entirely within this corridor and would have a smaller area.

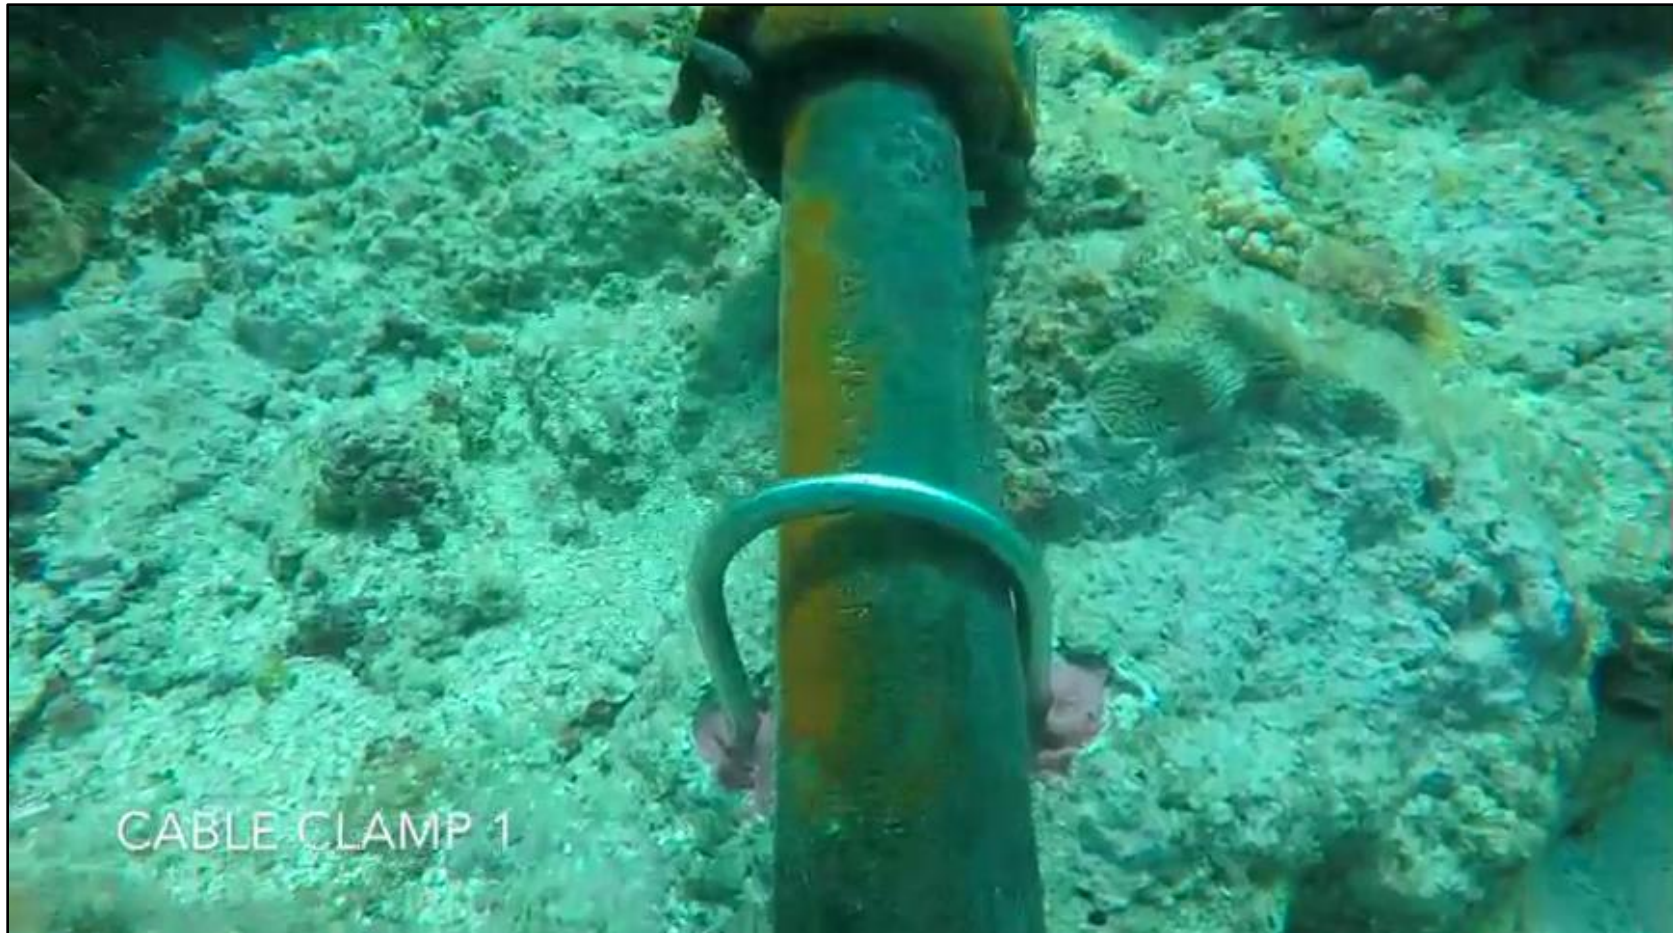
Photo 4. Cable pin installed on the ATISA Cable in 2017. The same hardware and methods would be used for the HK-G Cable pin installation.

the channel mouth to prevent lateral movement of the cable. The U-bolts will be stainless steel with typical dimensions of 14 in. long, 5 in. wide, and 0.5 in. diameter (38 cm long, 12.7 cm wide, and 1.2 cm diameter). After the U-bolts are positioned over the cable, two 1 in. (3 cm) diameter holes for each bolt will be drilled down to approximately 12 in. (30 cm) with a marine-grade hydraulic drill, and the bolts will be inserted and secured in place with a non-toxic marine epoxy. Pins will be installed at approximately 33 ft. (10 m) intervals along the cable's path over the reef crest. A total of 20 pins will be installed.
