An Aerial Analysis of Shoreline Variability along the Western Shore of Guam

for
Shore-line Development Recommendations

Government of Guam
Bureau of Statistic and Plans (BSP)

OYO Corporation, Pacific
919 Pale San Vitores Road #103
Tumon, Guam 96913

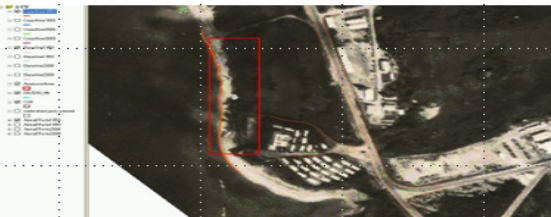
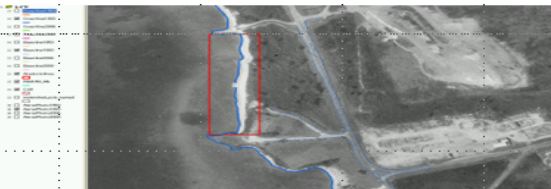
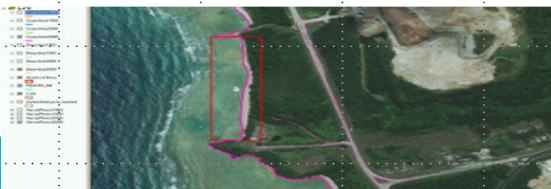
Procedure One and Two – Digitize

The following step by step approach to aerial analysis was used for all nine areas. Aerial photos from 1953, 1975, 1993, 2006 and 2009 were provided by BSP. It should be noted that cost effective PC based Geographic Information Systems really didn't really begin in earnest until 1991 when ESRI released ArcView in response to the popularity of a GUI desktop environment.

1) Manually-Digitizing 1953 and 1975 Aerial Photo

- ✓ 1953 and 1975 Aerial Photo have no geographic information therefore cannot ortho-rectify.
- ✓ Aerial Photo of 1993, 2006, and 2009 has geographic information. Used them without amendment.

2) Digitizing shore line and reference line

- ✓ Digitizing shoreline and reference line.
- ✓ Reference line: relatively permanently affixed mark that establishes exact position of a place. (Roads and buildings).

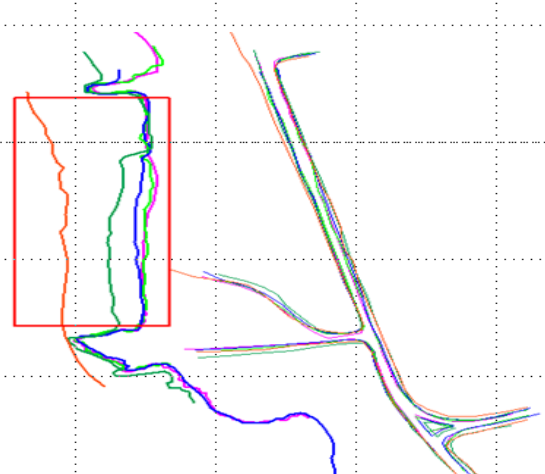
Procedure Three – Adjustments

3) Adjusting shore line and reference line

- ✓ Aerial Photo of the year 1953, 2006, 2009 have position gap to a greater or lesser extent.
- ✓ Gap level differs each year and varies from region to region.
- ✓ Adjusted position differences using reference line of 2009 Aerial Photo.

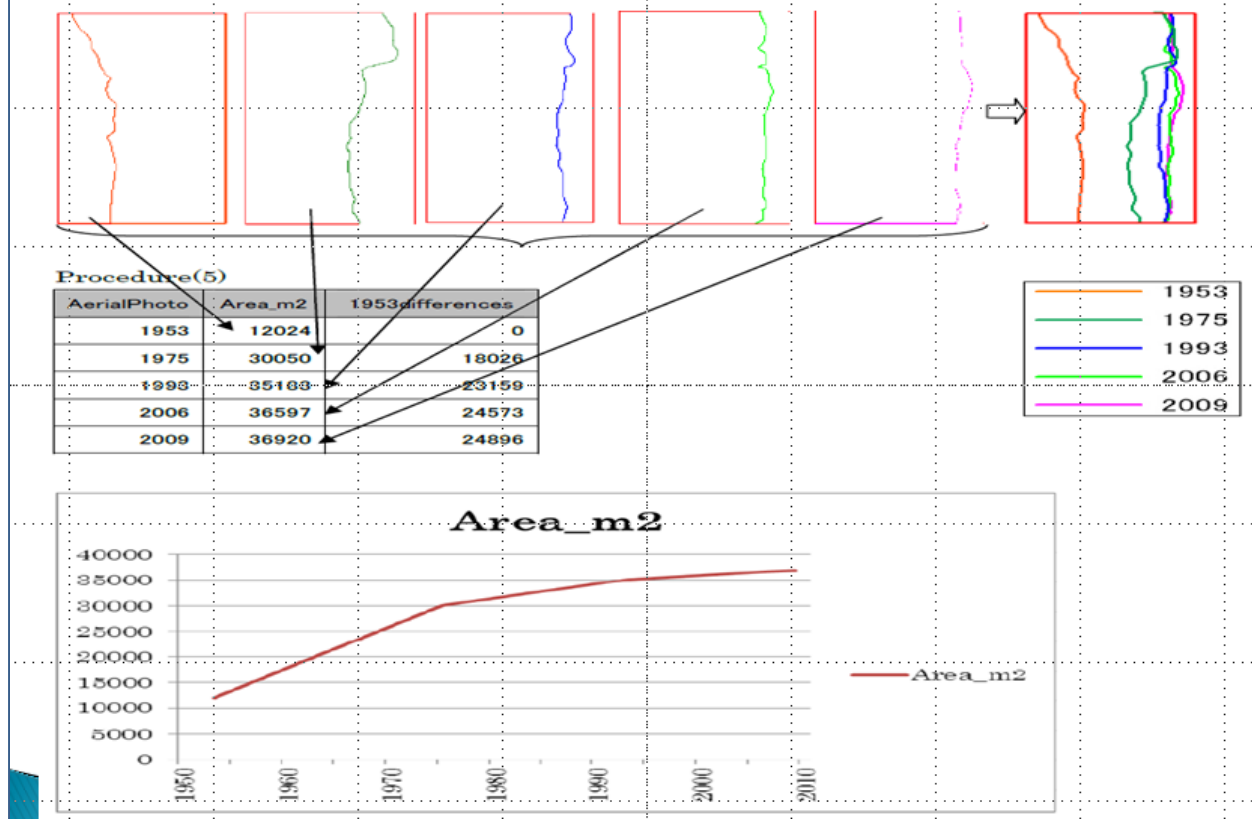
Procedure 4 & 5 - Area Calculations

The above area calculation was developed as follows:

1. A rectangle of known dimensions is placed over (layered) over an area of analysis for each year.
2. Within the rectangle, both the land area and sea area in square meters is determined.
3. The sea area is placed in the column labeled Area_m2 for each year.
4. The change, or delta, in the area is placed in the column to the right.
5. An increasing delta or area indicates the sea area increased and the land is eroding.
6. In turn the area divided by the length of the rectangle over time provides an estimation or mean rate of erosion on an annual basis.

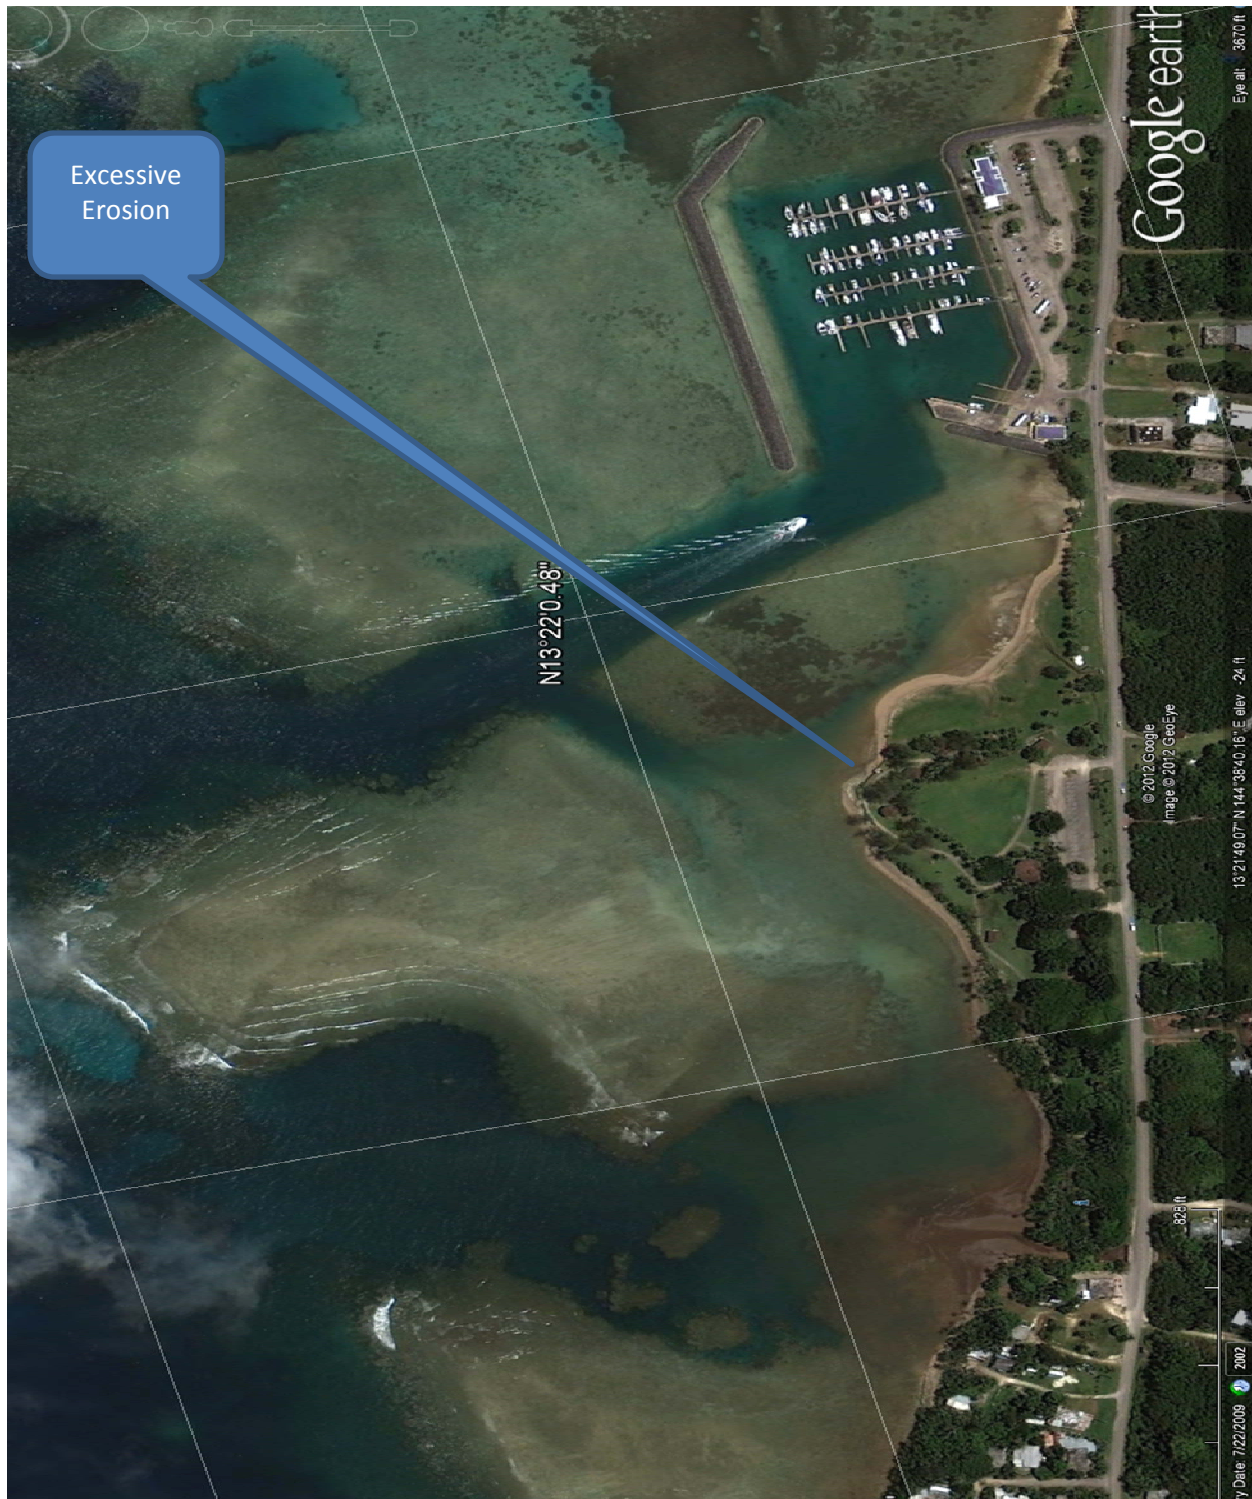
Figure 1 - 2009 Aerial – Agat Marina, Guam (Google Earth)
Excessive Shoreline Erosion

Agat Harbor, Guam, is a small boat harbor excavated from a coral reef flat and protected by a detached breakwater. It has been studied by the Army Corp of Engineers prior and after its construction around 1984. The western side of Guam is in the lee of the predominant trade winds, and, since the reef dissipates much of the incoming wave energy, the reef flat and harbor are quiescent the majority of the time. Some lessons learned are presented herein as taken directly from reference four.

- b. Wind waves dissipate most of their energy in breaking at the reef face. Wave energy propagates across reef flats moving water shoreward, that returns seaward through breaks in the reef face. Agat Harbor and its entrance channel provided such a pathway.

- d. *The combination of seiche, return flow from wave setup, and mass transport of bore-like waves can result in large currents running parallel to shore. For structures located on the reef flat, forces due to the resulting currents may be of larger magnitude than forces due to the wind waves themselves.*

- h. The detached breakwater design promotes flushing of the harbor, but can result in a significant influx of sediment during high-current events.

Agat Marina / Nimitz Park – it appears a short man-made channel was created at such an angle to the deeper main channel to allow wave action along with increasing velocities to occur along the shoreline

during tidal changes. This diurnal occurrence most likely allows erodible velocities to occur frequently along the shoreline which is comprised of a reasonable amount of fine grained materials susceptible to erosion.
