Manell-Geus Watershed Characterization Report

August 2022
FINAL

Prepared for:
NOAA Coral Reef Conservation Program

Prepared by:
Horsley Witten Group, Inc.

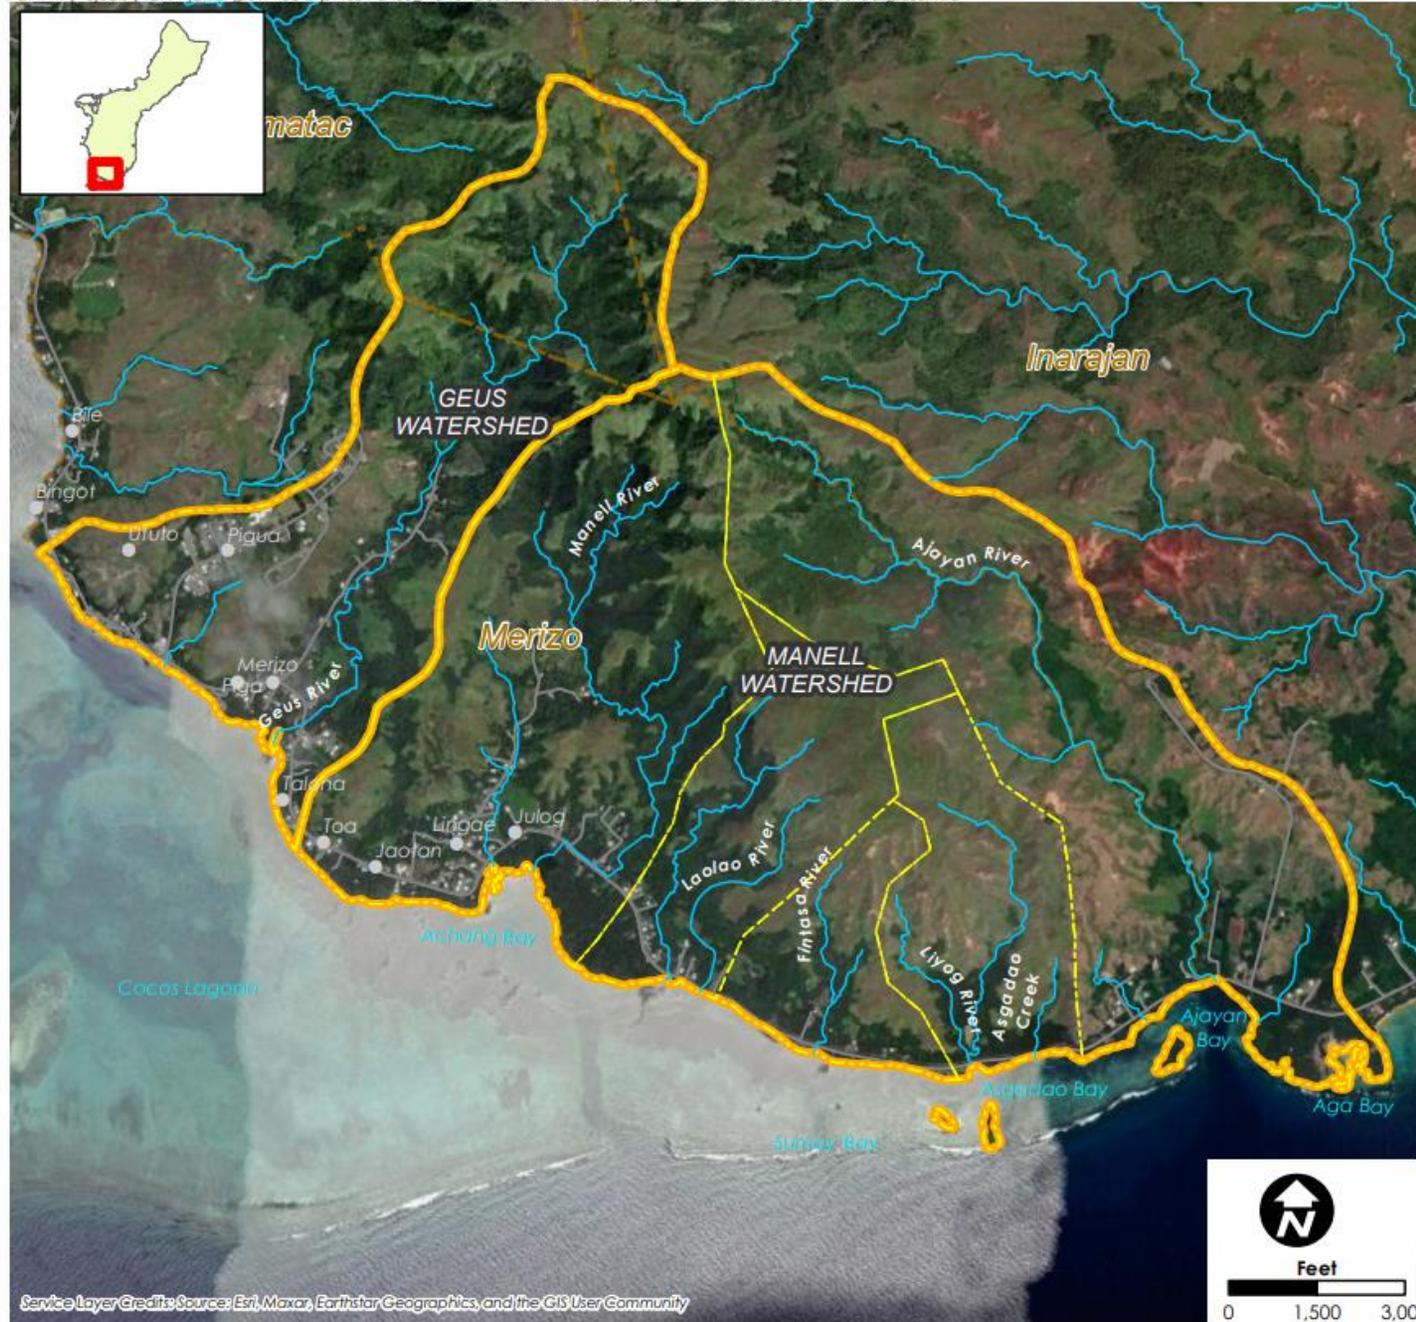
Manell Geus
Subwatersheds.

The Nelansa (Manell) subwatershed is an area of about 1.13 square miles. The subwatershed extends from Mount Sasalaguan to Achang Bay. The subwatershed slope is moderately steep at approximately 13%. This river is predominantly natural and unlined, until it moves through a concrete-lined drainage ditch that runs parallel to and under Route 4. The Manell River is joined by a tributary from the west at a point just above Route 4. A 2020 U.S. Army Corps of Engineers Flood Hazard Study developed a one-dimensional study flow model of the subwatershed. The study indicated that floodwaters enter the overbank areas and residential properties as often as the 50% AEP (2 year) event due to the narrow channel, low overbanks, and structural constrictions along the Manell River (U.S. Army Corps of Engineers, 2020b).

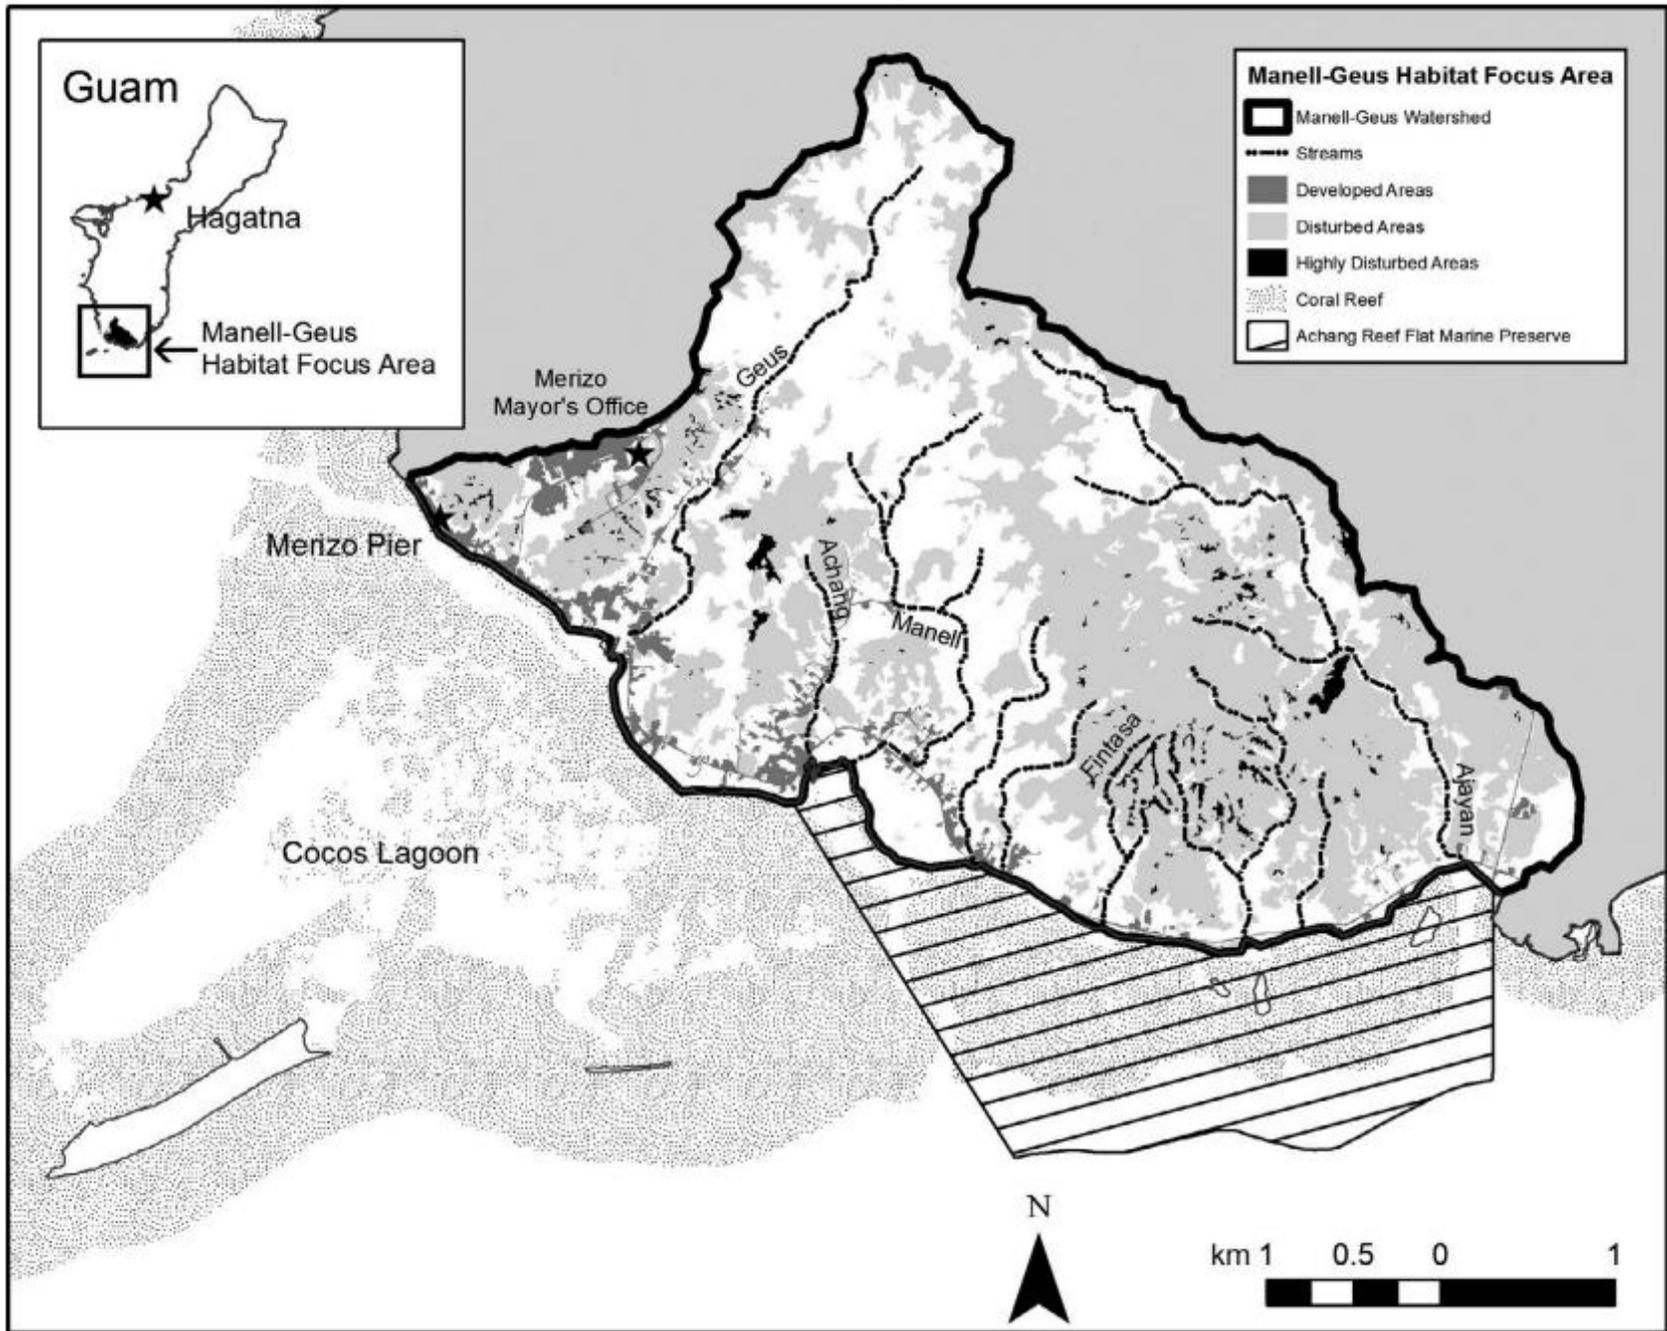
While developed land is fairly limited along the coastline of the watershed, disturbed areas, primarily from arson, are present in larger numbers in the watershed (**Figure 2**). Based on the 1994 Guam Generalized Land Use Map (**Figure 3**), parks, recreation, and open space make up the majority of the Manell-Geus watershed. Limited residential developments, farmland, and roadways cover the lower reaches of the watershed (W.B. Flores et al., 1994).

Figure 2. Manell-Geus Watershed Developed, Disturbed, and Highly Disturbed Areas (NOAA, 2012).

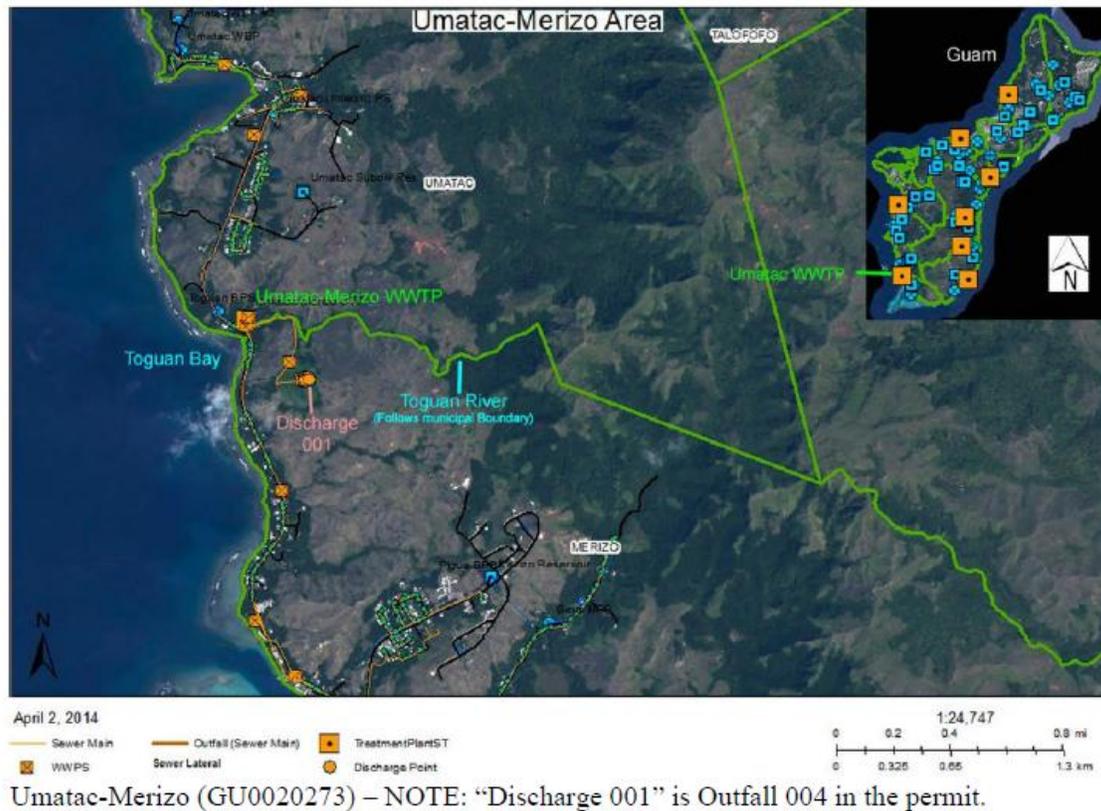
The below figure shows the sewer infrastructure for the Umatac-Merizo Wastewater Treatment Plant (WWTP), operated by the Guam Waterworks Authority under an issued current NPDES permit (permit no. GU0020273).

Figure 7. Map of sewer infrastructure for the Umatac-Merizo NPDES permit (NPDES Permit No. GU0020273).

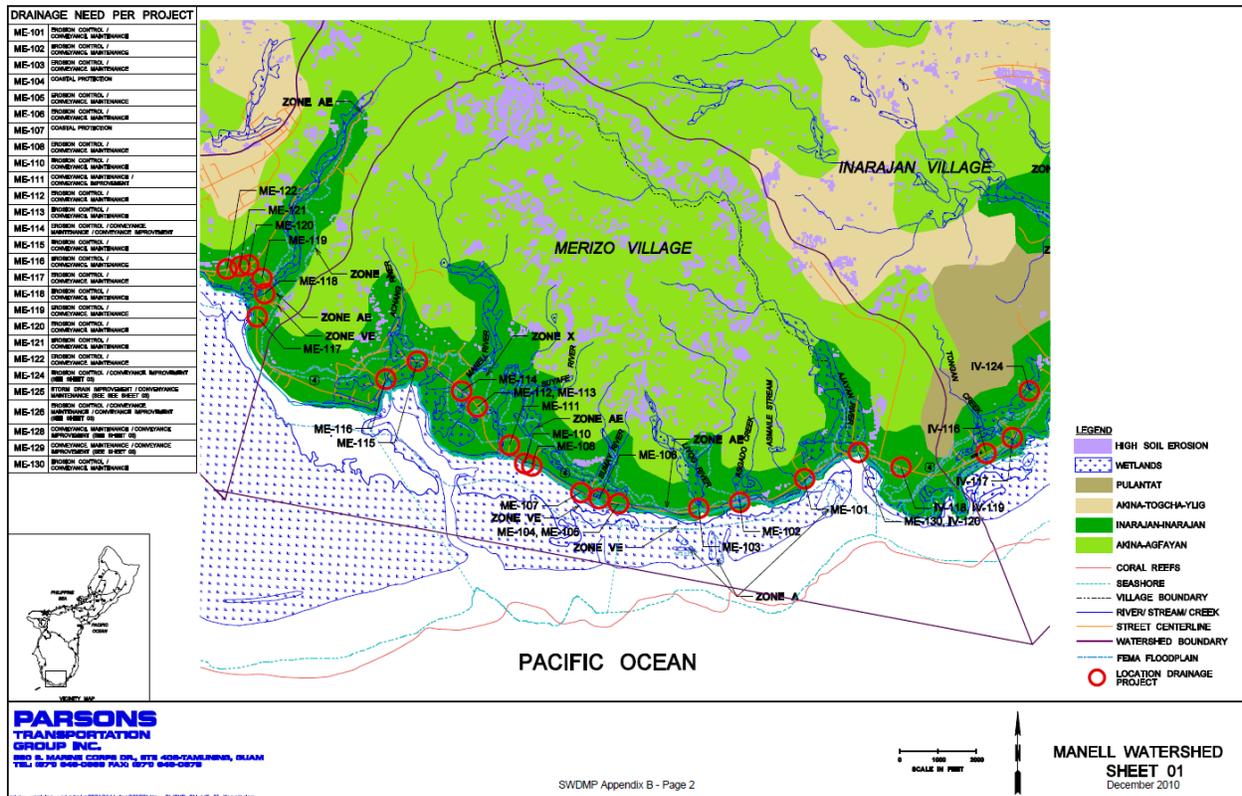
The report provides a prioritized list of drainage improvement projects for each village based on criteria detailed in Section 3 of the report. A total of 30 potential projects were considered for the village of Merizo, covering drainage improvements for both the Manell and Geus watersheds (**Figure 8**).

Figure 8. Drainage improvement projects list and map for the Village of Merizo (Guam DPW SW Drainage Master Plan).

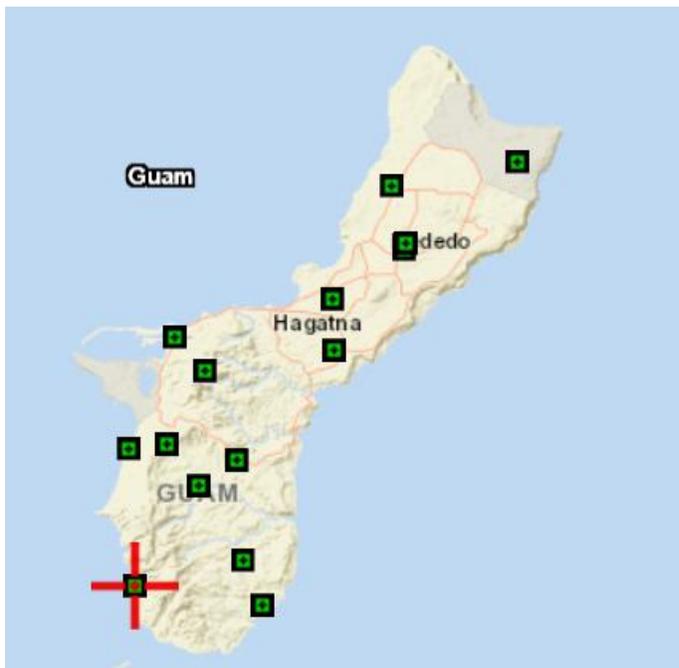
Recurrence Interval (24-hour duration)	Precipitation (in) NOAA Atlas 14
1 year	4.76 (3.82-5.98)
2 year	6.32 (5.07-7.94)
5 year	8.46 (6.76-10.7)
10 year	10.1 (8.06-12.8)
25 year	12.4 (9.80-15.8)
100 year	16.1 (12.4-20.8)

Figure 16. NOAA Umatac Precipitation Station, Guam (left) and precipitation totals for 24-hour storm events (right) (NOAA Atlas 14).

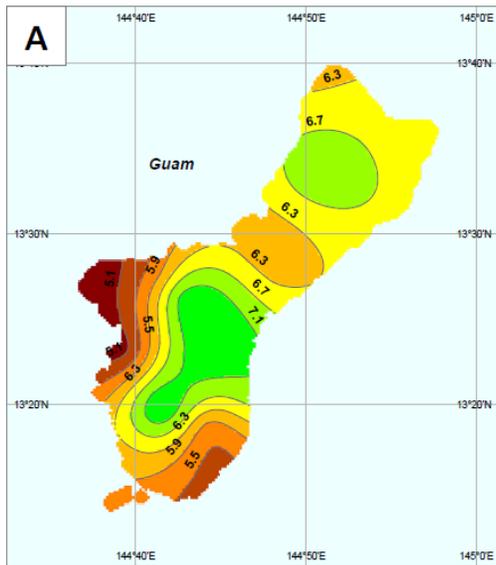
Figure 17. Isopluvial of 24-hour precipitation event with average recurrence interval of 2-years in Guam (NOAA Atlas 14).

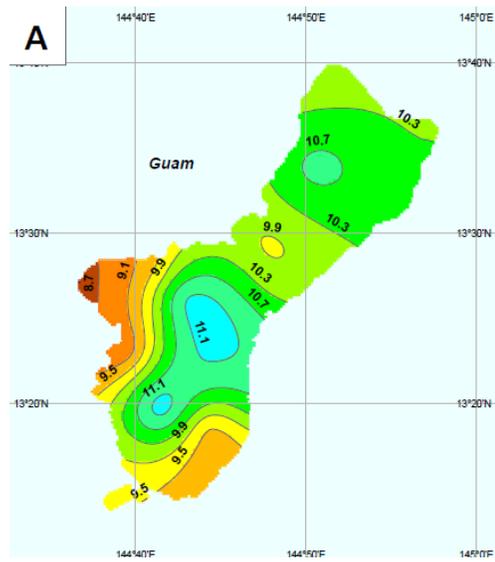
Figure 18. Isopluvial of 24-hour precipitation event with average recurrence interval of 10-years in Guam (NOAA Atlas 14).

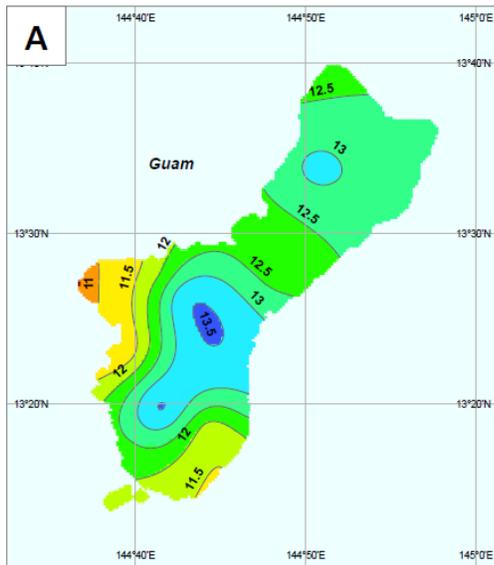
Figure 19. Isopluvial of 24-hour precipitation event with average recurrence interval of 25-years in Guam (NOAA Atlas 14).

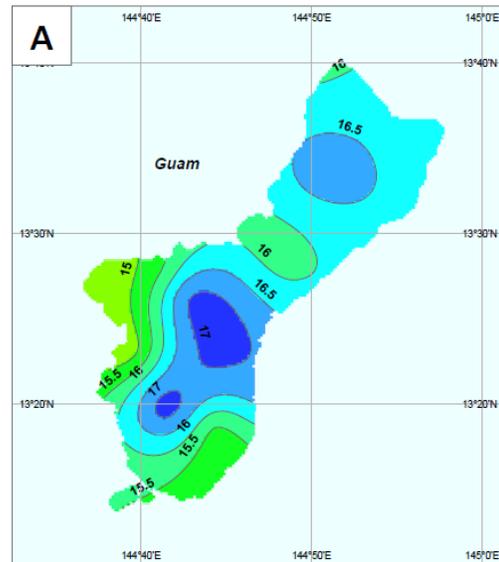
Figure 20. Isopluvial of 24-hour precipitation event with average recurrence interval of 100-years in Guam (NOAA Atlas 14).

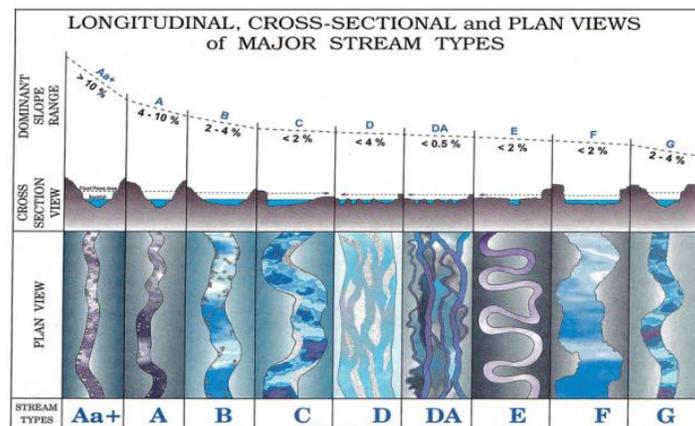
Figure 22. Rosgen Stream Types (Rosgen and Silvey, 1996).

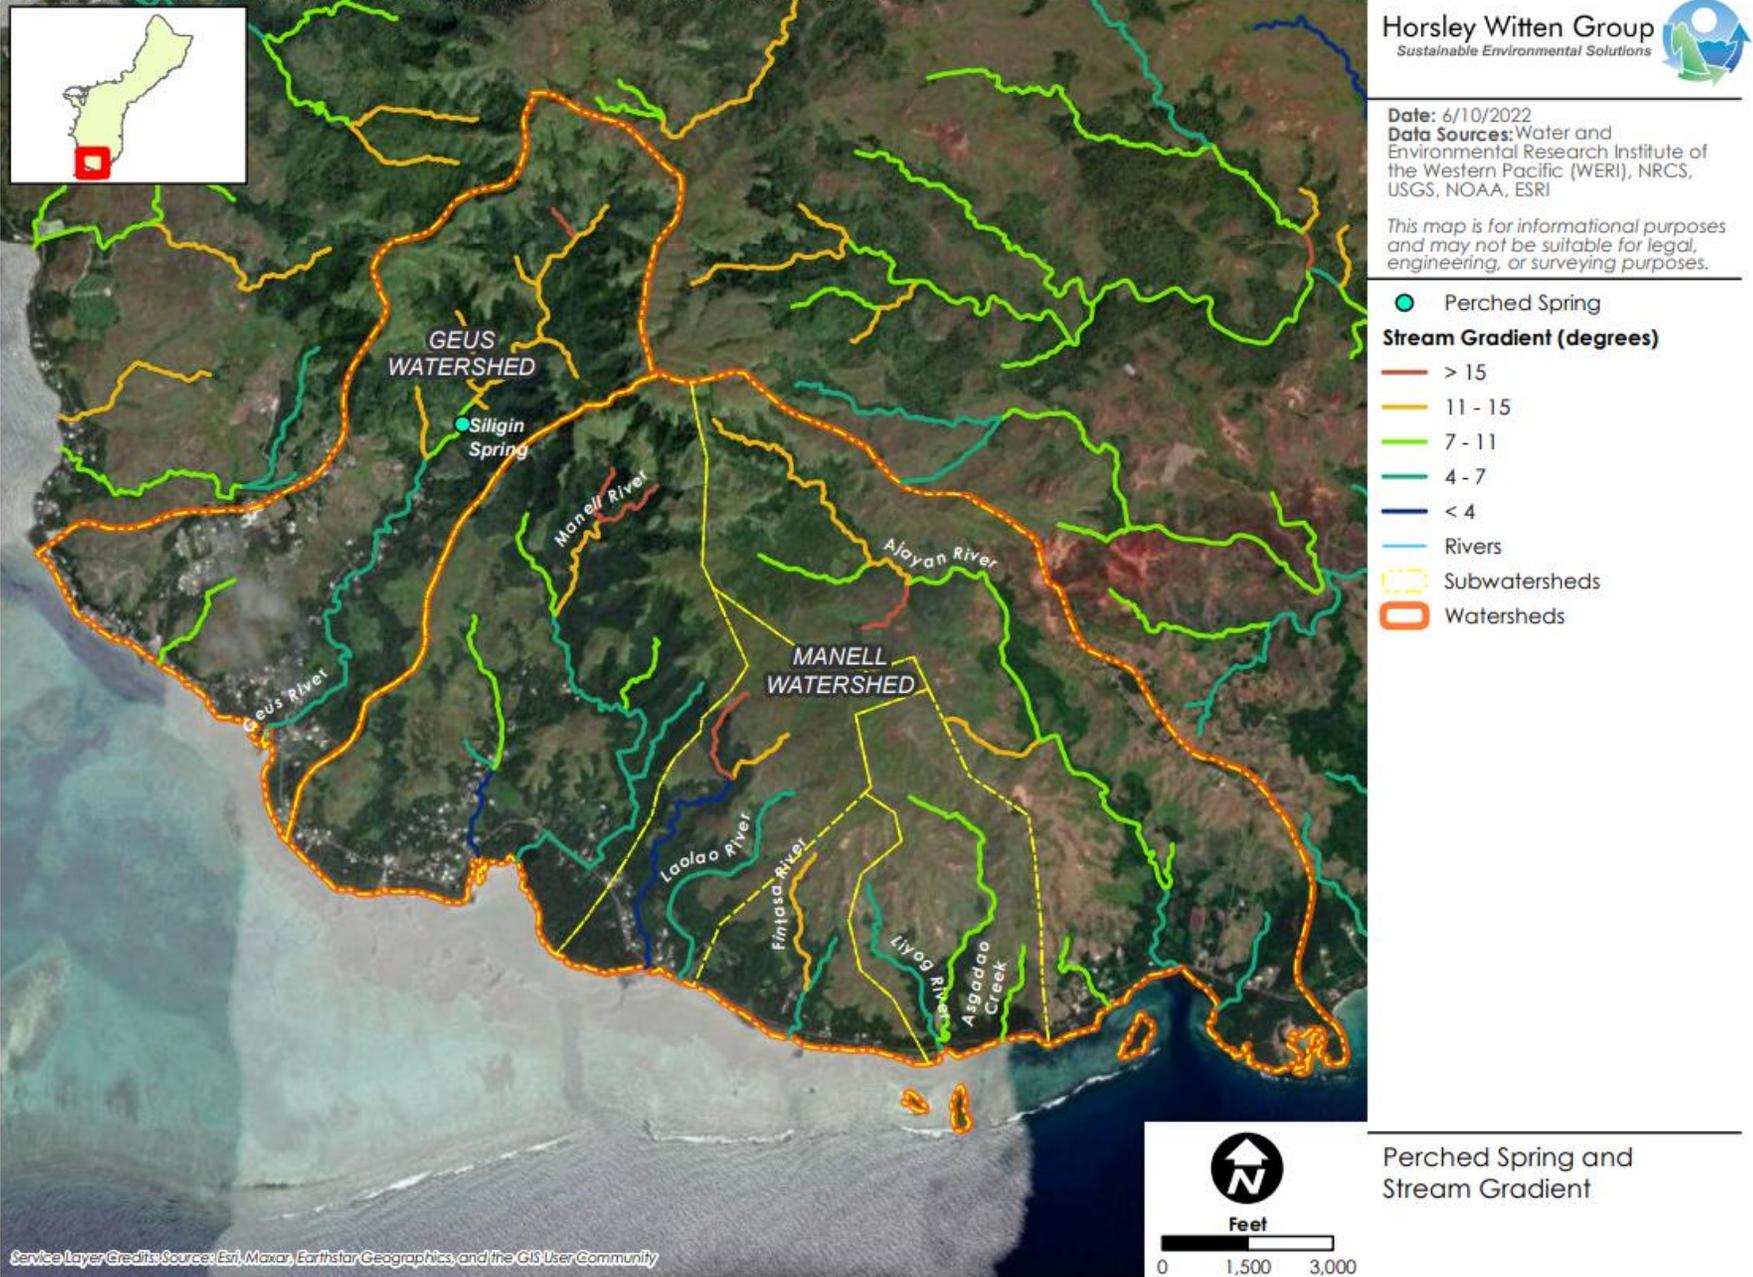
Figure 23. Perched springs and stream gradient in the Manell-Geus watershed (NRCS, USGS, NOAA, Water and Environmental Research Institute of the Western Pacific (WERI), ESRI).

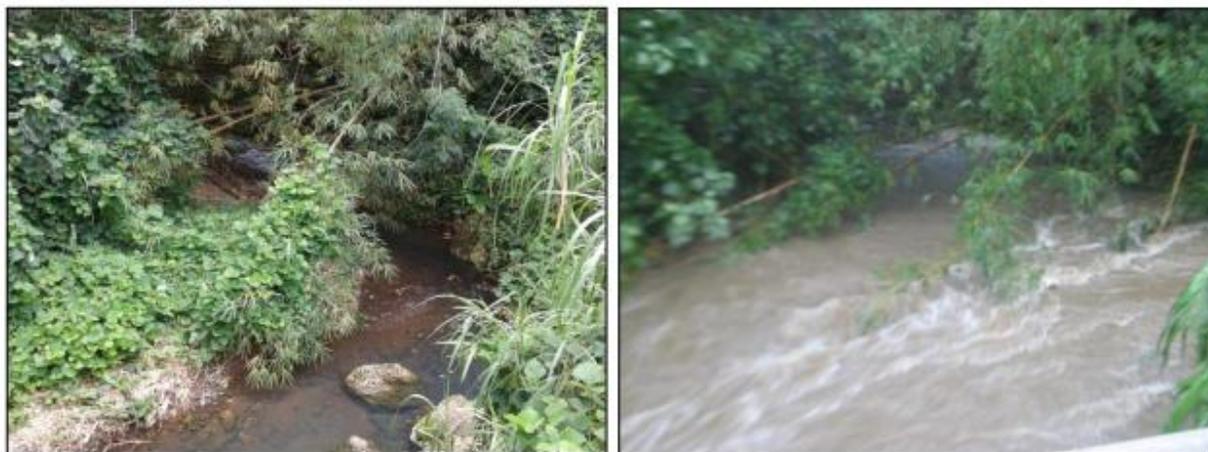
The Geus watershed is a dynamic watershed. A 2015 assessment of conditions in the Geus watershed determined that there is a strong correlation between stream level and rainfall. In addition, the assessment indicated that there was a strong correlation between turbidity and rainfall in the Geus watershed. Intensity of storms was identified as a key factor influencing erosion and runoff as indicated by turbidity levels. For example, during the largest storm event recorded during the study (Tropical Storm Halong on July 30, 2014) the maximum stream level recorded was 7.0 feet at 2:05 am. Duration at that height was a five-minute interval. During that spike, stream level was greater than 6 feet for 30 minutes, greater than 5 feet for 40 minutes, and greater than 4 feet for 70 minutes. Based on this data, the stream level doubled then came back down (from 3.5 to 7 feet) in less than an hour and a half. A similar pattern was exhibited in the turbidity data, which recorded a maximum concentration of 964.9 NTU from 2:15 am to 2:30 am. Turbidity above 900 NTUs lasted about an hour and a half, and significant increases were observed when the stream level rose to more than three feet. Based on the dimensions of the Geus Watershed, the assessment concluded that the river floods appear to last less than a couple of hours (Khosrowpanah et al., 2015).

Figure 24. Geus River conditions before and after Tropical Storm Halong (Khosrowpanah et al., 2015).

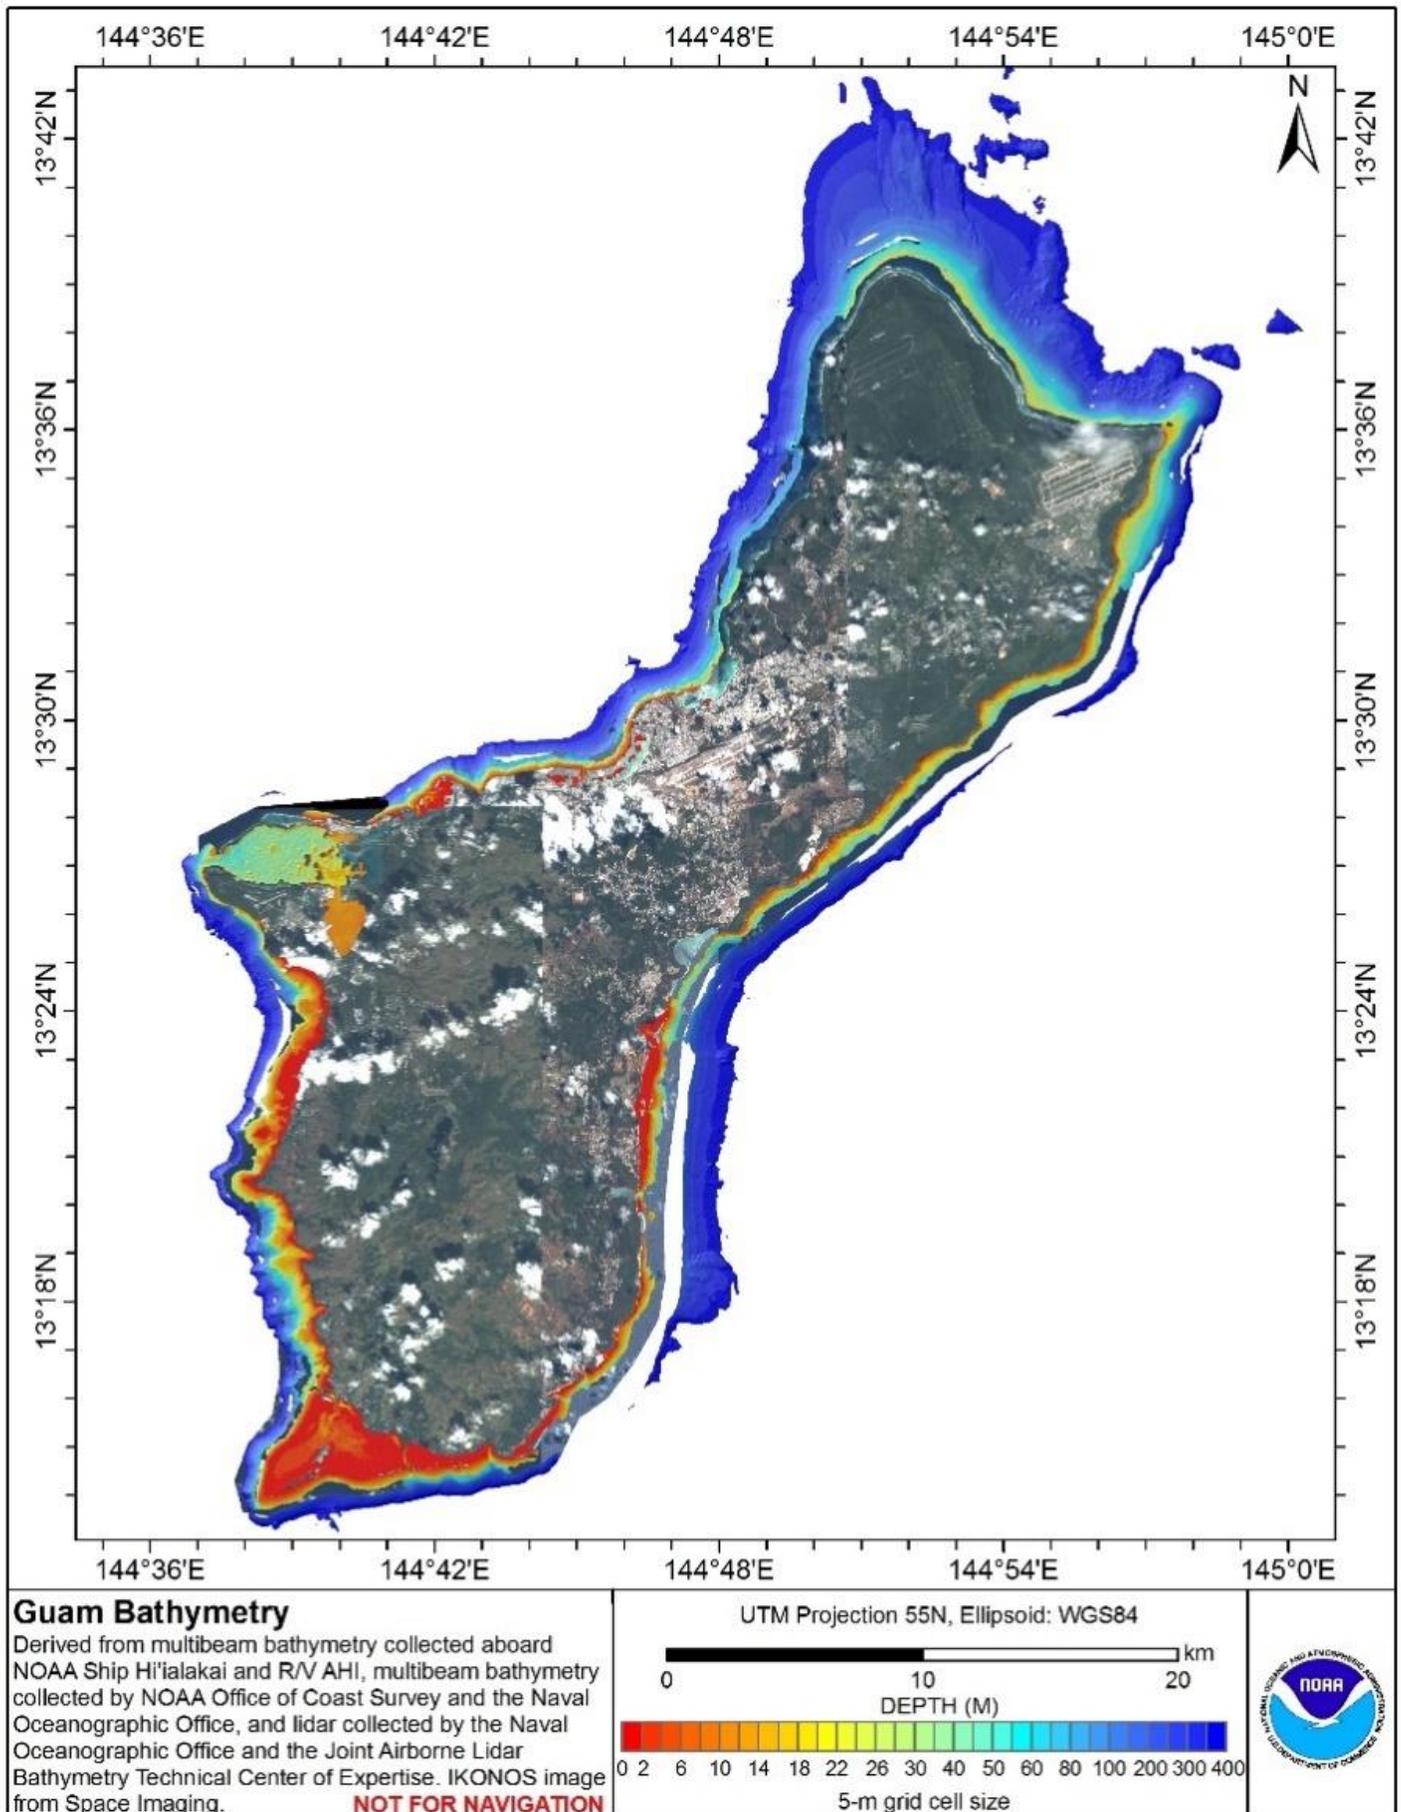
Figure 26. Multibeam and Lidar integrated bathymetry for Guam (NOAA, 2011).

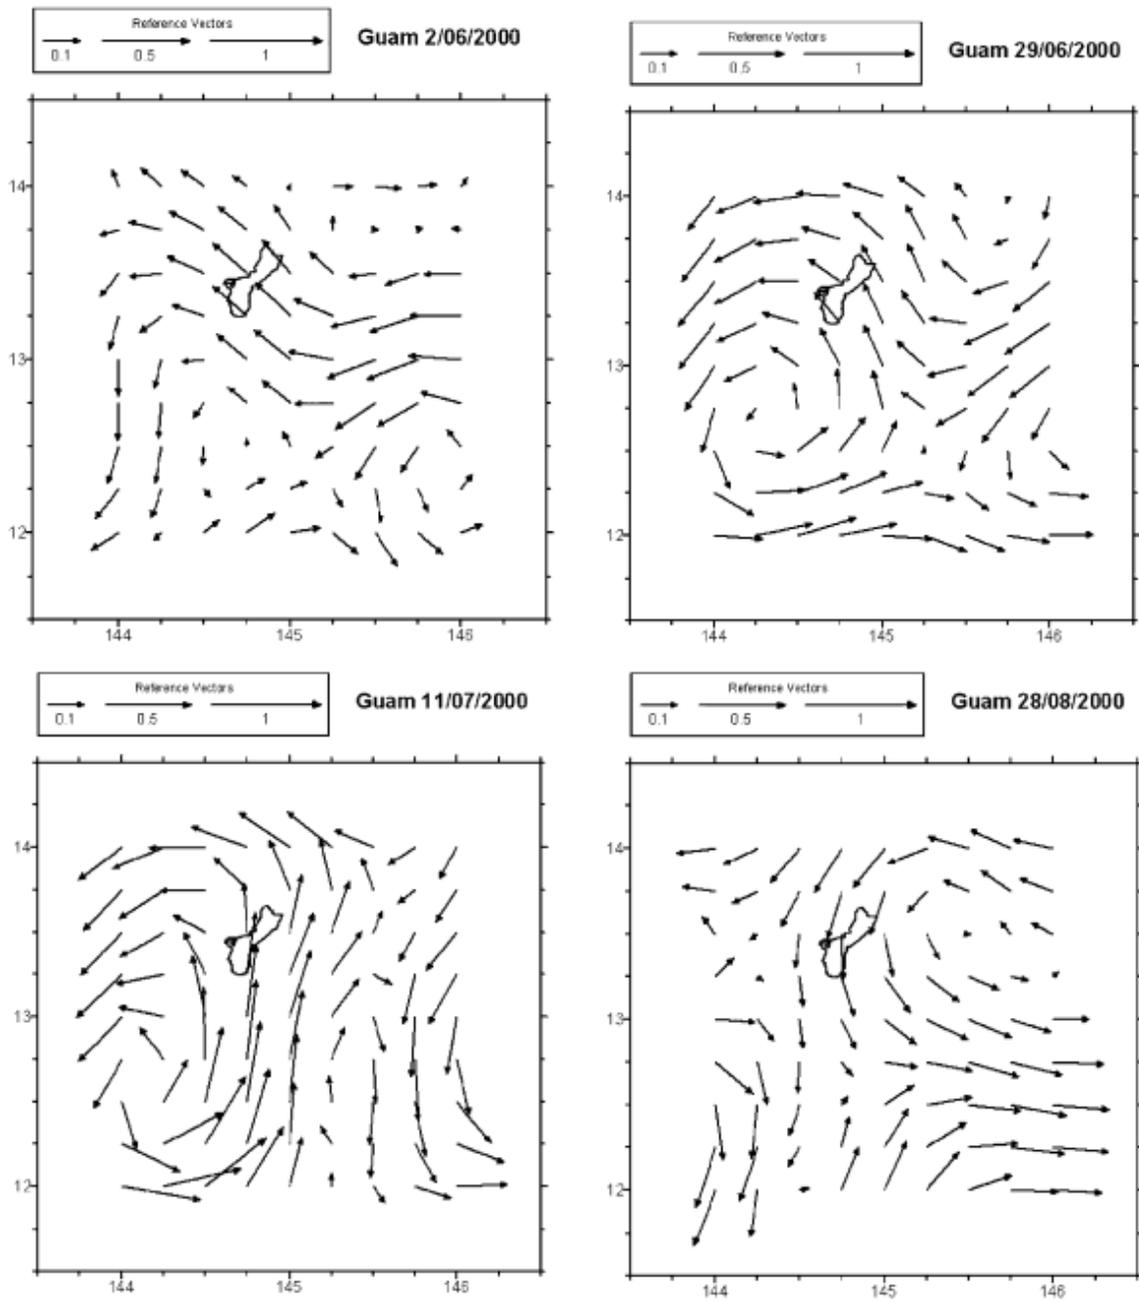
Information regarding large-scale oceanic circulation and how the island modifies circulation is fairly limited. Large-scale oceanic circulation around Guam is controlled by the North Equatorial current flowing northwestward at about $0.1\text{--}0.2\text{ m s}^{-1}$. One 2003 assessment of eddies around Guam identified Cocos Island as one of three salient capes in Guam that could steer currents and generate eddy motions. To the south of Guam, drifter data showed a westward current at a speed of 0.1 m s^{-1} and to the southwest of Guam, the data showed energetic, cyclonic eddies with a complete rotation in 4–5 days (**Figure 27**). However, it was noted that circulation around the island of Guam is spatially and temporally variable. These eddies are significant biologically for the island because they provide a mechanism for the trapping and return of eggs and larvae of coral and fish on Guam coral reefs. In addition, they control the connectivity among various reefs along the island (Wolanski et al., 2003).

Figure 27. Synoptic distribution during 2000 of near-surface currents ($m s^{-1}$) in a $2^{\circ} \times 2^{\circ}$ domain centered around Guam, as derived from satellite altimetry data from TOPEX/Poseidon (Wolanski et al., 2003).

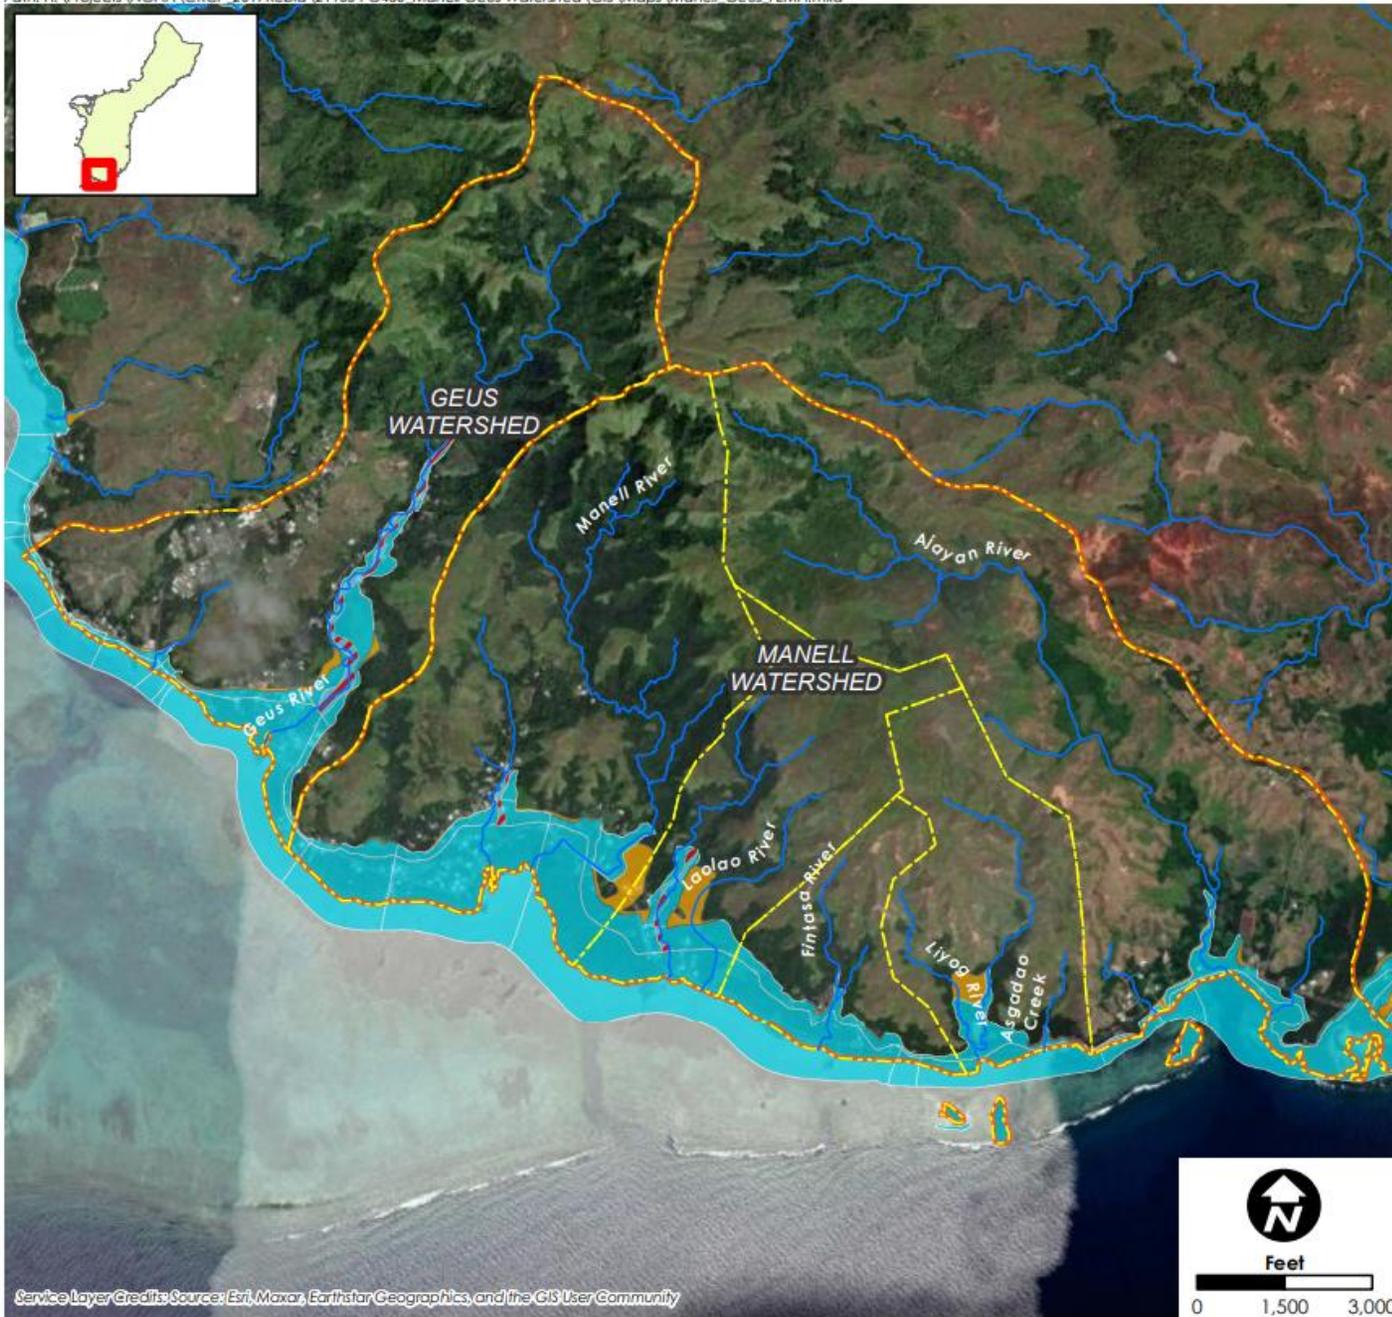
FEMA National Flood Hazard Layer.

Figure 30. FEMA National Flood Hazards in the Manell-Geus watershed (NRCS, USGS, NOAA, Water and Environmental Research Institute of the Western Pacific (WERI), ESRI).

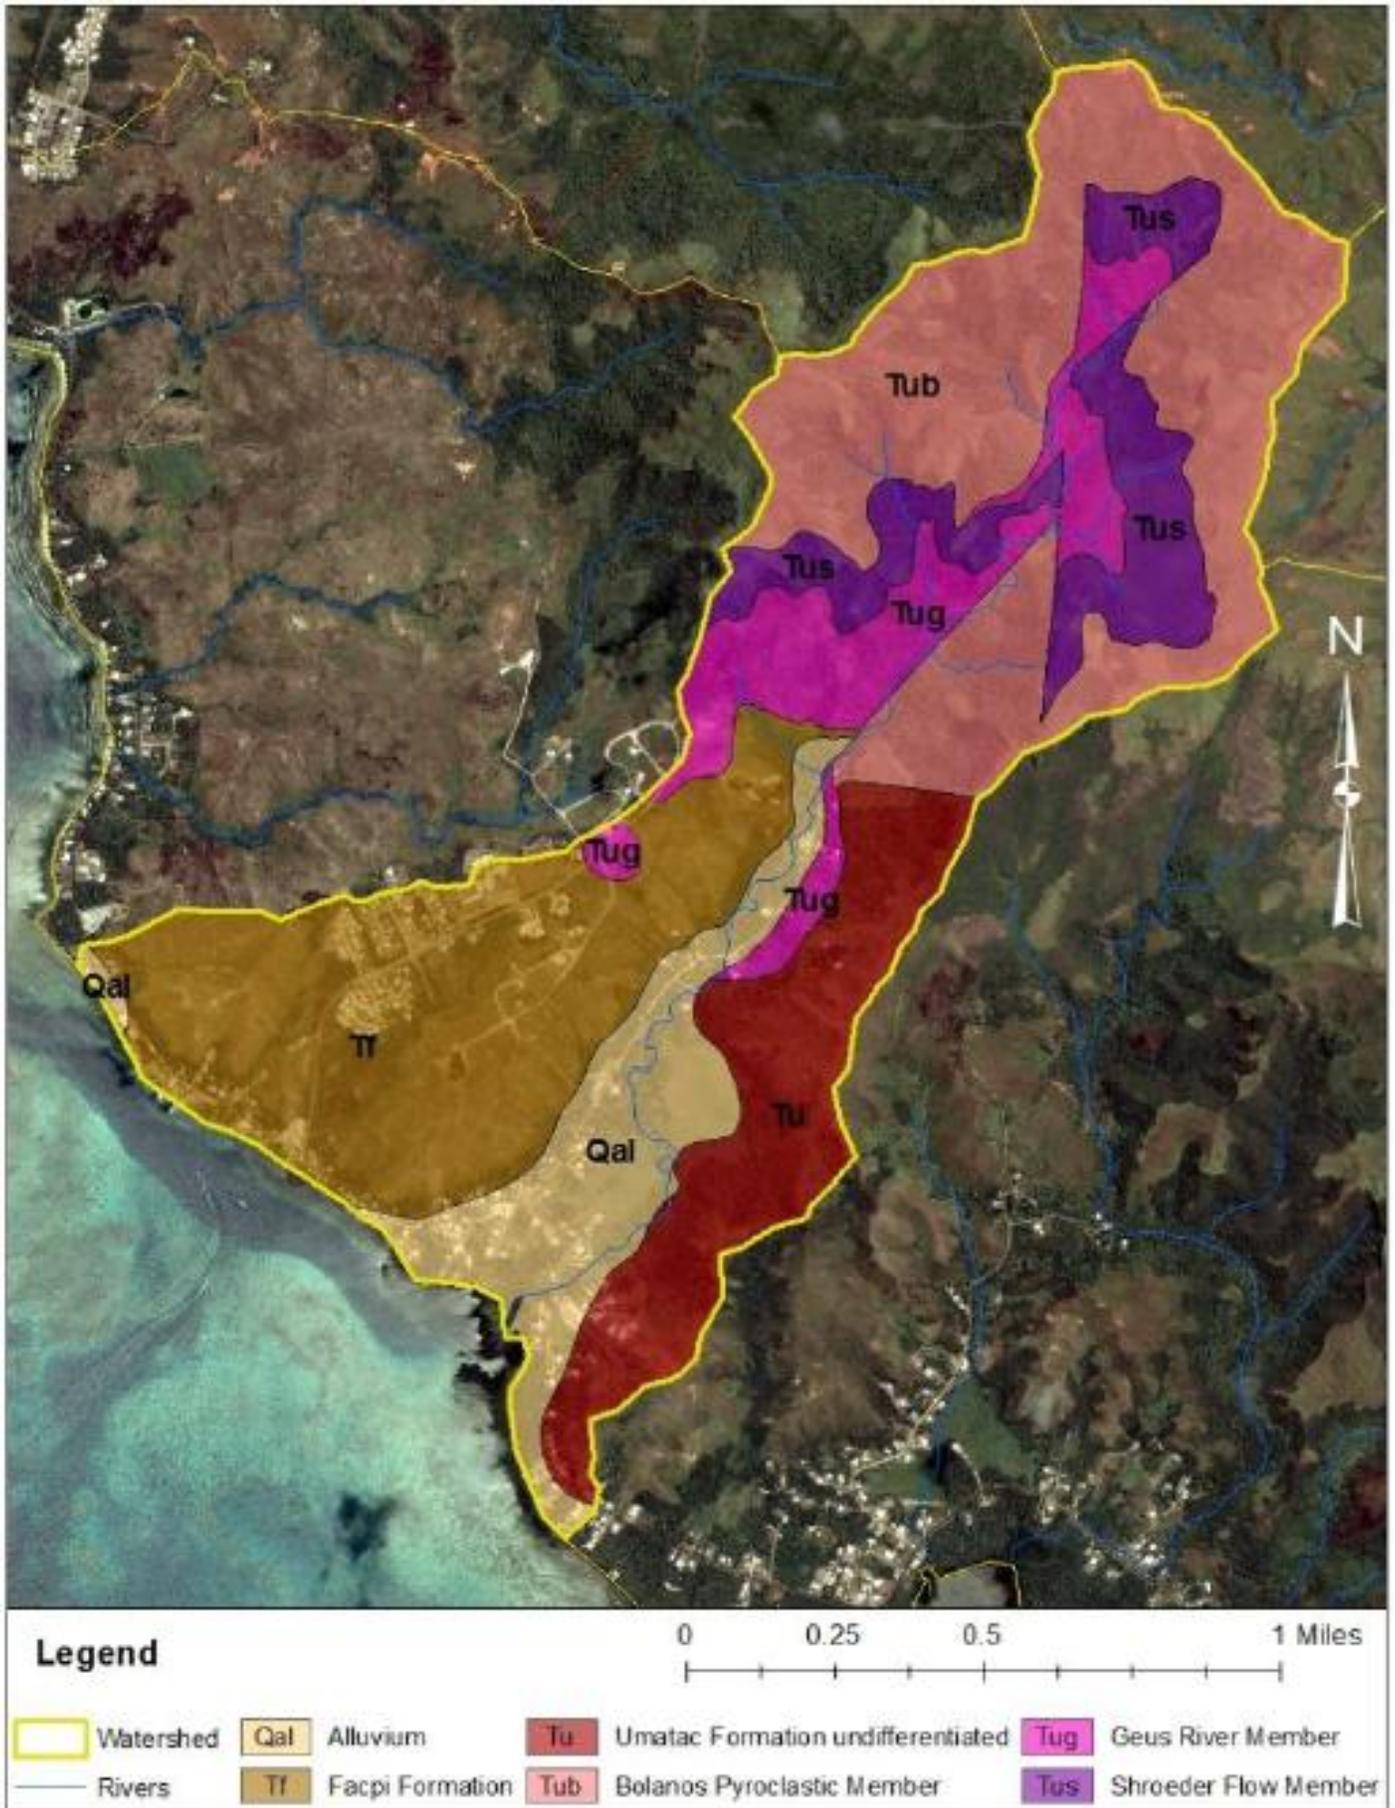
The Geus Watershed is part of the Umatac formation deposited during early Mocene times composed of three major geologic formations, which include volcanic conglomerates, lava flows and dikes, and alluvium (Kami et al, 1974)

Figure 36. Geus watershed geology (Siegrist et al., 2008 via Khosrowpanah et al., 2015).
