Manell-Geus Watershed Characterization Report

August 2022
FINAL

Prepared for:
NOAA Coral Reef Conservation Program

Prepared by:
Horsley Witten Group, Inc.

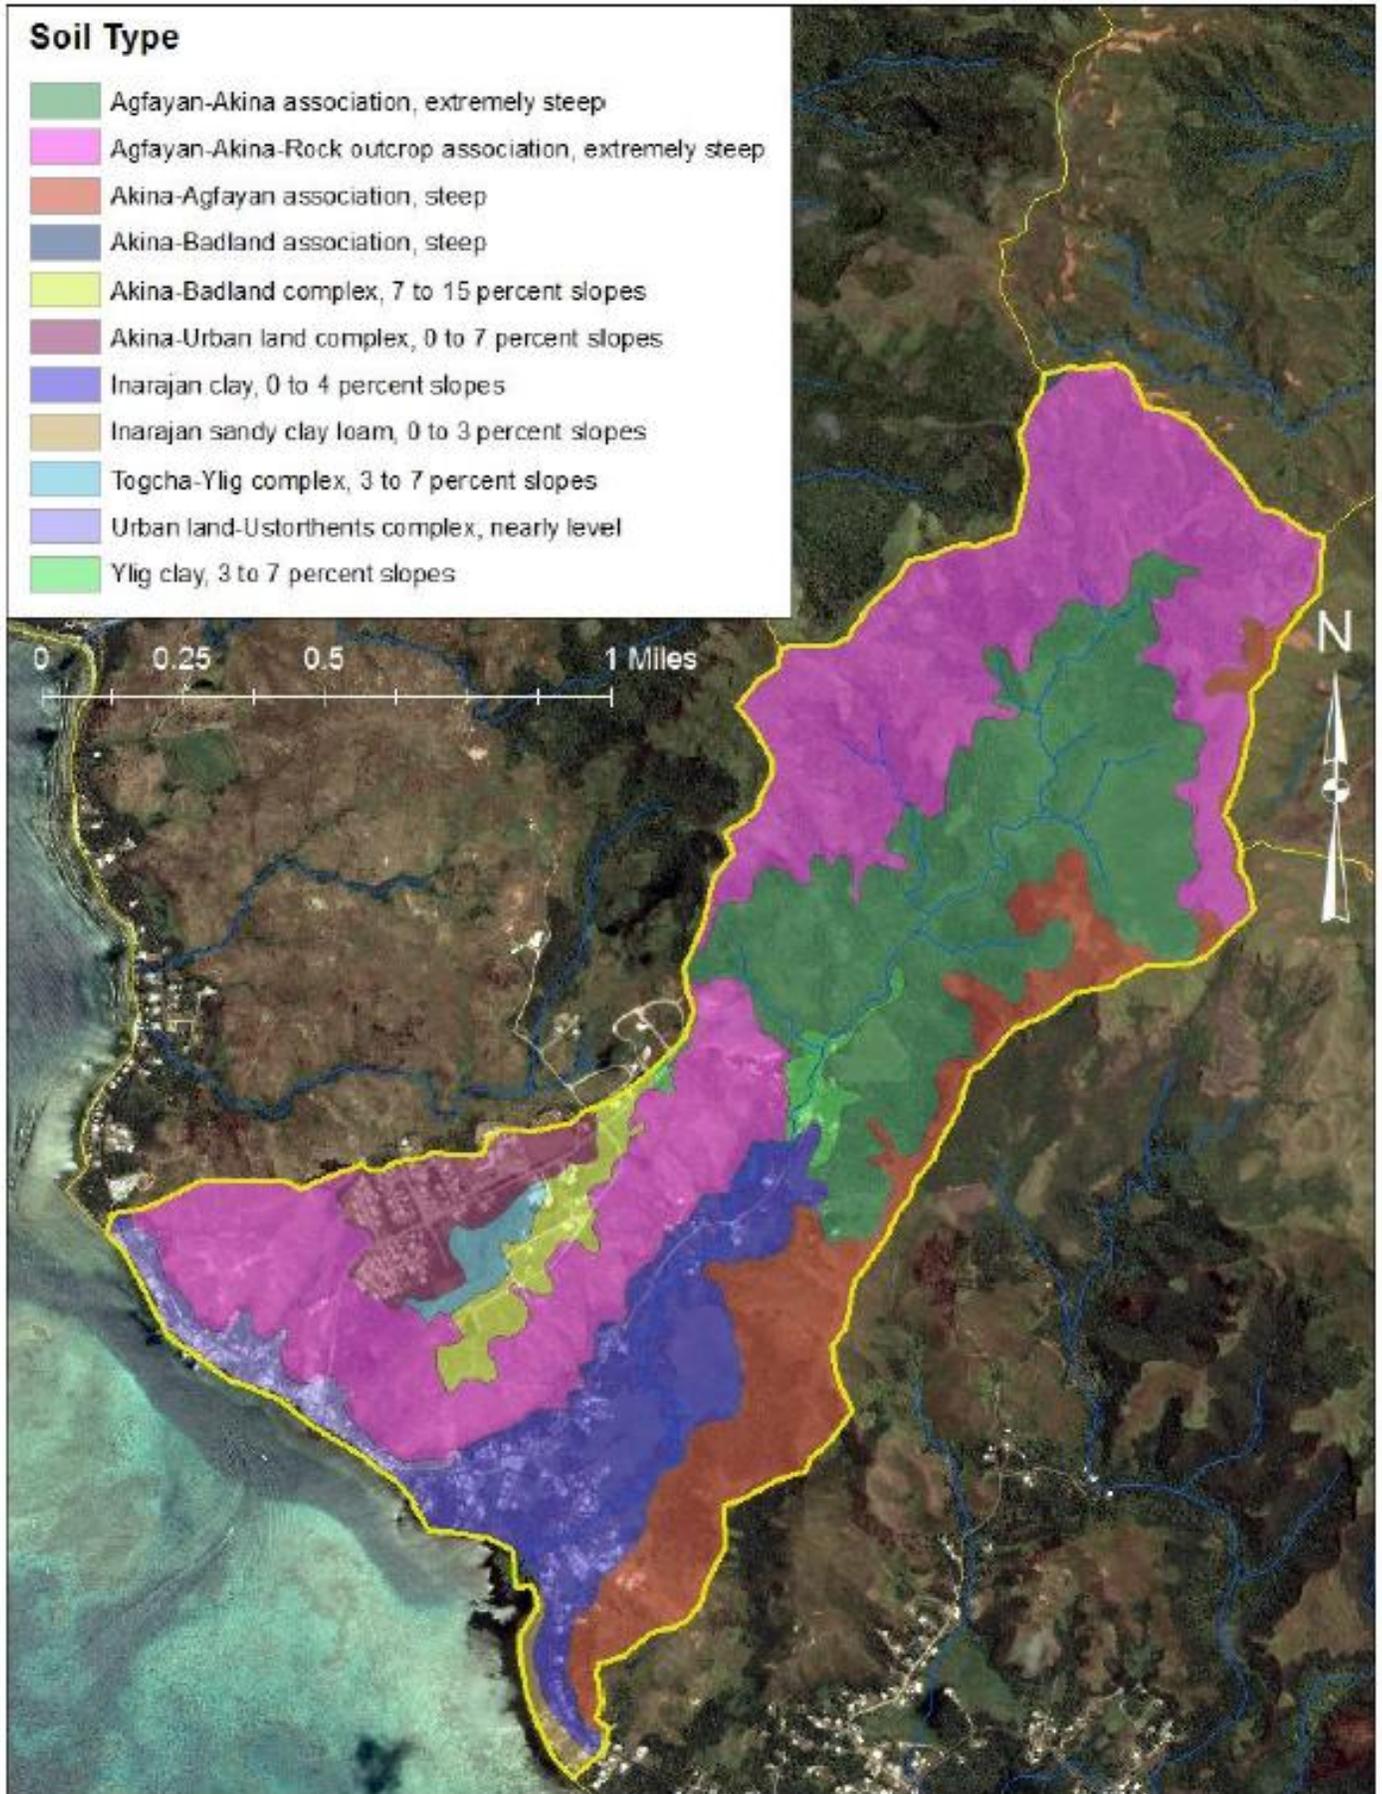
Figure 37. Soil types and location within the Geus watershed (Young, 1988 via Khosrowpanah et al., 2015).

The Manell and Geus watersheds primarily contain the Akina-Agfayan soil series. The soil ranges from very shallow to very deep, well drained, and moderately steep to extremely steep soils. Soils vary based on location, including dissected mountains, plateaus remnants, and jagged mountains. Akina soils are primarily found on the side slopes and ridgetops in these watersheds. These soils are very deep and well drained. The soils are red, acidic silty clay and clay and are underlain by saprolitic tuff at a depth of 20 to 40 inches. Agfayan soils are primarily found on side slopes and ridgetops in these watersheds. These soils are very shallow and are well drained. The soils are slightly acid to neutral clay and are underlain by weathered bedrock at a depth of 4 to 15 inches (EA Engineering, Science, Technology, 2014).

The soil types and topographic conditions of the Geus watershed are common for areas of southern Guam susceptible to badland development. Badlands occupy approximately 1.7% (18.5 acres) of the Geus watershed. Approximately half of the Geus badlands are located on Agfayan-Akina-Rock outcrop association, extremely steep soils. Akina-Agfayan association, steep make up approximately 37.2% of Geus badlands, and about 16.6% of the badlands are on Agfayan-Akina association, extremely steep. (Khosrowpanah et al, 2015).

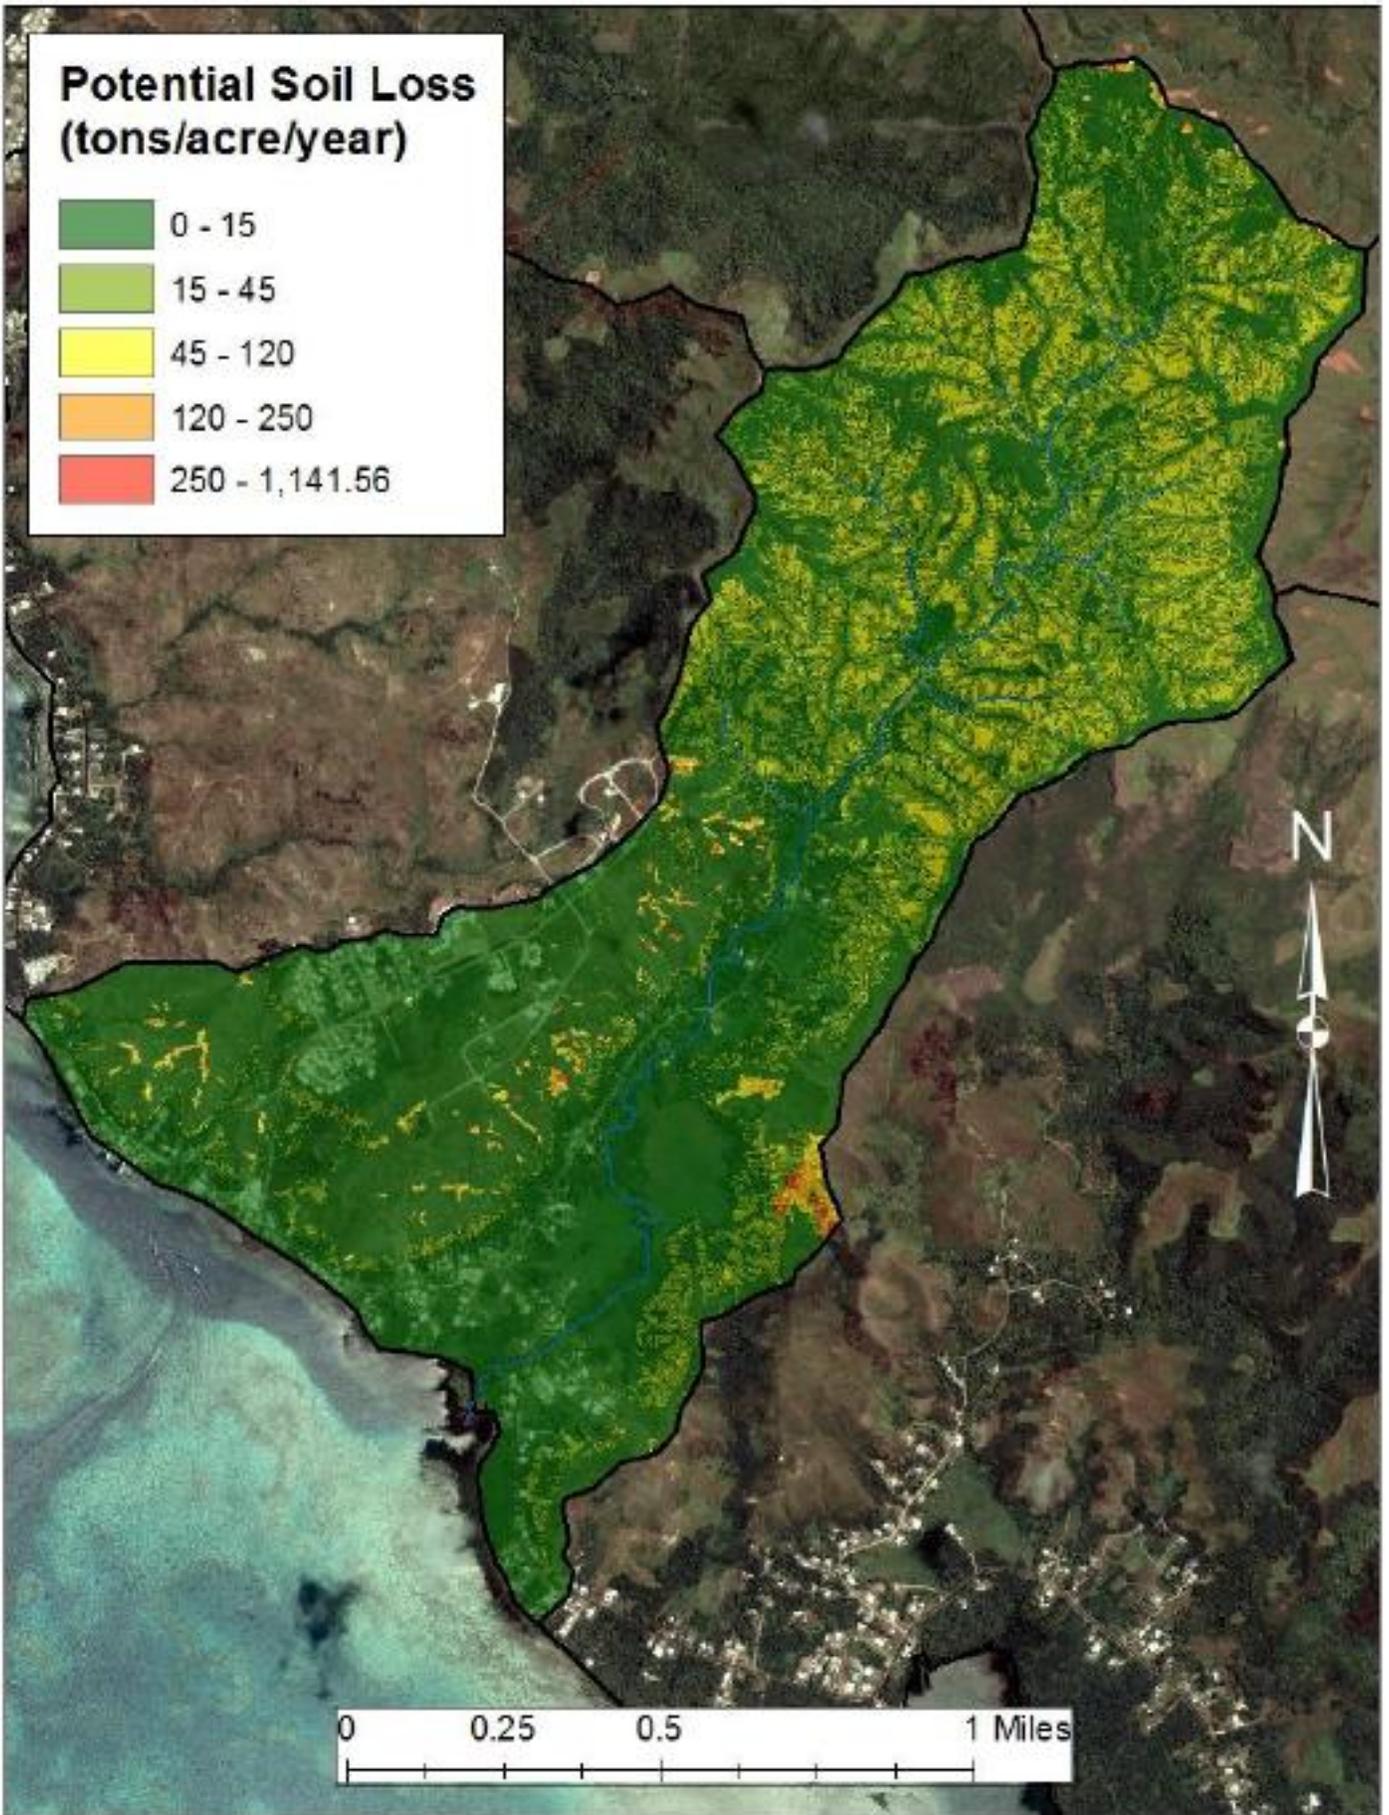
Figure 41. Erosion/soil loss potential within the Geus watershed (Khosrowpanah et al, 2015).

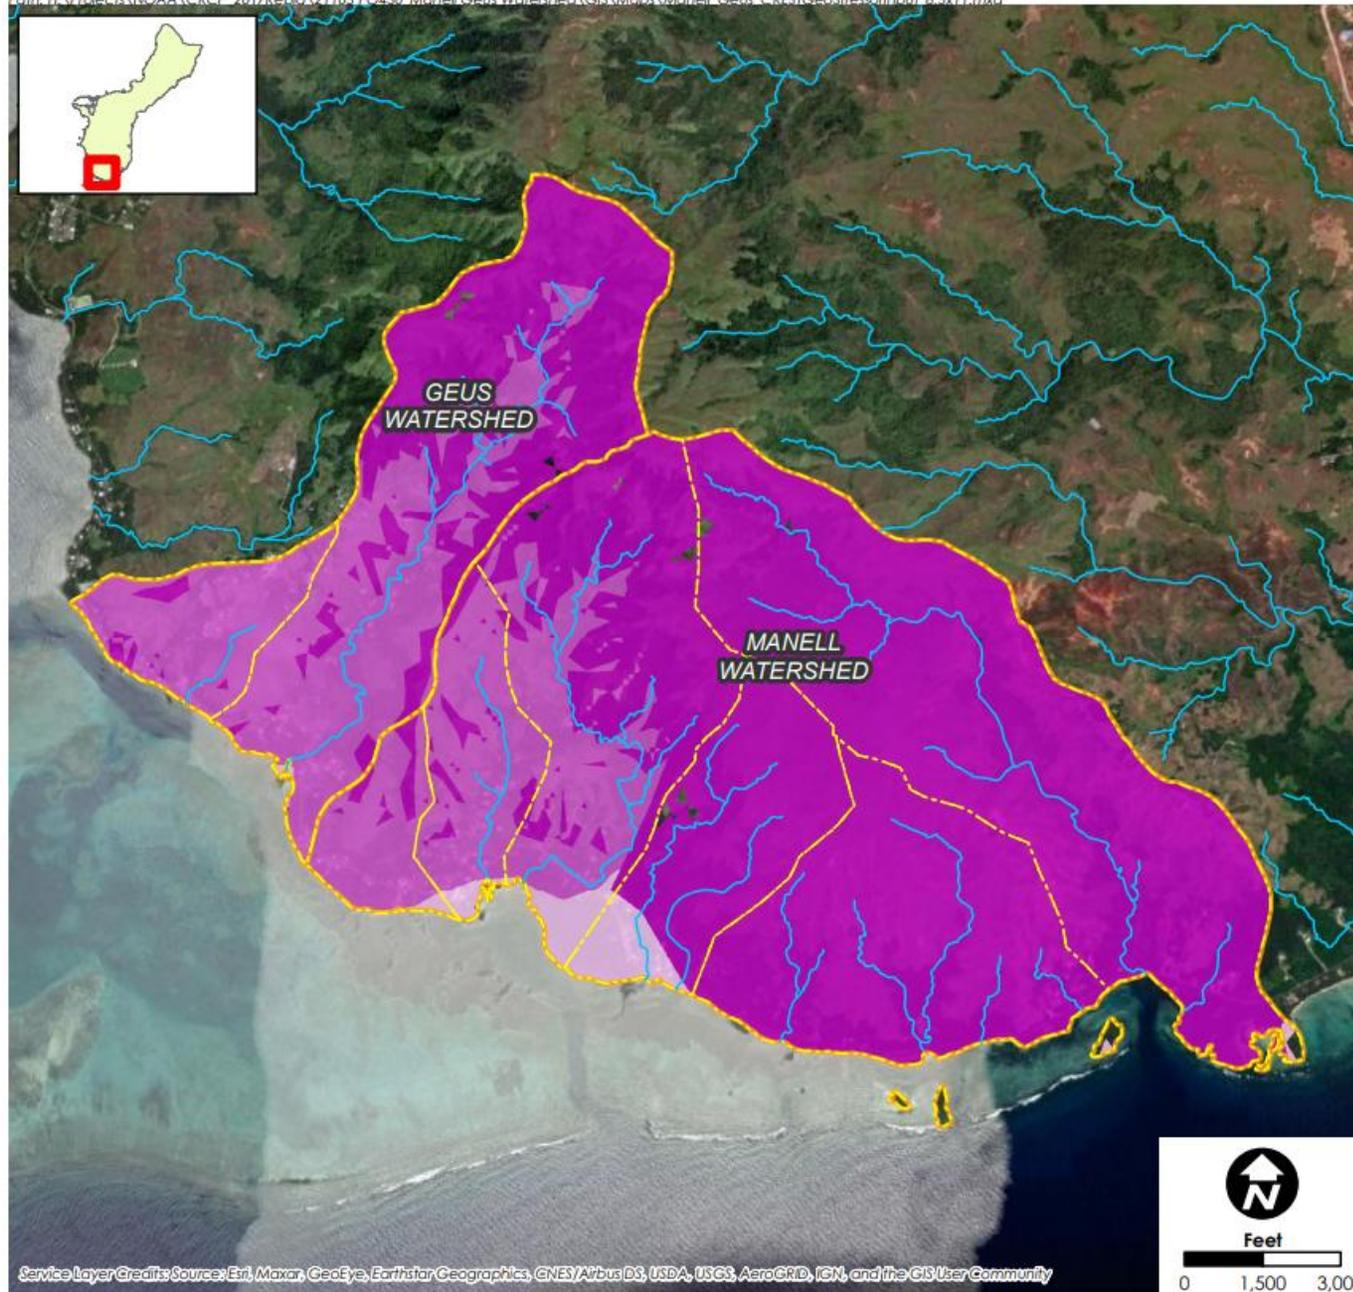
Figure 43. CREST NFWF Landslide Susceptibility in the Manell-Geus watershed (NFWF, USGS, NOAA, Water and Environmental Research Institute of the Western Pacific (WERI), ESRI).

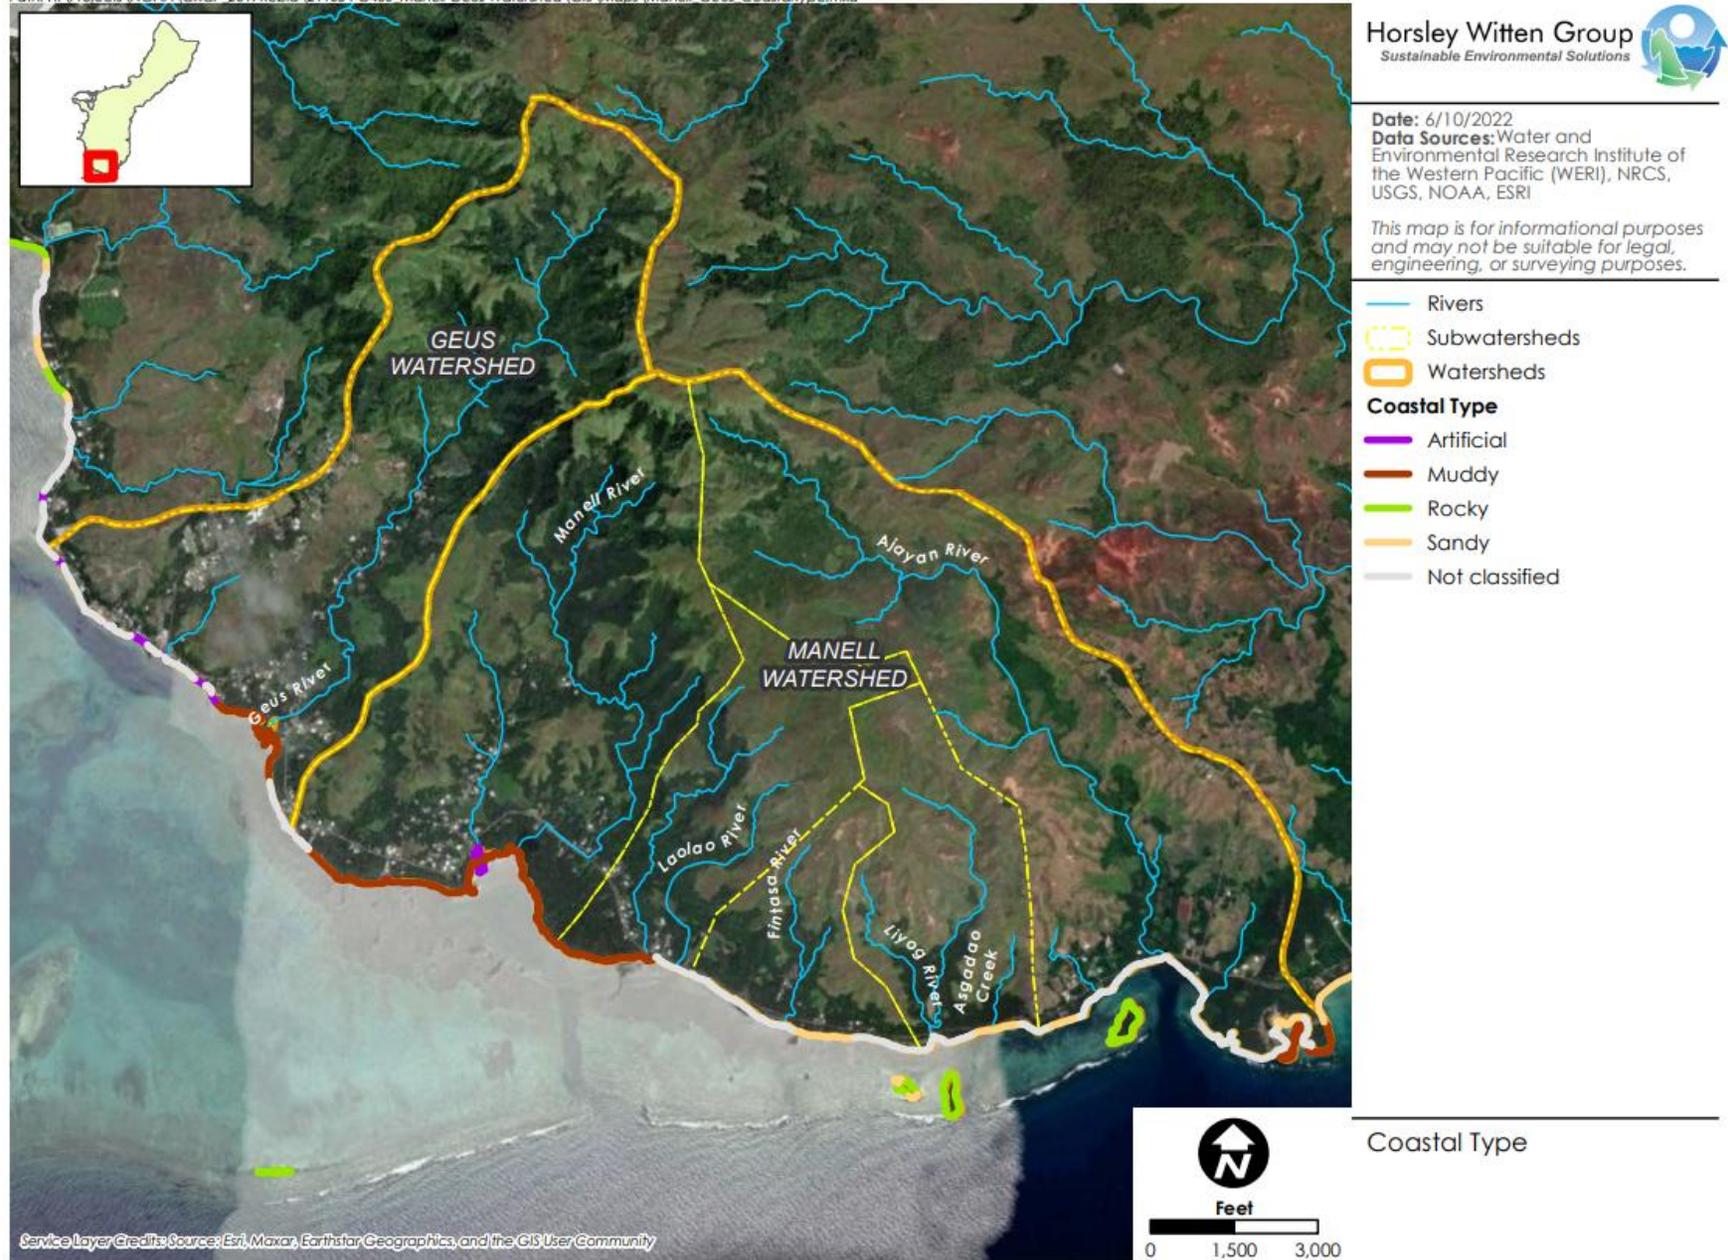
Figure 44. Coastal shoreline classification for the Manell-Geus watershed (NRCS, USGS, NOAA, Water and Environmental Research Institute of the Western Pacific (WERI), ESRI).

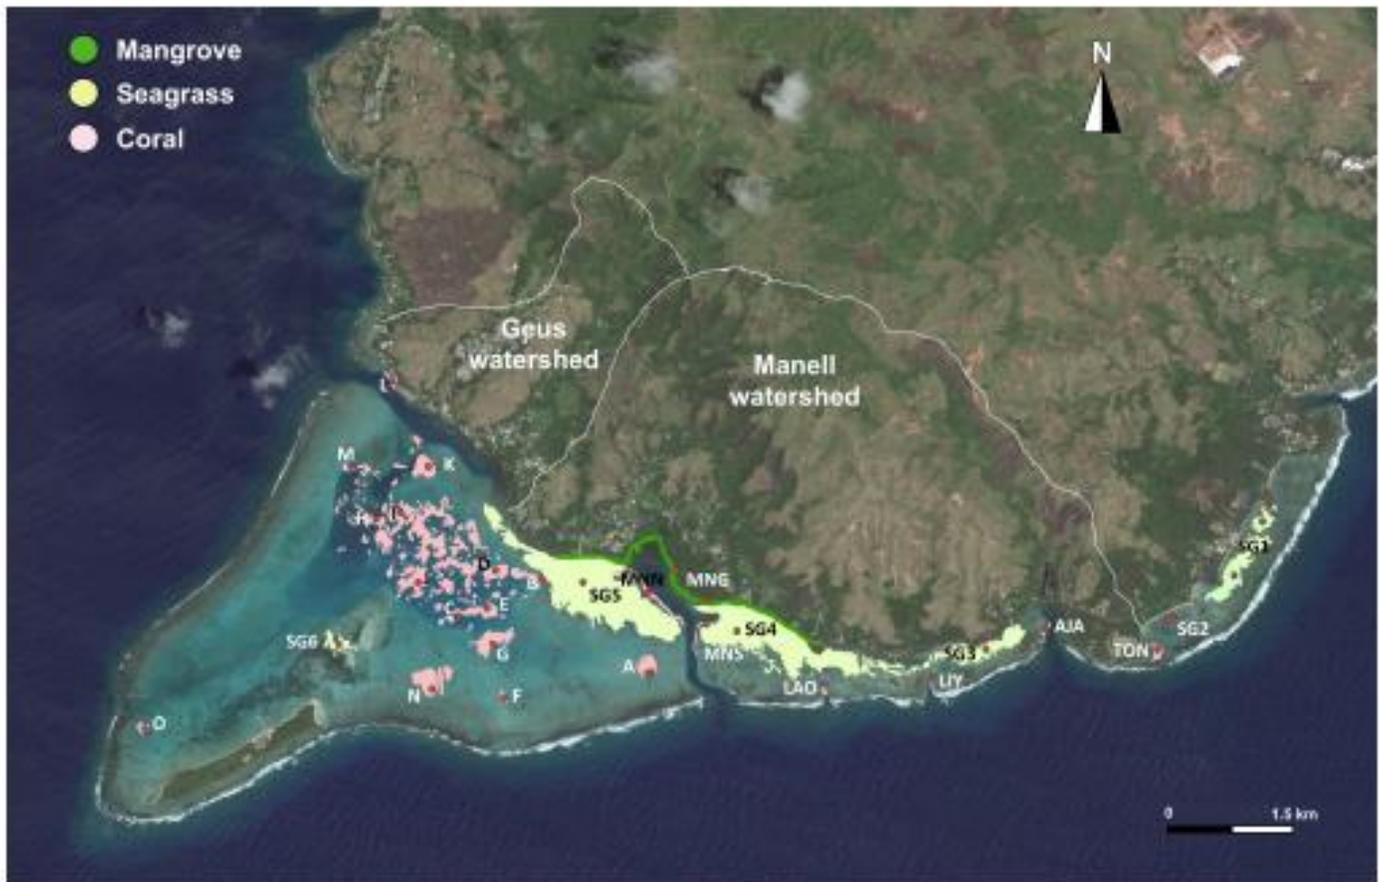
Figure 49. Map from the Atlas of the Nearshore Shallow Benthic Habitats within the Manell-Geus Habitat Focus Area (Raymundo et al, 2018).

Map of the Manell-Geus Habitat Focus Area, showing the location of the survey sites presented in this manual. SG = seagrass; MNG = mangroves; Sites A through O are Cocos Lagoon coral patches; TON = Tonggan Way; AJA = Ajayan River; LIY = Liyog River; LAO = Laolao River; MNS and MNN = Manell Channel South and North.

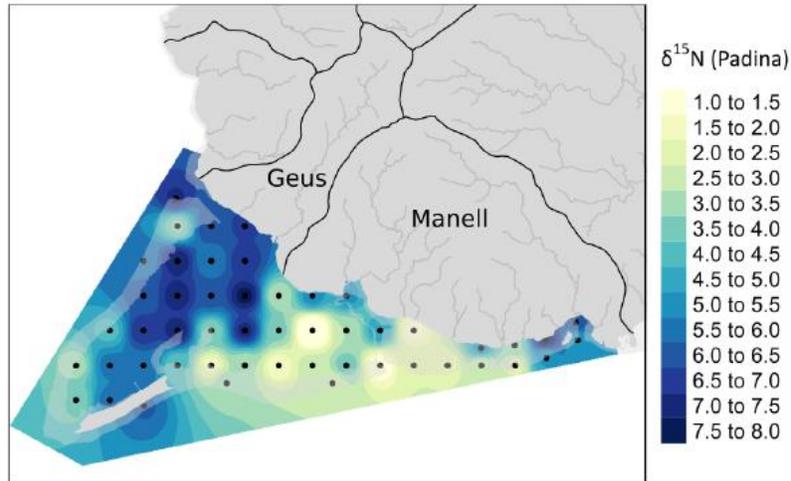
Figure 58. Nutrient enrichment experiment results (Raymundo et al, 2018).

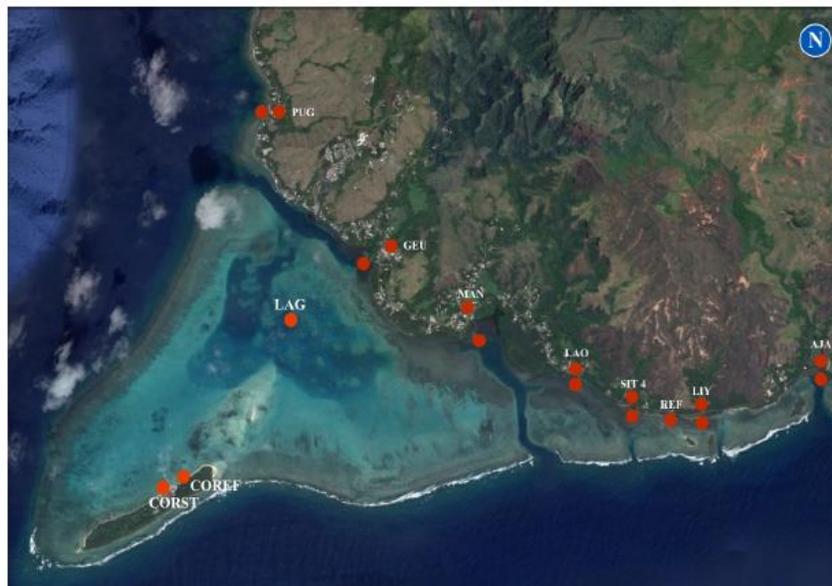
Figure 59. *Enterococcus* contamination study points (Raymundo et al, 2018).

An additional experiment was conducted by the University of Guam in January of 2017 to test for *Enterococcus* bacterium concentrations entering the coastal waters from the rivers of the Manell and Geus watersheds (Figure 59). The *Enterococcus* bacterium is found in mammalian digestive tracts, so can be used to test for fecal contamination of water. The experiment results showed that 9 out of 17 sites tested contained higher *Enterococcus* concentrations than the EPA limits (35 CFUs/100ml), with every upstream test site (i.e., landward of Highway 4) demonstrating *Enterococcus* concentrations above the EPA limit (Table 9). Potential sources were not identified in the study (Raymundo et al, 2018).

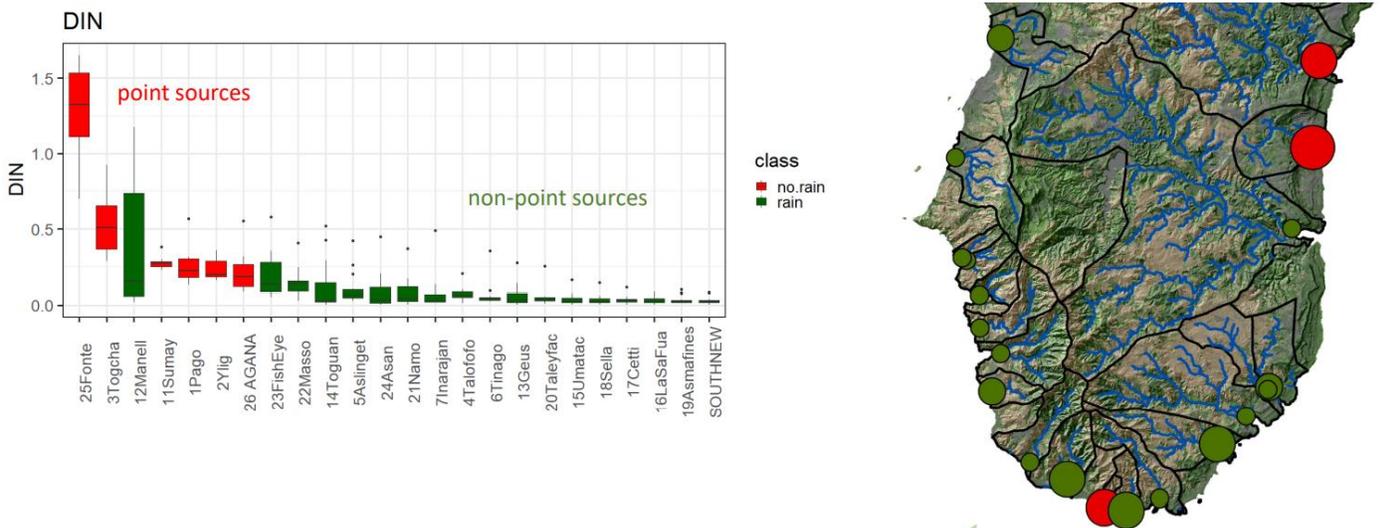
Figure 60. DIN levels and mapped survey sites in Southern Guam (Houk et al., 2022).

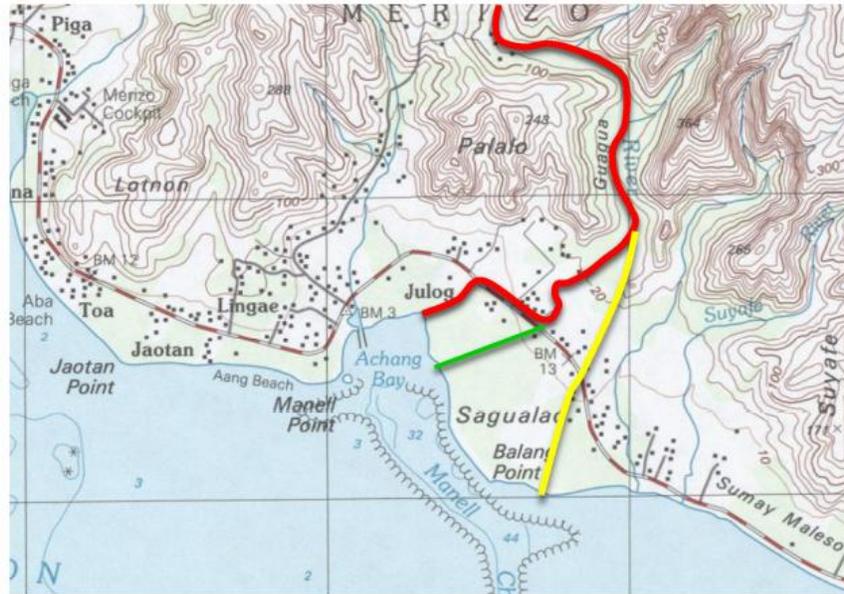
Figure 61. Current (Red), Proposed (Green), and Historic (Yellow) Path of the Nelansa River (U.S. Army Corps of Engineers, 2020b).

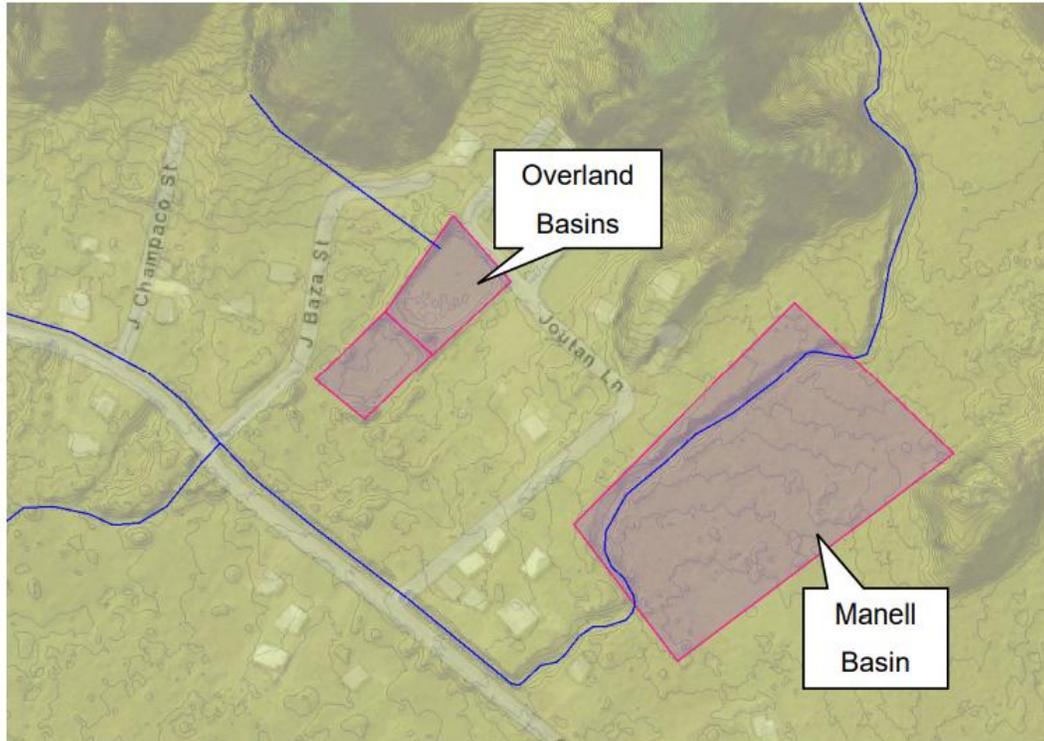
Figure 62. Potential Detention Basin Placement in the Manell Subwatershed (U.S. Army Corps of Engineers, 2020b).
