# MARINE ENVIRONMENTAL EFFECTS OF DREDGING AND POWER-PLANT CONSTRUCTION IN PITI BAY AND PITI CHANNEL, GUAM

Technical Report No. 8

Submitted to  
GUAM POWER AUTHORITY

TECHNICAL REPORT No. 8  
May, 1974

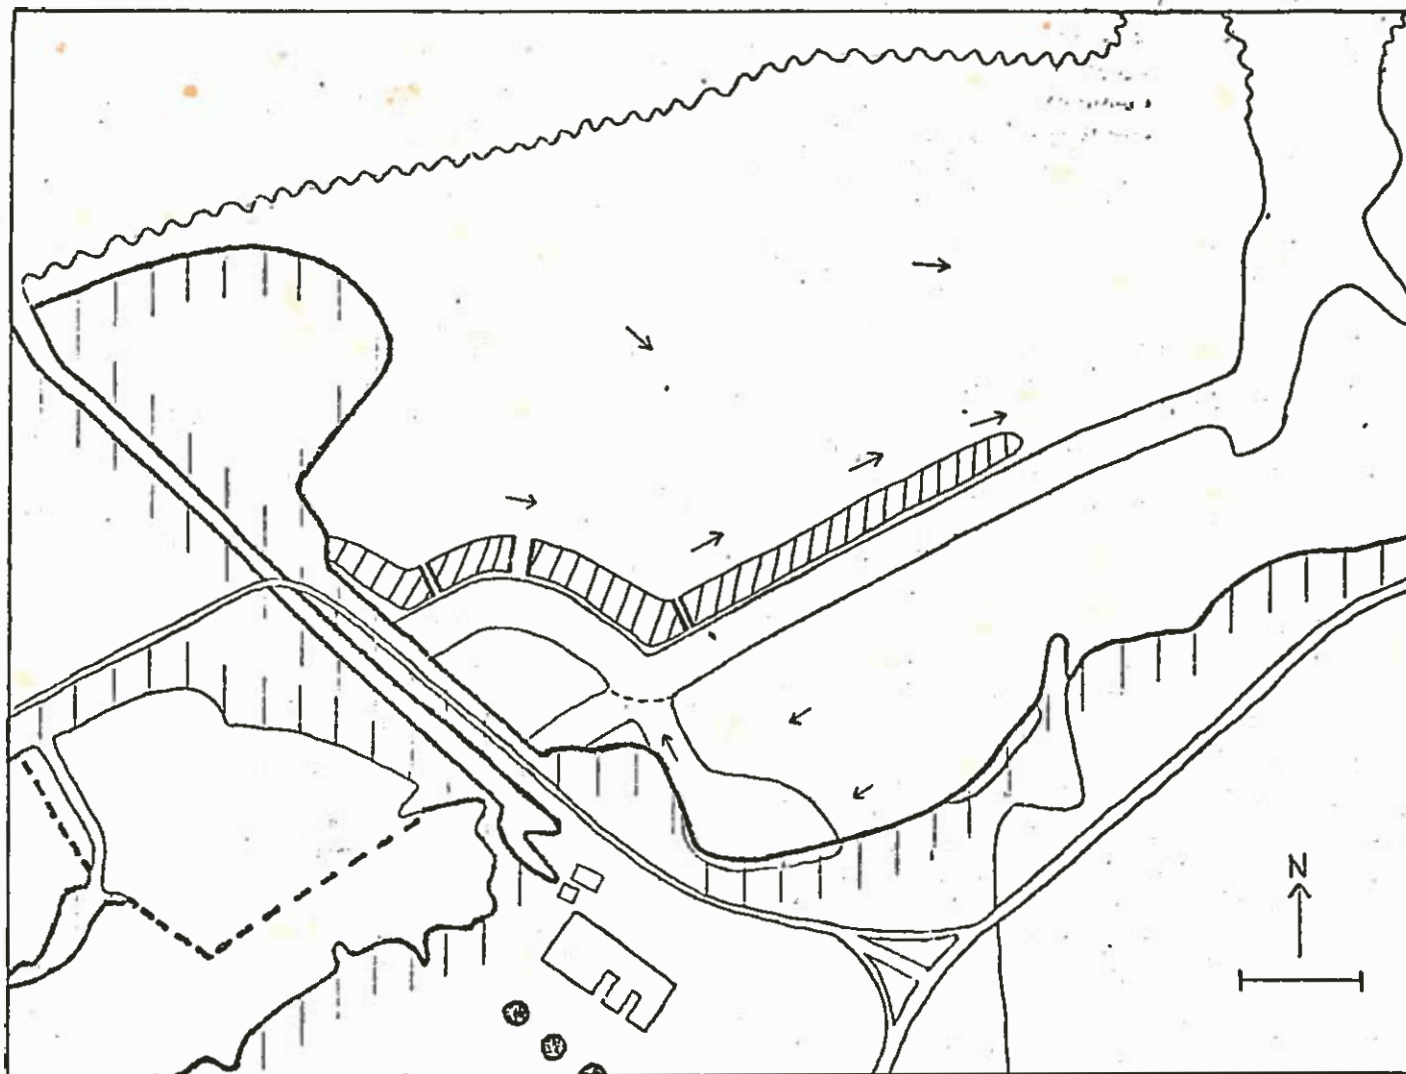
Figure 5. General current patterns in West Piti Bay with the construction dike extending approximately halfway along Tepungan Channel. The length of the arrows is roughly proportional to the flow velocity. Note the placement of culverts and passes in the dike.
