# **POWER PLANTS AND THE MARINE ENVIRONMENT ADDITIONAL OBSERVATIONS IN PITI BAY AND PITI CHANNEL, GUAM**

**Technical Report No. 21**

**July 1975**

GUAM POWER AUTHORITY

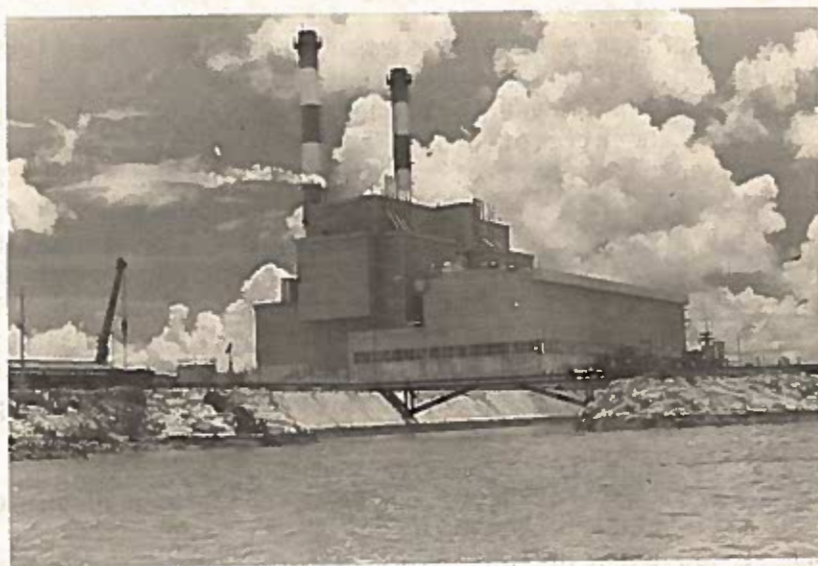
Figure 3. Cabras Power Plant with its outfall channel in foreground.

Both power plants pump their heated condenser effluent water into a common receiving area (Figs. 2, 3). This outfall lagoon is the eastern end of Piti Channel, which extends westward through an area of tidal flats for 1600 m and enters the Commercial Port area of Apra Harbor (Fig. 4). This latter area in turn communicates with outer Apra Harbor. Piti Channel is generally less than 2 m deep throughout its length. The surrounding tidal flats are often exposed subaerially during low tides and are covered by no more than a meter of water during high tides. The tidal flats are thus subject to considerable solar heating, especially during midday or afternoon low tides. Hence, the effluent area generally is subject to two major sources of heating: waste heat from the power plants and solar heating.

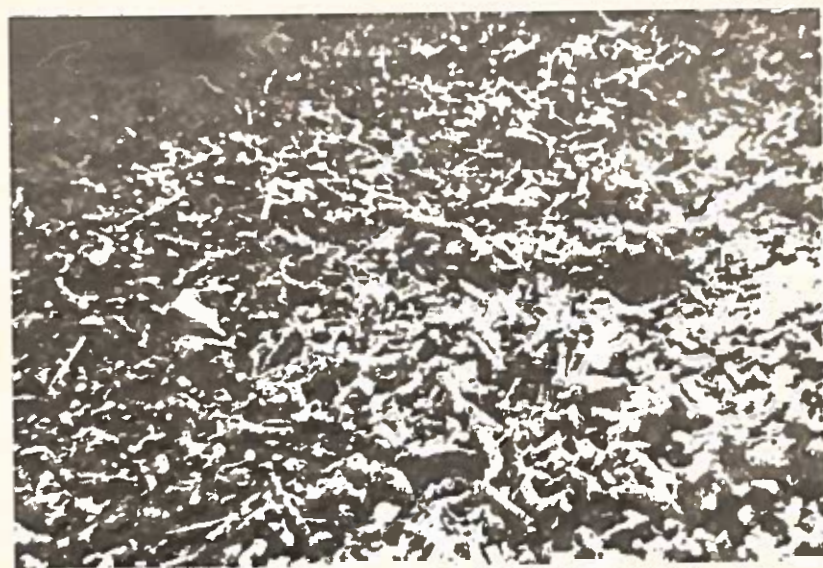
Figure 19. Crushed Acropora in the area of reef damaged by bulldozer operations.

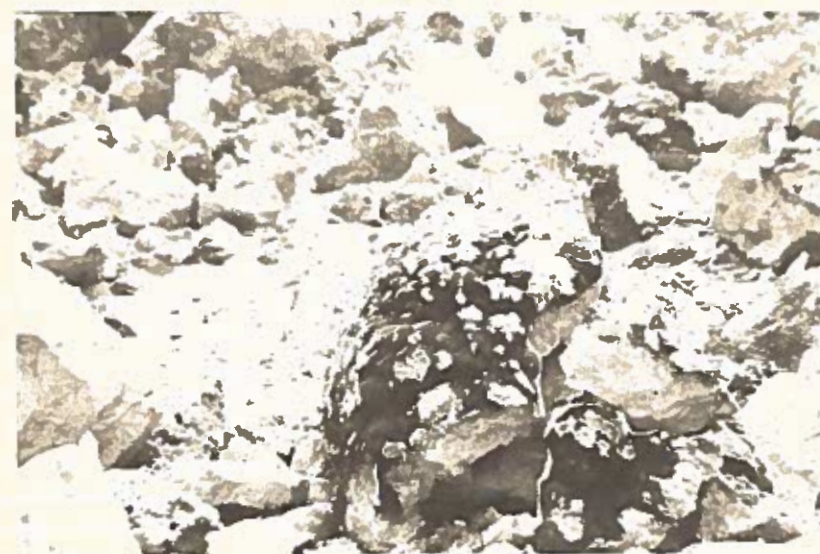
Figure 21. Crushed and split Porites heads in the area damaged by bulldozer operations.

Coral colonization is the key to the recovery of the damaged area. As pointed out by Marsh and Gordon (1974), the destruction in the bulldozed area broke up most of the large massive *Porites* heads and overturned the rest. Many of the broken fragments were still alive immediately after the damage occurred. A major point of interest was whether or not these broken fragments would continue to live and provide "seed organisms" or "centers of colonization" for future reef recovery. While the fate of the smallest fragments (less than about 15 cm across) could not be followed, there do not appear to be any large numbers of these fragments still alive. However, larger fragments fortunately showed good survival and for the most part are still alive. This is an encouraging sign and suggests that the damaged area does have the potential for future recovery. However, *Porites* is known to be a slow-growing coral, and there is no reason to shorten the previous estimate of 25 years needed for the area to reach its former state.
