MEMORANDUM

To: Rob Ferguson and Marie Auyong (NOAA)
From: Ben Wollman, Janelle Veary, Michelle West (HW)
Date: October 26, 2022
Re: Manell-Geus Watershed Inventory – Field Findings
cc: Margaret Aguilar, Guam EPA
Farron Tajeron, The Nature Conservancy
Christine Fejeran, Guam Department of Agriculture

This memorandum summarizes data collection and key findings from a rapid watershed assessment of the Manell and Geus watersheds conducted by HW, Guam EPA, Department of Agriculture, The Nature Conservancy, NOAA, and others the week of August 4 – 9, 2022. The purpose of the assessment was to map drainage infrastructure, identify problem areas (pollution sources, flooding, damage, etc.), and identify potential restoration project opportunities. During this effort, the field team:

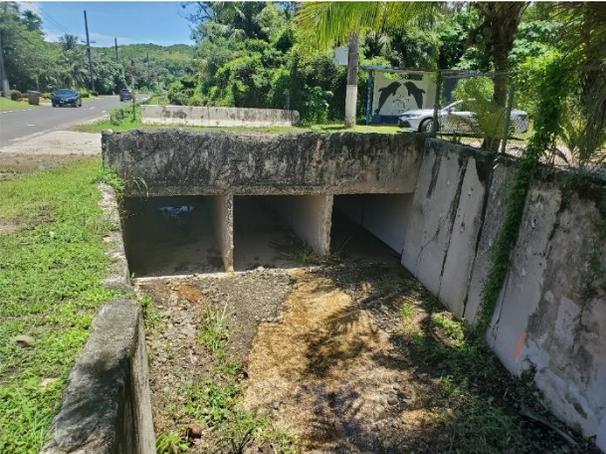
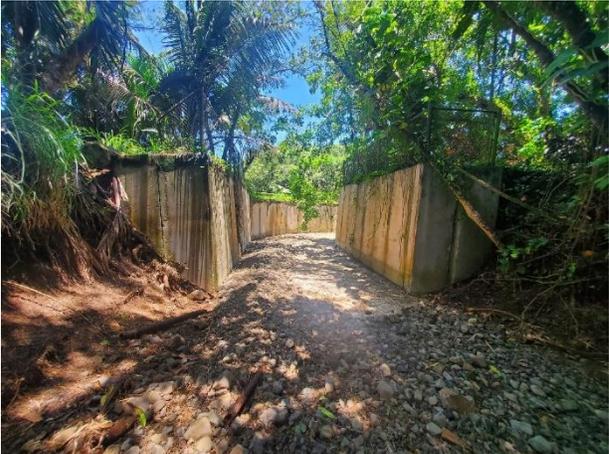
Through observations in the field and discussions with residents and community members, the field team identified areas where roads and residential properties are flooding. The most significant flooding appears to be occurring along the roadway and adjacent properties where the Manell River crosses Route 4. A combination of potential solutions will likely be required to alleviate the flooding in this area, including alternative routing options, stormwater infrastructure upgrades/improvements, and maintenance equipment provisions (**Photos 1 & 2**).

Photo 1 (LEFT). Bridge/culvert crossing where the Manell River flows along the north side of Route 4. Photo 2 (RIGHT). Looking south from the Manell River channel where the river is forced to make a ninety degree turn to the west along the north side of Route 4.

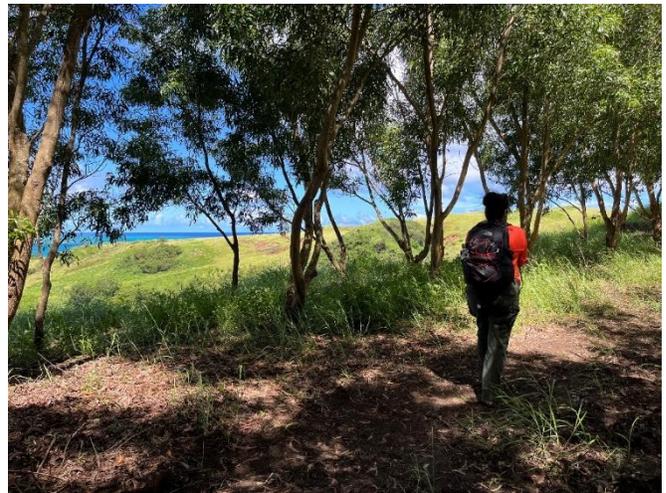
Areas within the mountain regions of the Manell-Geus watersheds where vegetation is sparse or lacking entirely (i.e., badlands) are hotspots for erosion, which leads to sedimentation issues further downstream (**Photo 4**). These badlands area can be initiated and/or exacerbated by wildfires that are primarily anthropocentric in nature. The Guam Department of Agriculture's Forestry Division has implemented two, ongoing badland restoration projects within the Manell watershed which

Photo 4 (LEFT). View of a badland area of minimal vegetation near the Asgadao restoration site. Photo 5 (RIGHT). Christine Fejeran, Forestry Chief of the Guam Department of Agriculture, giving the field team a tour of the Quinene reforestation site in the Manell Watershed.

- The Guam Department of Agriculture should continue and/or increase investment in the Forestry Division’s staffing needs.
- The Forestry Division should continue progress with the planning, implementation, maintenance, and performance monitoring of the revegetation/restoration projects.
- The appropriate authorities should develop and initiate additional enforcement capabilities related to wildfires that are intentional and unauthorized.
- Additional strategic areas should be identified for revegetation/restoration based on sedimentation priorities and visibility.
- Consideration should be given to any alternative erosion control methods that have low- or non-combustible potential.

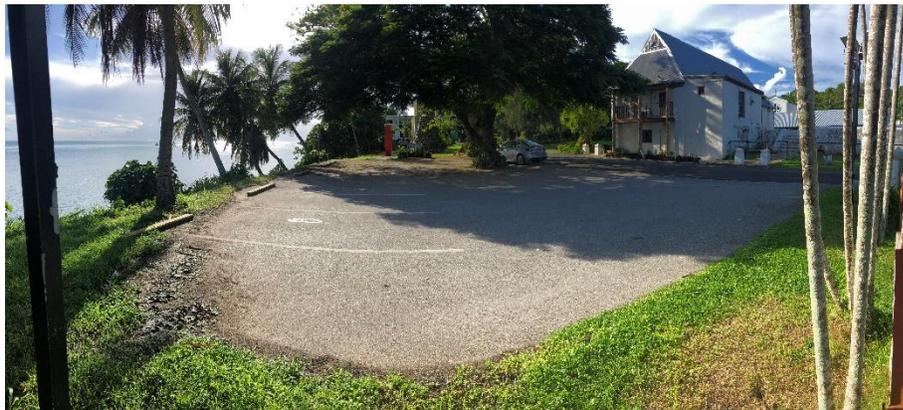
There are numerous locations within the Manell-Geus watersheds where on-site stormwater management practices could be implemented in public spaces to provide water quality treatment or volume reduction (**Photos 12 & 13**). There is potential for various types of green infrastructure, such as bioretention basins, wet swales, rain gardens, and constructed wetlands, to be designed and implemented at sites that include the Merizo Elementary School, the Merizo Mayor’s Office, the Merizo Library, the Santa Marian Kamalen Park, and the Merizo Pier Park.

Photo 13. Santa Marian Kamalen Park location for potential on-site stormwater management practice(s) along Route 4.

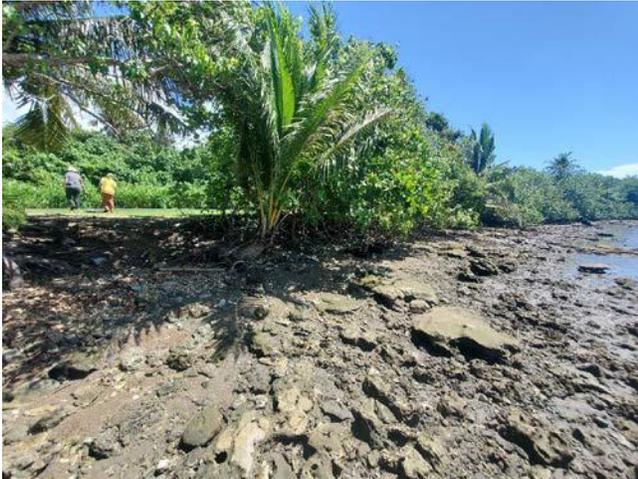
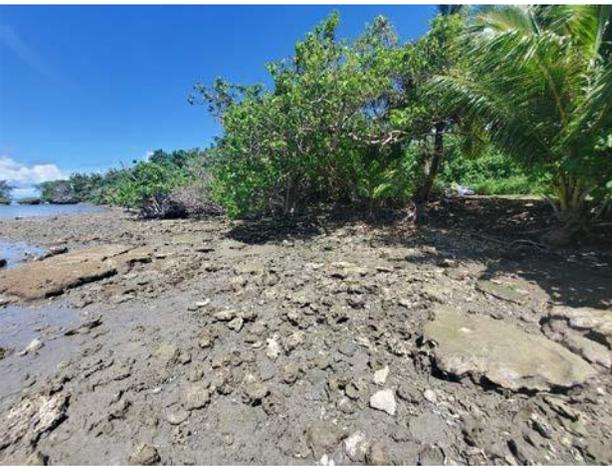
Photo Caption: Lack of vegetation in this narrow strip along the road.	Photo Caption: Very few mangroves currently growing here.

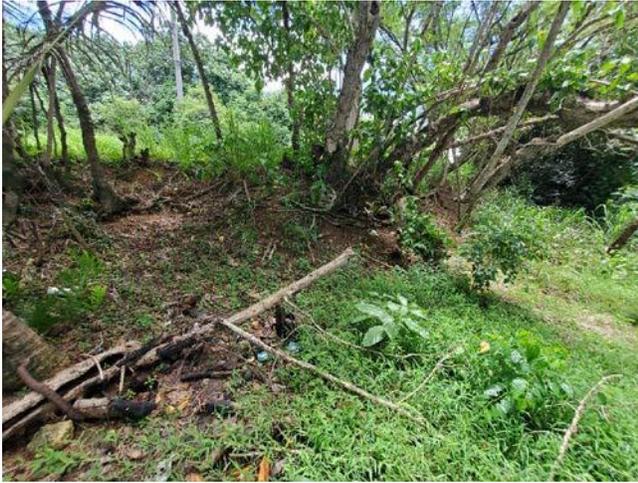
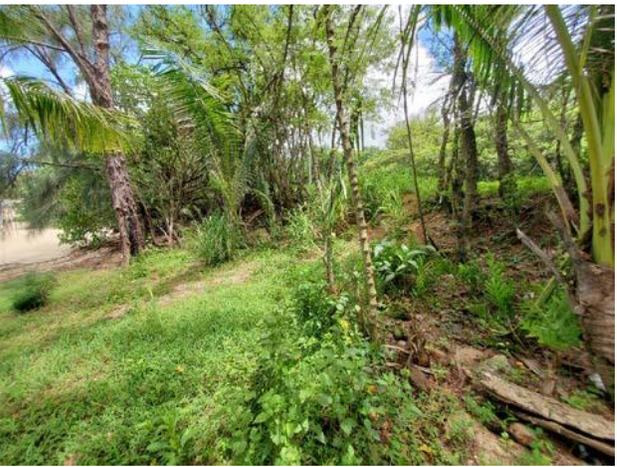
<p>Photo Caption: Existing vegetation and erosion along shore – Route 4 is in the background (note utility pole).</p>	<p>Photo Caption: Existing vegetation and erosion.</p>

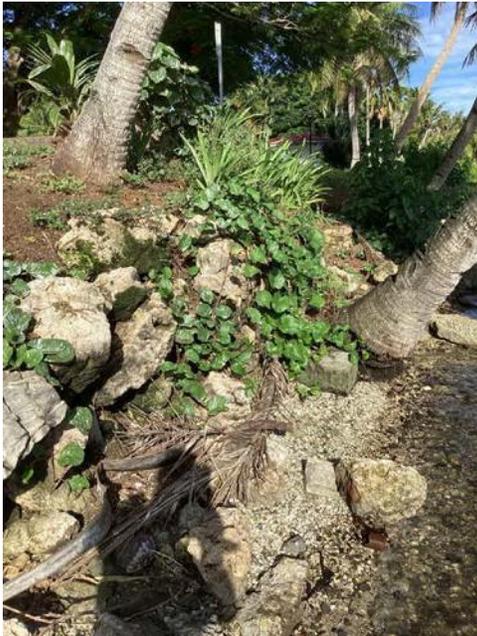
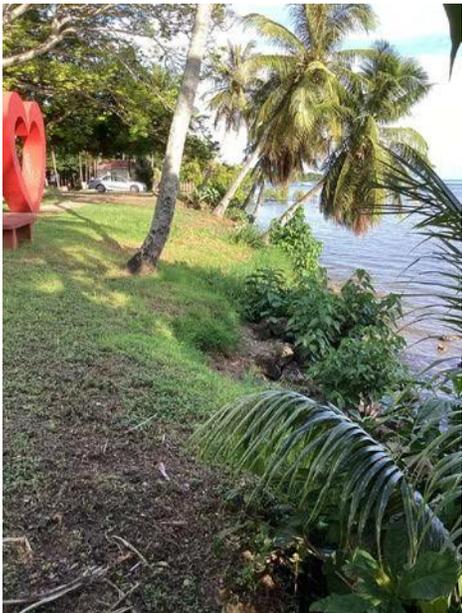
Site Name: Santa Marian Kamalen Park Shoreline Stabilization		ID#: R-03
DESCRIPTION		
Type of Project: Coastal Shoreline Stabilization	Preliminary Ranking: Medium	
Existing Conditions: Park area - eroding bank seaward of park, except where existing wall remains in place at east side.	Site Location:

Photo Caption: Eroding shoreline. Placed rock is starting to fall in from undermining.	Photo Caption: Eroding shoreline. Little vegetation in this area.

Proposed Solution: Bank stabilization and revegetation (possible mangrove restoration, but long-term views may be a factor).		
Site Constraints: Sewer, parking lot, historical park features, water	Other Notes:	
PHOTOS/SKETCHES

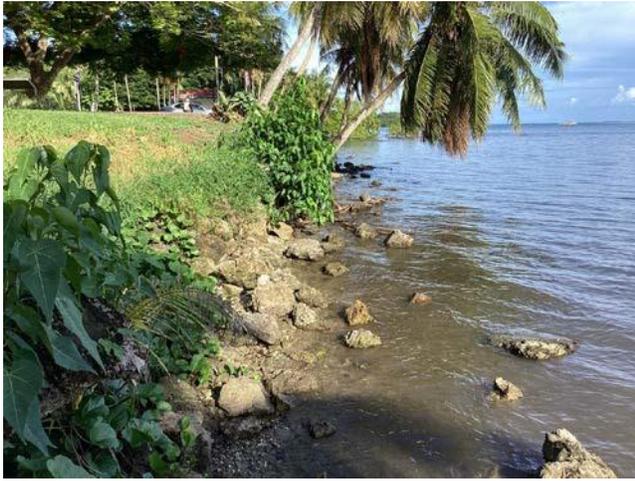
Photo Caption: Eroding shoreline with displaced rocks.

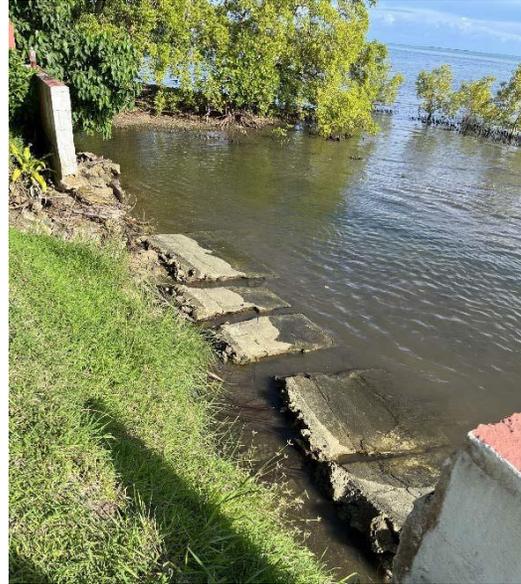
Photo Caption: Undermined section of wall that collapsed. See adjacent mangroves in the background.

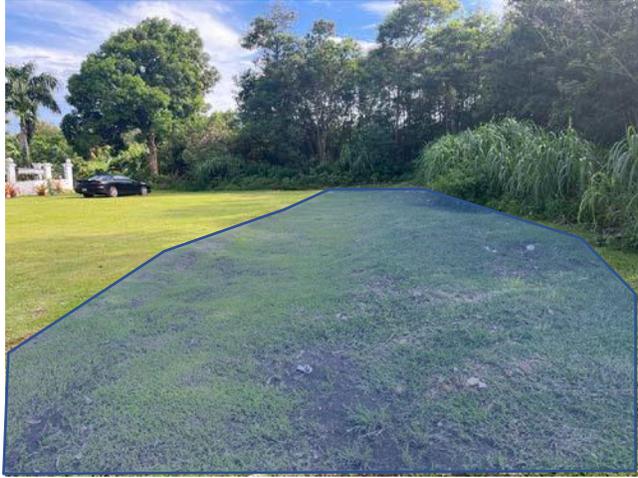
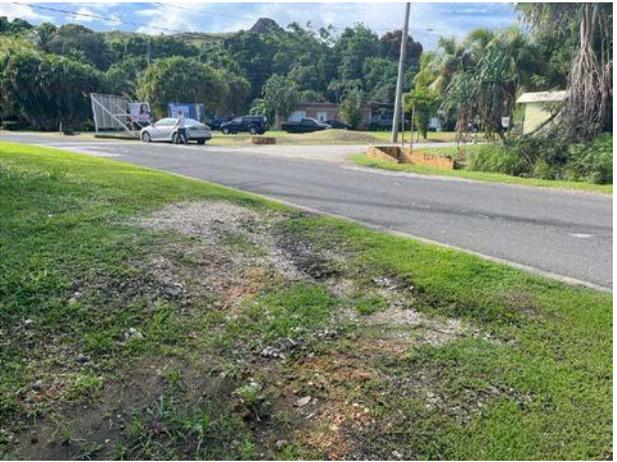
Photo Caption: Evidence of stormwater flows in this grassy area. Convert into a formalized wet swale.	Photo Caption: Existing erosion where runoff from Geus Rd is flowing into this area, bypassing the upgradient paved channel and culvert (see yellow headwalls).

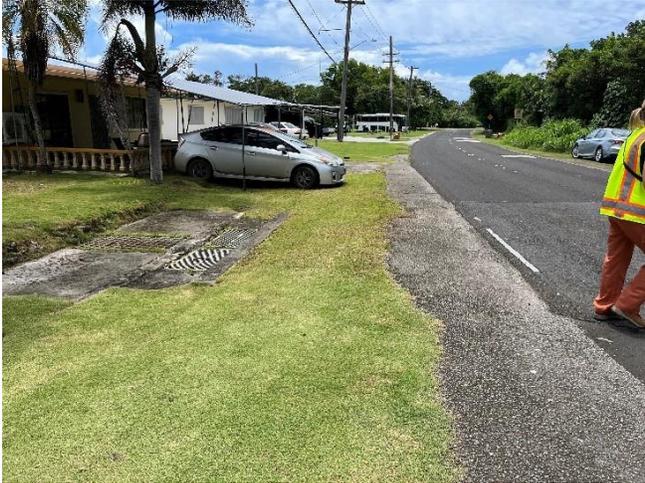
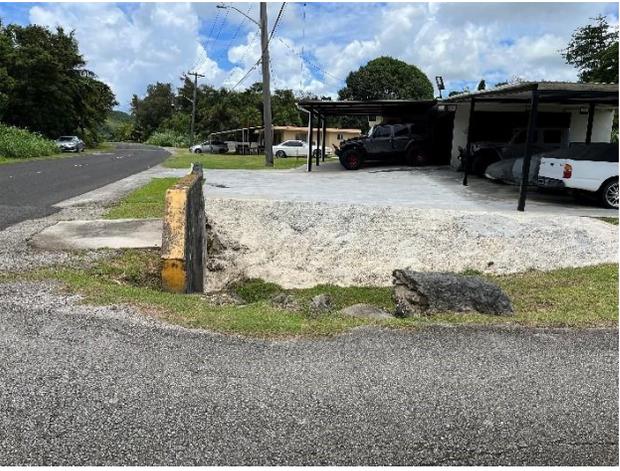
Type of Project: Residential Stewardship	Preliminary Ranking: Low
Existing Conditions: Two homes along Route 4 next to 1 Babauta St. with direct connection of roof runoff into adjacent infrastructure.	Site Location:

Photo Caption: House roof and yard drain to inlet structure along road.	Photo Caption: This house’s roof and yard drain to culvert that discharges on other side of Route 4.
--	---

Proposed Solution: Rain gardens would be a good option for these homes. Existing lawn areas are available and could be converted to rain gardens.

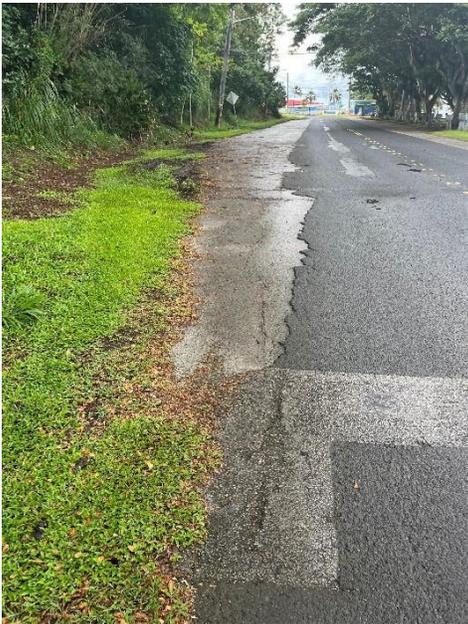
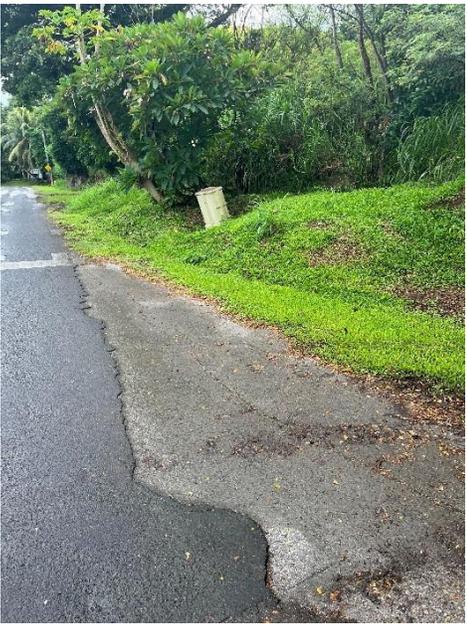
Photo Caption: Paved and unpaved roadside parking that could be converted to stabilized pavers.	Photo Caption: Hillside berm redirecting runoff from badlands. This feature should be evaluated and improved as needed to ensure safe flows and sediment capture.

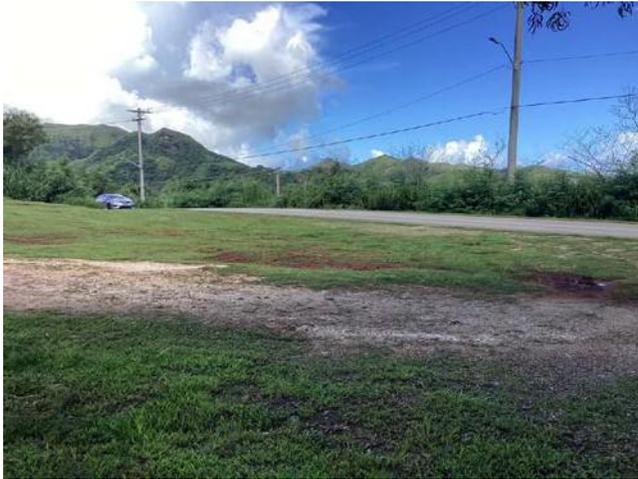
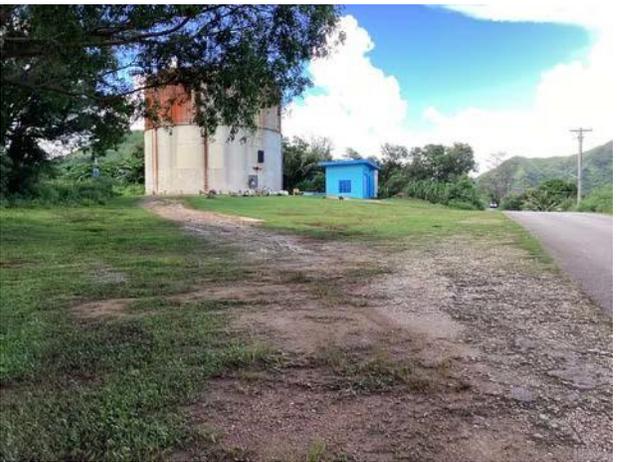
Site Name: Water Tank Paving		ID#: R-09
DESCRIPTION		
Type of Project: UP Road Improvement	Preliminary Ranking: Medium	
<p>Existing Conditions: Area in front of the water tower is unpaved and eroded, likely exacerbated from parking for the ballpark.</p>	<p>Site Location:</p>

Photo Caption: Eroded parking area for adjacent ballpark.	Photo Caption: Unpaved driveway for water tower.

<p>Proposed Solution: Proposed solution here is to pave the driveway for the water tower and add stabilized paver parking for the ballpark. Addressing this source of sediment will reduce impacts to downstream practices (e.g., Mayor’s Office site – R-14).</p>		
Site Constraints: Waterline. Large trees.	Other Notes:	
PHOTOS/SKETCHES

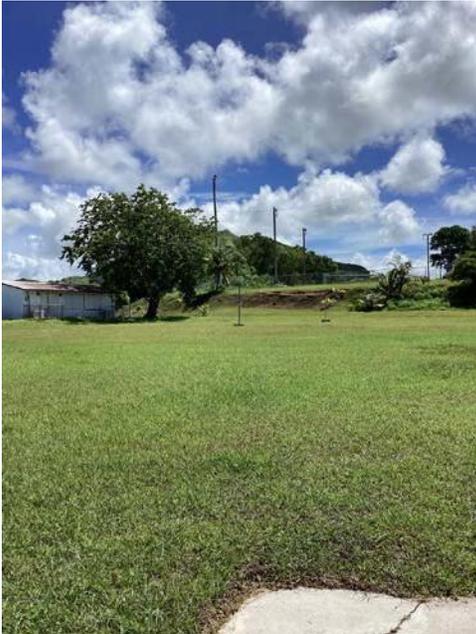
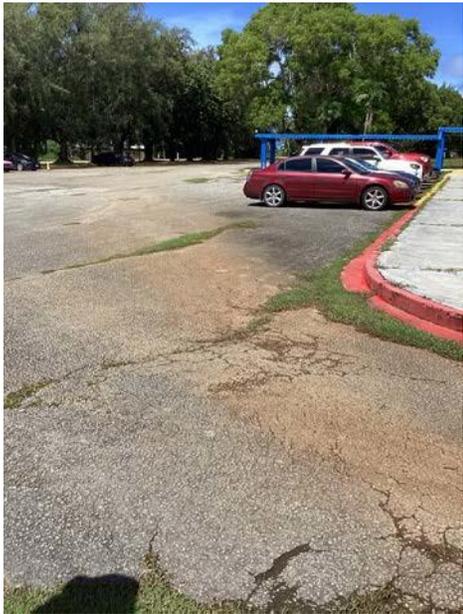
<p>Type of Project: Stormwater Retrofit</p>	<p>Preliminary Ranking: High</p>
<p>Existing Conditions: Staff informed us the field gets soggy and brown water runs off from grassed courtyard into the parking lot and road. Trucks will drive through field, get stuck, making muddy holes.</p>	<p>Site Location:</p>

<p>Photo Caption: Grassy field looking up towards ballpark and steep, eroded slope.</p>	<p>Photo Caption: Parking lot staining where flow discharges from grassy field.</p>
--	--

<p>Proposed Solution: Install cutoff trench along base of adjacent steep slope to intercept groundwater flowing through this area and divert it to proposed stormwater features for R-20. Stabilize steep slope with vegetation to better hold soil in place.</p>

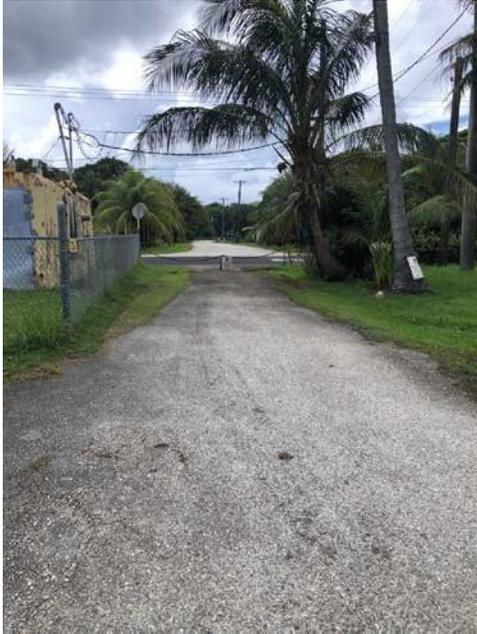
Site Name: Boat Ramp Rain Gardens		ID#: R-11
DESCRIPTION		
Type of Project: Stormwater Retrofit		Preliminary Ranking: High
<p>Existing Conditions: Runoff coming from Quinene Road and boat ramp parking. Boat ramp eroding, particularly near water. Some ponding at corner of pavement.</p>		<p>Site Location:</p>

<p>Photo Caption: Looking up western driveway toward Route 4 from boat ramp parking.</p>

<p>Proposed Solution: Two rain gardens with public educational signage. See sketch.</p>		
<p>Site Constraints: Waterline in grassy area between two driveways.</p>		<p>Other Notes: Potential site for education.</p>
PHOTOS/SKETCHES

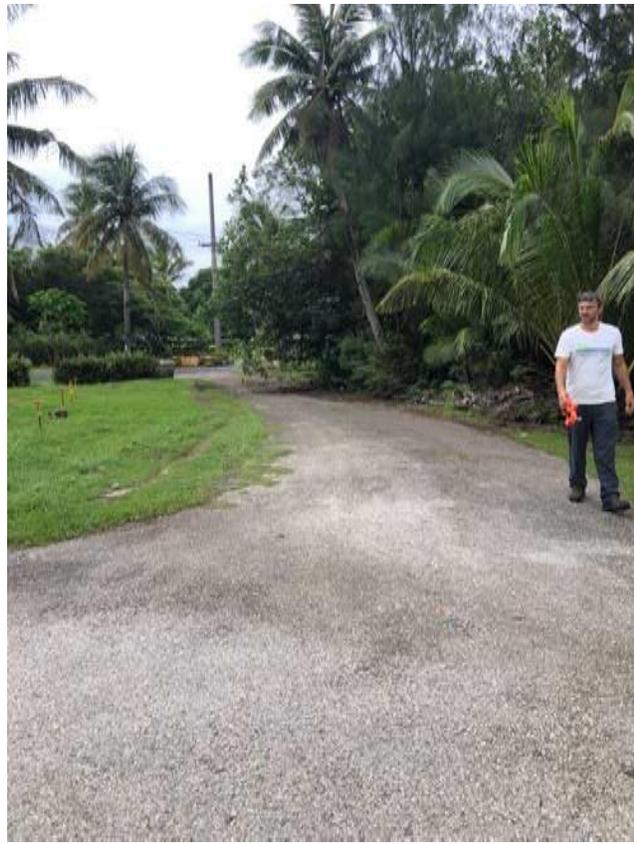
Photo Caption: Looking up eastern driveway toward Route 4 from boat ramp parking. Waterline marked out with stakes.

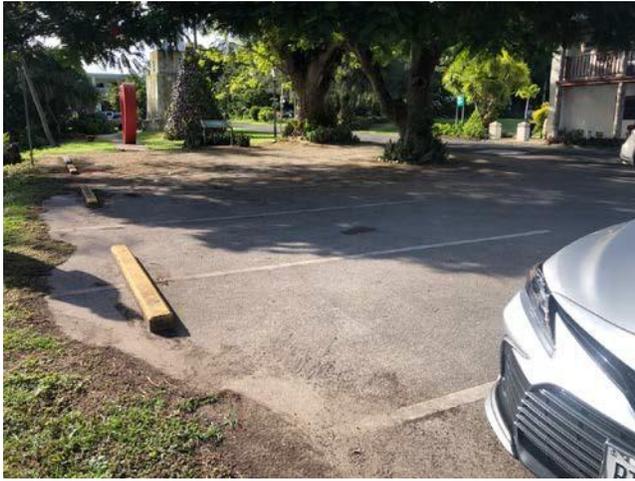
Photo Caption: This area can be adjusted for stormwater management.

<p>Proposed Solution: Shift parking towards road on east side to line up with road alignment. Add bioretention system to southeast corner of parking lot.</p>	<p>Site Constraints: Coastal bank, utilities</p>	
		<p>Other Notes: Noddy roost in large tree in parking lot. Hundreds of birds roosting here – need to be protected.</p>
PHOTOS/SKETCHES

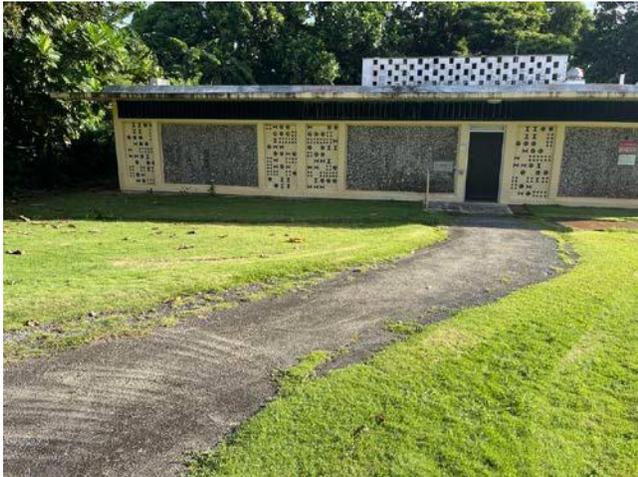
Site Name: Rosa Aguigui Reyes Memorial Library, Merizo Branch		ID#: R-13
DESCRIPTION		
Type of Project: Stormwater Retrofit	Preliminary Ranking: High	
<p>Existing Conditions: Parking lot drains to a grassy area in front of the library building. Runoff also flows from the rooftop in a drip line in this area. There also seems to be flow coming from the main road down into the grassy area from the parking lot entrance.</p>	<p>Site Location:</p>

<p>Photo Caption: Walkway to library; proposed rain gardens for both sides of walkway (see sketch).</p>	<p>Photo Caption: Looking back at library parking lot from front of library. Note eroded ditch in the grassy area proposed for a rain garden.</p>

<p>Proposed Solution: Proposed project here is a swale to a bioretention system. Also, great opportunity for public education.</p>	<p>Other Notes: There are seven regular parking spaces and one handicap space in the lot. Sediment build up at the driveway entrance from the main road.</p>	
<p>Site Constraints: Overhead wires. Water and sewer. Existing sidewalk that we would need to add conveyance underneath (i.e., pipe).</p>		
PHOTOS/SKETCHES

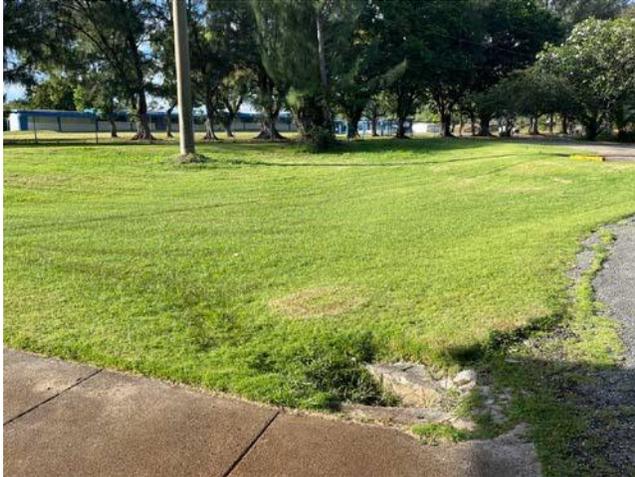
Photo Caption: Looking toward road and school beyond from front of library. Note eroded ditch and clogged culvert in the grassy area proposed for another rain garden.

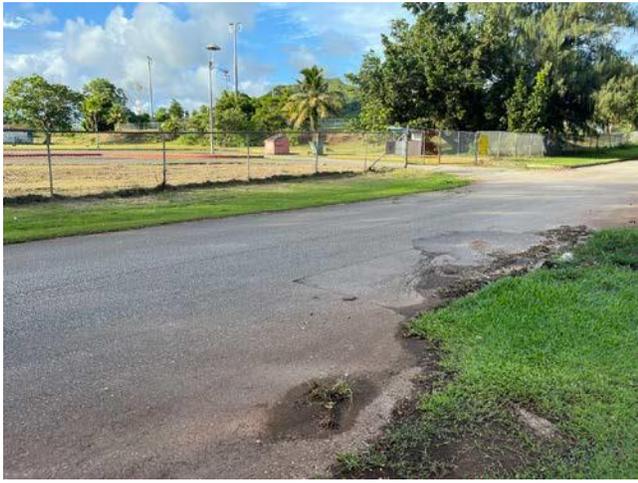
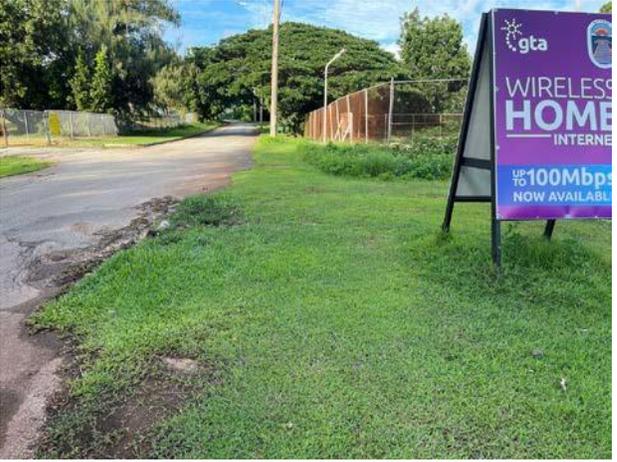
Site Name: Merizo Mayor's Office Constructed Wetland		ID#: R-14
DESCRIPTION		
Type of Project: Stormwater Retrofit	Preliminary Ranking: High	
<p>Existing Conditions: Low point just down from tennis courts at mayors office and community center. Indications of ponding in this area from road runoff as well as school parking lot. Sediment buildup and cracking along the edge of the road here as well as staining from the ponding.</p> <p>Proposed Solution: Propose to turn the existing depression into a constructed wetland for additional treatment and storage in this location.</p>	<p>Site Location:</p>

<p>Photo Caption: Looking across the road at the school. Note sediment build-up in road.</p>	<p>Photo Caption: Looking upgradient at drainage area. Recreational courts located at chainlink fence on the right.</p>

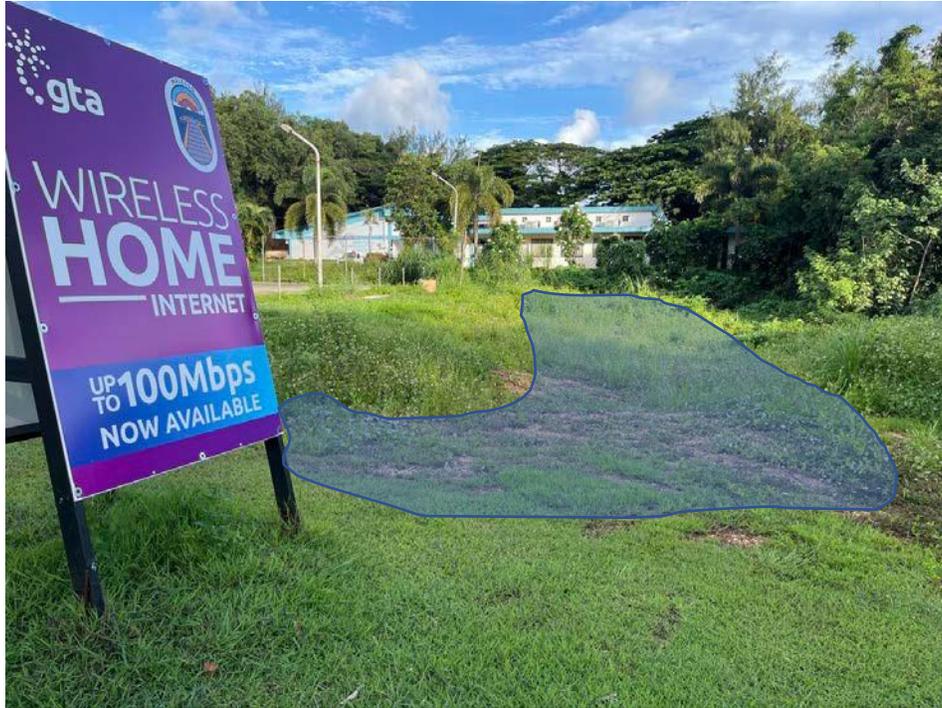
Photo Caption: Existing depression for proposed constructed wetland, shown in blue

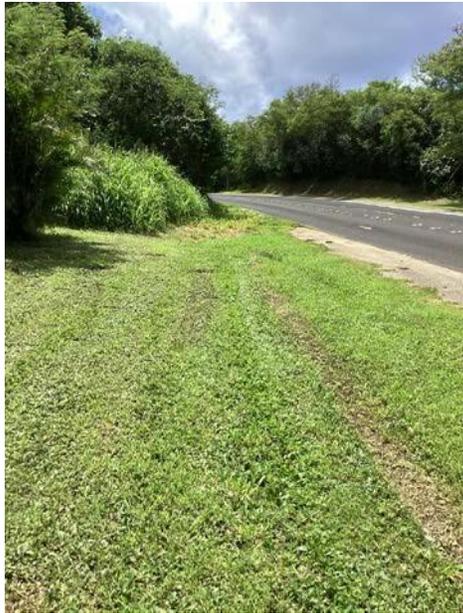
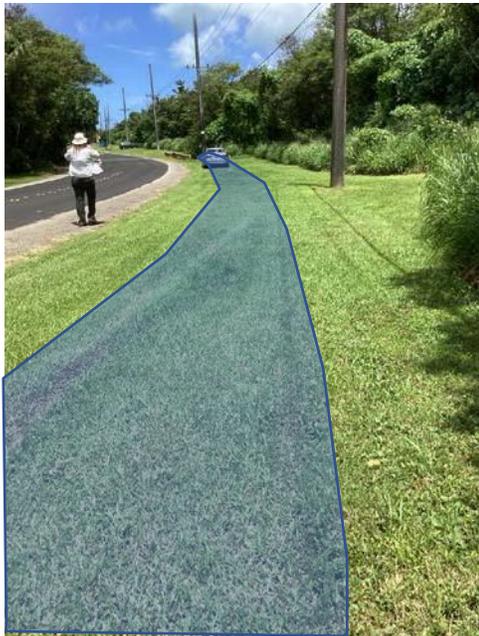
Site Name: Route 4 Roadside Wet Swale		ID#: R-15
DESCRIPTION		
Type of Project: Stormwater Retrofit	Preliminary Ranking: High	
<p>Existing Conditions: Existing road is superelevated towards mountain side with a paved channel. Channel is mostly filled with sediment and grasses. It carries flow down towards the Asgadao Creek. Before runoff reaches the river, area flattens out in a wide cleared right of way area.</p> <p>Proposed Solution: Stormwater retrofit here should be a wet swale in the right of way area to treat runoff before discharging into the Asgadao Creek.</p>	<p>Site Location:</p>

Photo Caption: Looking upgradient at where clogged paved channel brings flow into grassy area.	Photo Caption: Looking downgradient where grassy area flattens out before reaching Asgadao Creek. Proposed wet swale shown in blue.

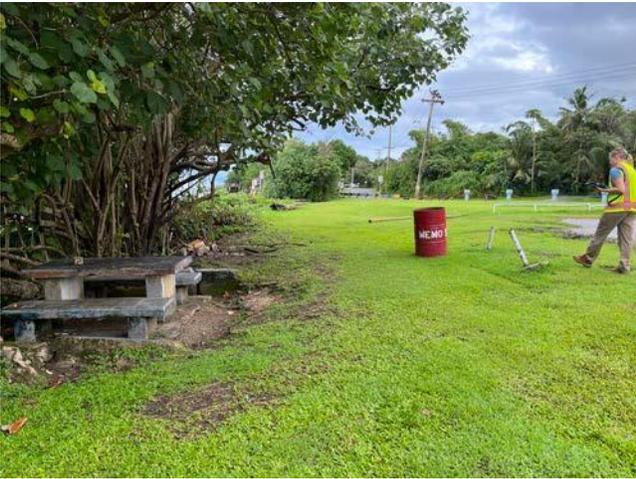
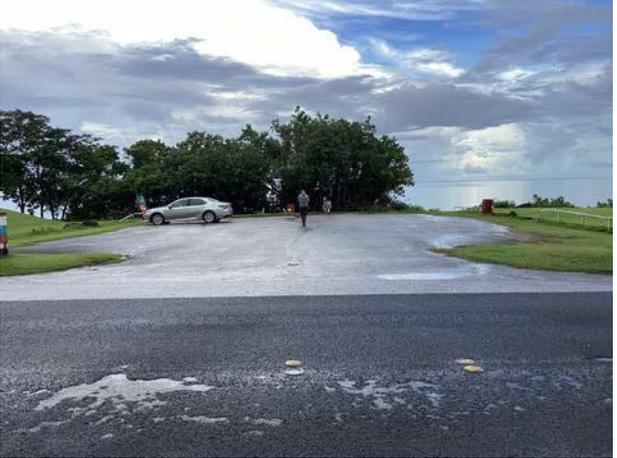
Site Name: Merizo Pier Park Court Parking Lot Bioretentions		ID#: R-16
DESCRIPTION		
<p>Type of Project: Stormwater Retrofit</p>	<p>Preliminary Ranking: High</p>	
<p>Existing Conditions: Grass overgrown on edges of pavement. Flow path appears to flow down across grass to picnic table at the shoreline. Causing erosion around the picnic table and on the shoreline down to the water. Puddling at back of parking lot.</p>	<p>Site Location:</p>	
<p>Proposed Solution: Direct flows from parking lot and courts into two bioretention areas at each downgradient corner of the parking lot. Opportunities here to stabilize shoreline, improve amenities (picnic table area, trash collection), and provide public education.</p>

<p>Photo Caption: Grassy area and erosion near picnic table along shoreline.</p>	<p>Photo Caption: View of parking lot from road with ocean in the background.</p>

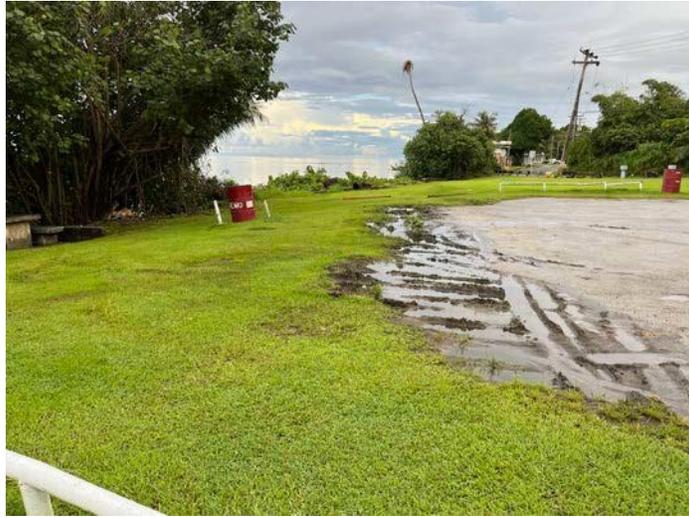
Photo Caption: Existing ponding along parking lot edges.

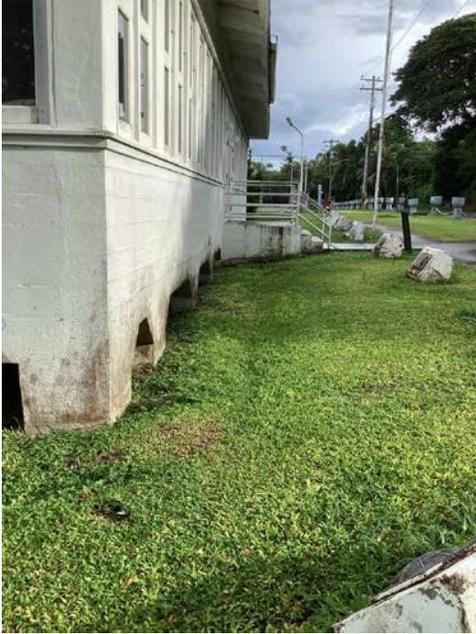
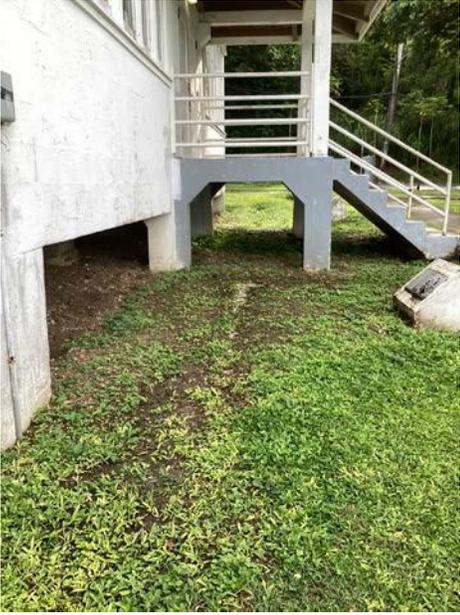
Site Name: Merizo Community Center Roof Rain Garden		ID#: R-17
DESCRIPTION		
<p>Type of Project: Stormwater Retrofit</p>	<p>Preliminary Ranking: High</p>	
<p>Existing Conditions: Drip line along perimeter of building. Some evidence of stone. Low point appears to be at back middle of building. Puddling behind building.</p>	<p>Site Location:</p>

<p>Photo Caption: Grassy dripline along front of building.</p>	<p>Photo Caption: Somewhat eroded dripline along side.</p>

<p>Proposed Solution: Formalize drip line around building and drain to low point at back of building. Direct water into rain garden.</p>		
<p>Site Constraints: Adjacent to coastal bank</p>	<p>Other Notes:</p>	
PHOTOS/SKETCHES

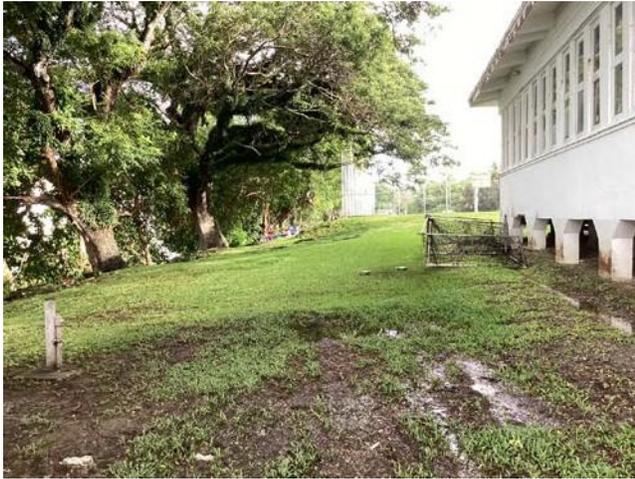
Photo Caption: Wet, muddy area where runoff ponds behind building.

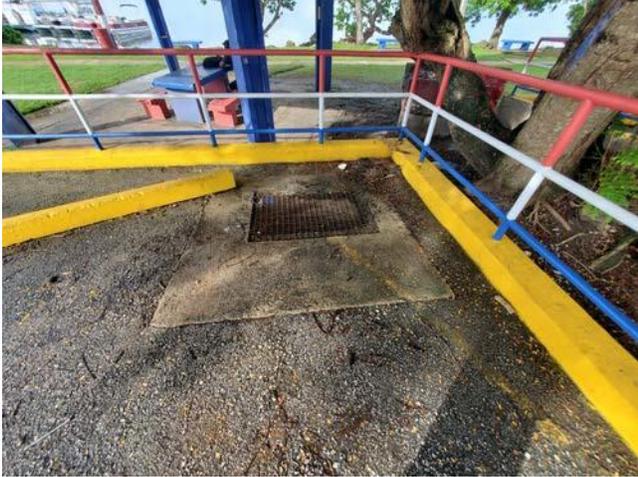
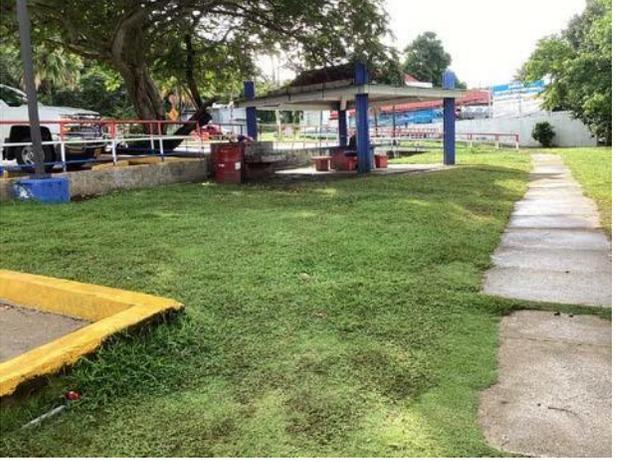
Site Name: Merizo Pier Park Parking Lot Bio West		ID#: R-18
DESCRIPTION		
Type of Project: Stormwater Retrofit	Preliminary Ranking: High	
Existing Conditions: Portion of parking lot and shower runoff directly going down boat ramp. Catch basin captures parking lot runoff and outlets it to the ocean (not able to find outfall).	Site Location:	
Proposed Solution: Divert parking lot area and shower runoff into a bioretention system in park area. Add educational signage. Create speed hump across boat ramp to direct water to bioretention system. Direct downstream catch basin from the upper parking lot to bioretention system.

Photo Caption: Downstream Catch basin in upper parking lot	Photo Caption: Grassy area in park to be the proposed area for Bioretention system.

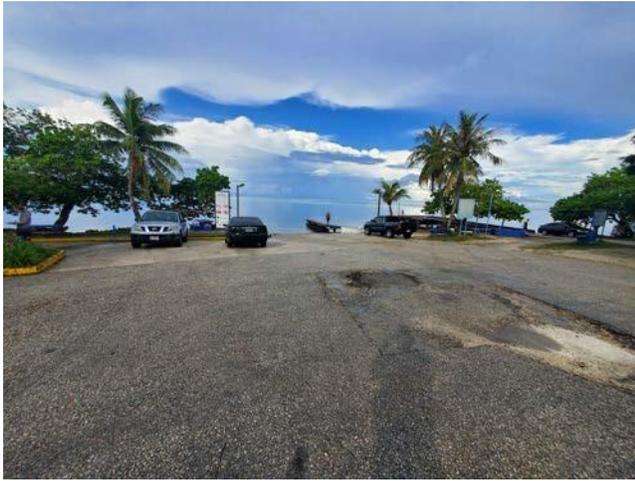
Photo Caption: View of parking lot area looking toward boat ramp. Area to be directed to Bioretention system.

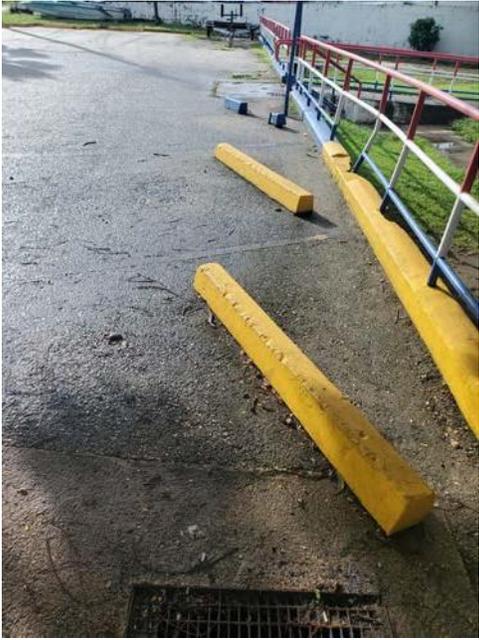
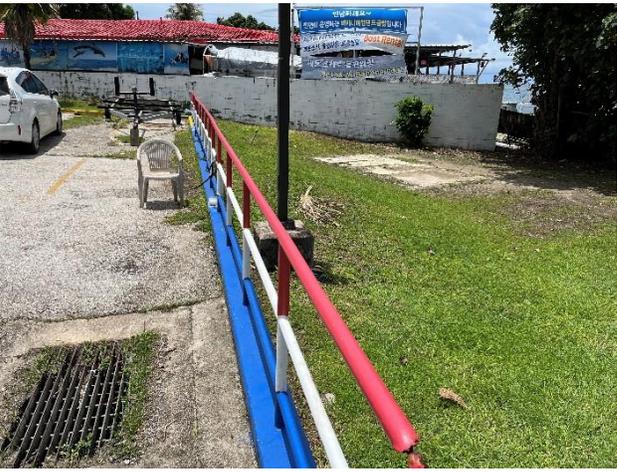
Site Name: Merizo Pier Parking Lot Bio East		ID#: R-19
DESCRIPTION		
Type of Project: Stormwater Retrofit	Preliminary Ranking: High	
Existing Conditions: Upgradient catch basin in the upper parking lot connects to downgradient catch basin. Unclear where they outlets to but suspect pipe runs to the riprap bank.	Site Location:	
Proposed Solution: Divert upgradient catch basin pipe to bioretention system in grass area on east side of sidewalk. Divert runoff from concrete paths and ramp to bioretention system. Add educational signage.

Photo Caption: Looking upgradient of second catch basin.	Photo Caption: Looking upgradient toward second catch basin and to grassy area to the east of the parking lot.

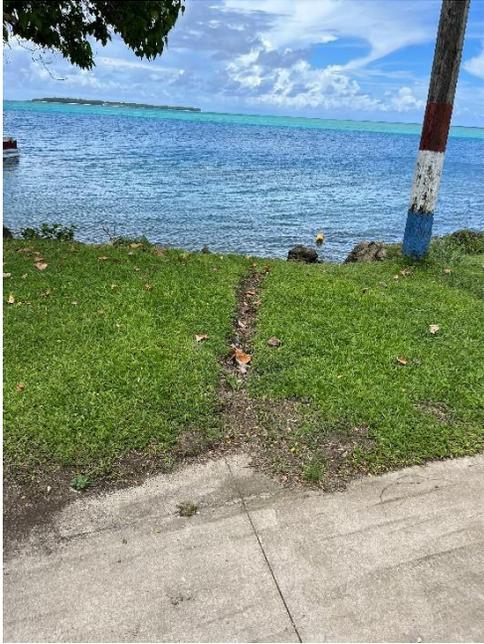
Photo Caption: Looking downgradient from bottom of concrete ramp. Eroded flow path that outlets to ocean.

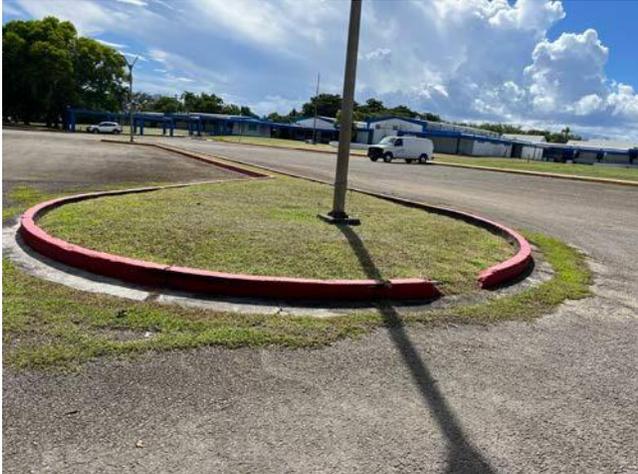
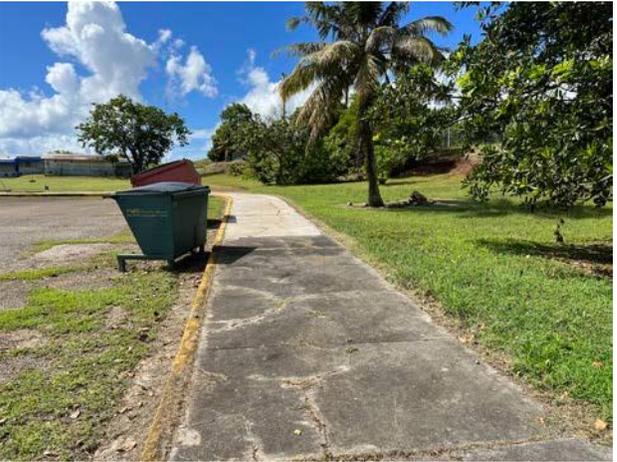
Site Name: School Parking Lot Bio		ID#: R-20
DESCRIPTION		
Type of Project: Stormwater Retrofit	Preliminary Ranking: High	
<p>Existing Conditions: Paved parking lot. No stormwater management. Flat. Some vegetation growing on pavement along curb line.</p> <p>Proposed Solution: Install a bioretention/dry swale system along the school entrance and road. Integrate with R-10 concept. Good location for educational signage.</p>	<p>Site Location:</p>

<p>Photo Caption: Parking lot island</p>	<p>Photo Caption: Sidewalk along parking lot looking toward eroded slope from R-10.</p>

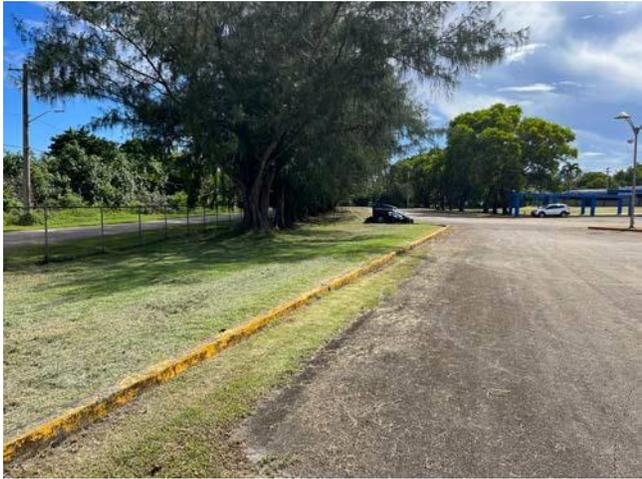
Photo Caption: Grassy area between parking lot and road where stormwater can be managed.

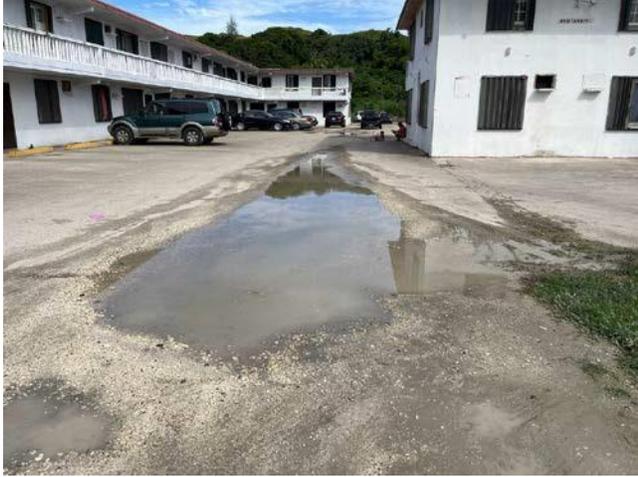
Site Name: Helmani's Apartments Rain Gardens		ID#: R-21
DESCRIPTION		
Type of Project: Stormwater Retrofit	Preliminary Ranking: Medium	
Existing Conditions: Apartment complex with large parking area and some ponding in the driveway.	Site Location:	
Proposed Solution: Proposed solution is to divert the flows to grassy areas on either side of the entrance in rain gardens.

Photo Caption: Poned water in the parking lot.	Photo Caption: Open grassy area where a rain garden could be installed.

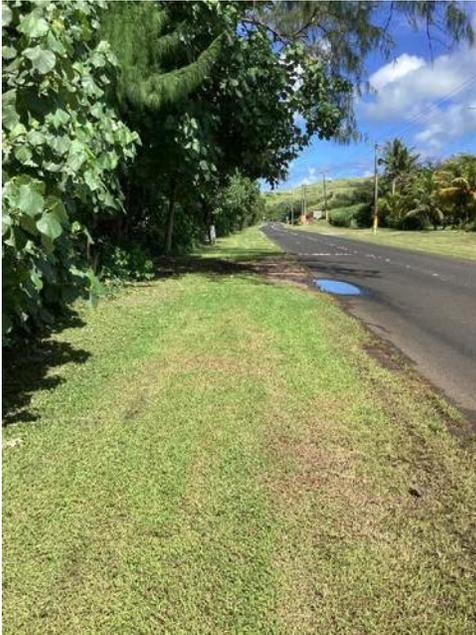
<p>Photo Caption: Open, grassy shoulder on ocean-side of road where a stormwater swale could be installed.</p>	<p>Photo Caption: Open, grassy shoulder on mountain-side of road where a stormwater swale could be installed.</p>

<p>Proposed Solution: Water quality swales on both sides of the road to minimize flooding, treat water, and help convey it to the stream where there's currently erosion around the existing headwalls.</p>	<p>Other Notes: Road is 20 feet wide. 12 1/2 grass strip on mountain side 14 1/2 grass strip. Indication that road shoulder is paved with grass growing over it</p>	
<p>Site Constraints: Existing constraints include a water line on the mountain side of the road and possible underground electrical line on the ocean side of the road. Overhead wires on the mountain side.</p>

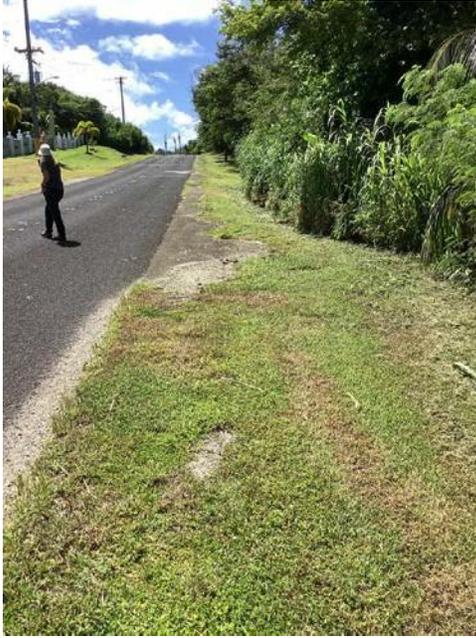
Photo Caption: Visible paved shoulder in this section with grass growing on top – likely more pavement than visible in other sections as well.

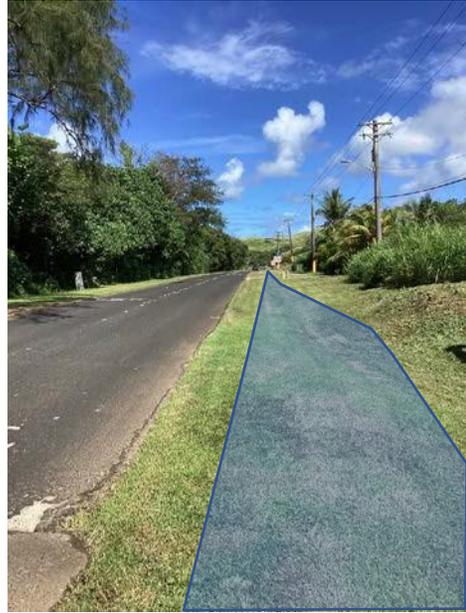
Site Sketch: Location of very shallow roadside swale for managing runoff.

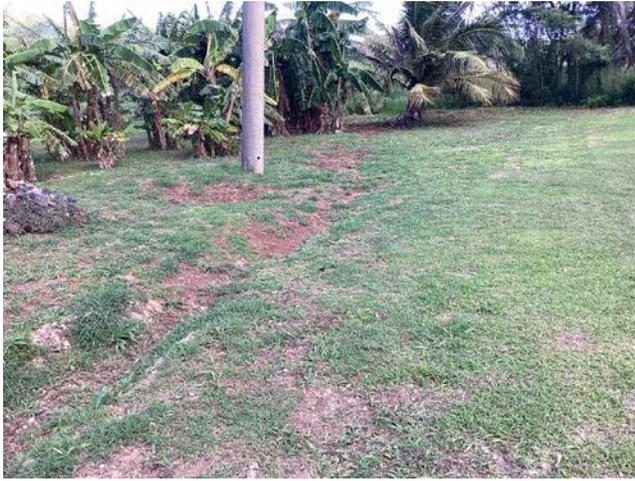
Photo Caption: Existing eroded ditch where runoff flows down towards the badlands.

<p>Proposed Solution: Bring runoff from concrete swale across the road via pipe to bioretention. Use to slow water down, reduce erosion and runoff volume, and treat stormwater. The discharge would continue on down the slope and may need to be stabilized. This practice would help reduce downstream flooding and sediment issues on Geus Road.</p>		
<p>Site Constraints: Overhead wires, utility pole and steep slopes.</p>	<p>Other Notes: Resident at adjacent house informed us the water tank across the street leaks and flows into his yard occasionally.</p>	
PHOTOS/SKETCHES

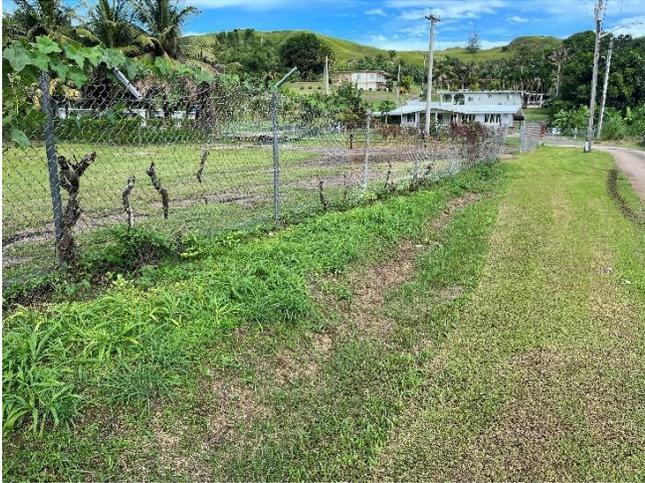
Site Name: Geus River Floodplain Restoration		ID#: R-25
DESCRIPTION		
Type of Project: Stream/Wetland Restoration	Preliminary Ranking: Medium	
<p>Existing Conditions: Cleared empty lot. Currently where storm water/river water flows to when Geus River culvert is clogged or just overwhelmed.</p>	<p>Site Location:</p>

<p>Photo Caption: Open grassy area for floodplain restoration behind chainlink/barb wire fence. During heavy rains, evidence that floodwaters already come here.</p>	<p>Photo Caption: Culvert for Geus River with bamboo floating and clogging this area.</p>

<p>Proposed Solution: Use this area for floodplain restoration/retention.</p>		
<p>Site Constraints: Private property.</p>	<p>Other Notes:</p>	
PHOTOS/SKETCHES

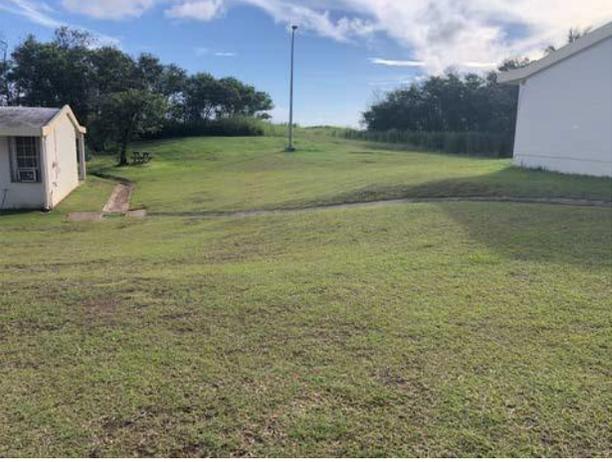
<p>Photo Caption: Parking and buildings in development.</p>	<p>Photo Caption: Concrete channel directing road and roof runoff.</p>
--	---

<p>Proposed Solution: Implement green infrastructure measures to the complex, including converting concrete swales to grassed swales, constructed rain gardens, and installing cisterns for rainwater harvesting of roof runoff.</p>	
<p>Site Constraints: Private property, utilities</p>	<p>Other Notes:</p>

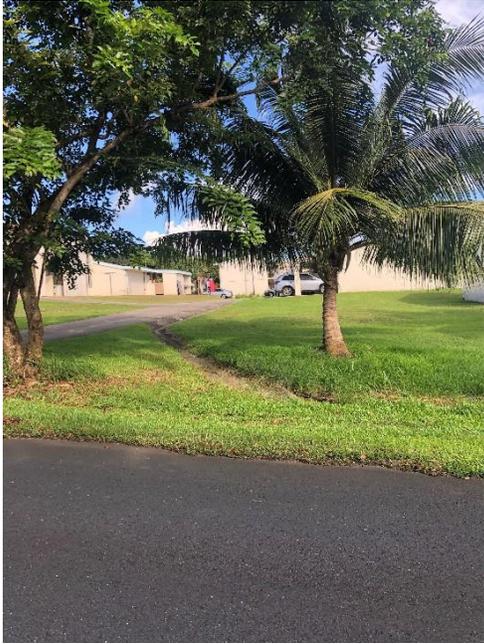
Photo Caption: Concrete channel directing road and roof runoff.
