MEMORANDUM

To: Rob Ferguson and Marie Auyong (NOAA)
From: Ben Wollman, Janelle Veary, Michelle West (HW)
Date: October 26, 2022
Re: Manell-Geus Watershed Inventory – Field Findings
cc: Margaret Aguilar, Guam EPA
Farron Tajeron, The Nature Conservancy
Christine Fejeran, Guam Department of Agriculture

This memorandum summarizes data collection and key findings from a rapid watershed assessment of the Manell and Geus watersheds conducted by HW, Guam EPA, Department of Agriculture, The Nature Conservancy, NOAA, and others the week of August 4 – 9, 2022. The purpose of the assessment was to map drainage infrastructure, identify problem areas (pollution sources, flooding, damage, etc.), and identify potential restoration project opportunities. During this effort, the field team:

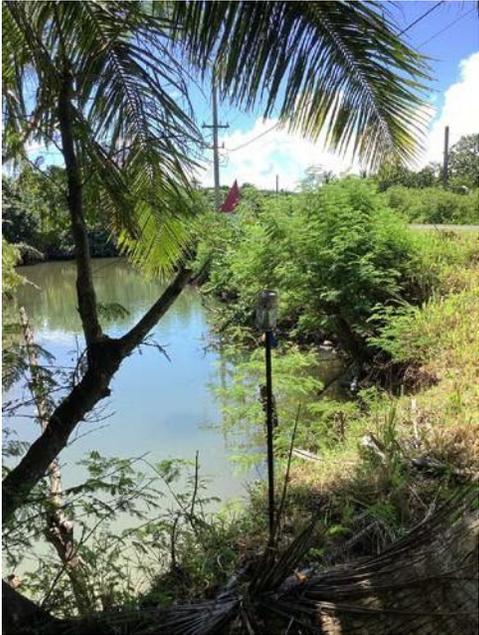
Site Name: Ajayan River Restoration		ID#: R-27
DESCRIPTION		
Type of Project: Stream/Wetland Restoration		Preliminary Ranking: High
<p>Existing Conditions: Extensive sediment deposit downstream of bridge. Major stream bank erosion where river comes out to the bay at route four. River takes 90° turn before bridge and the bank is being scoured away. Existing water line is leaking at a future connection point.</p> <p>Proposed Solution: Proposed restoration at the site includes stream bank hardening to protect the roadway infrastructure and reduce sediment source out to the bay here. Likely a hardened type structure with gabion baskets and some plants as well.</p>		<p>Site Location:</p>

<p>Photo Caption: Eroding bank of Ajayan River.</p>		<p>Photo Caption: Erosion along road.</p>

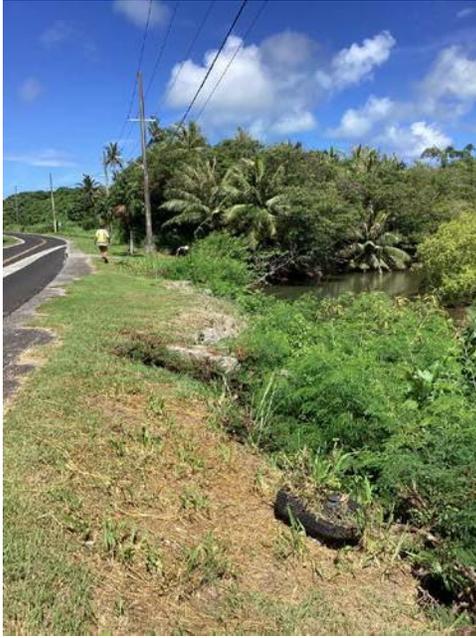
Photo Caption: Erosion along road.

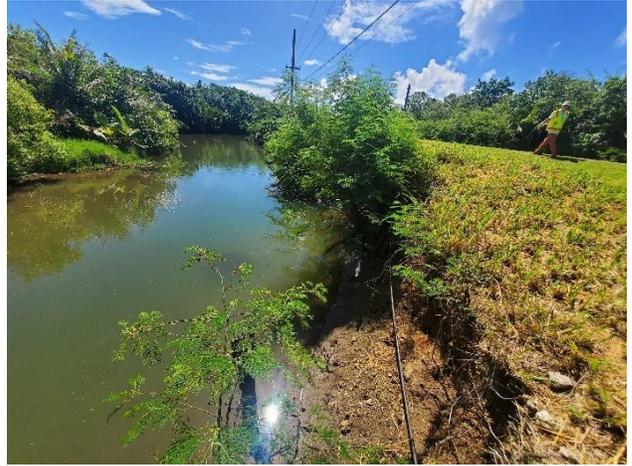
Photo Caption: Riverbank erosion.

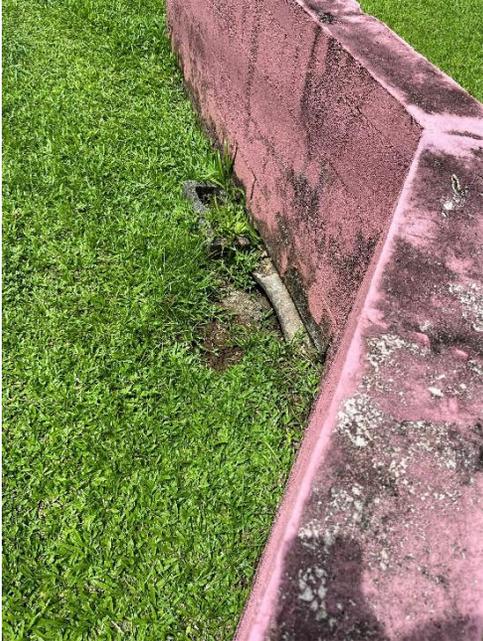
Photo Caption: Clogged culvert at downgradient side of road crossing.	Photo Caption: Concrete diversion channel full of sediment and debris. Downgradient of tributary redirection.

Site Name: Redirect Tributary along Quinene		ID#: R-28
DESCRIPTION		
Type of Project: Stream/Wetland Restoration	Preliminary Ranking: High	
Existing Conditions: Tributary has been rerouted to run along road. Resident says entire road floods often.	Site Location:	
Proposed Solution: Redirect tributary to the natural path of crossing the road and going directly to the stream prior to neighborhood.

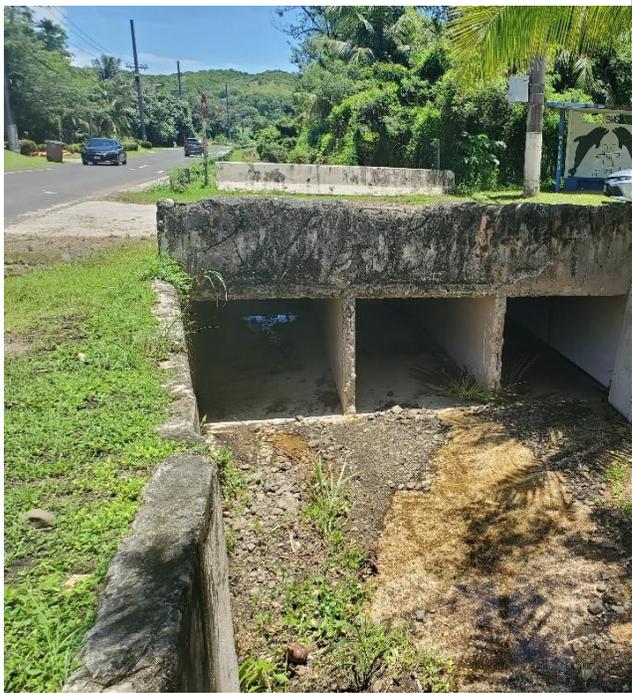
Type of Project: Stream/Wetland Restoration	Preliminary Ranking: High
<p>Existing Conditions: The Manell River currently makes a 90-degree turn immediately upstream of Route 4, flows parallel to the road in large concrete channel, then makes another 90-degree turn before crossing under the road in two locations. Diversion causes major flooding and debris build up for the whole neighborhood and Route 4.</p>	<p>Site Location:</p>

Photo Caption: Looking at culverts just downstream of upstream 90-degree bend.

<p>Proposed Solution: Restore a more natural river path closer to historic location by constructing a culvert crossing immediately before the upstream 90-degree bent culvert and recreating a naturally shaped channel downstream of Route 4 to the ocean.</p>

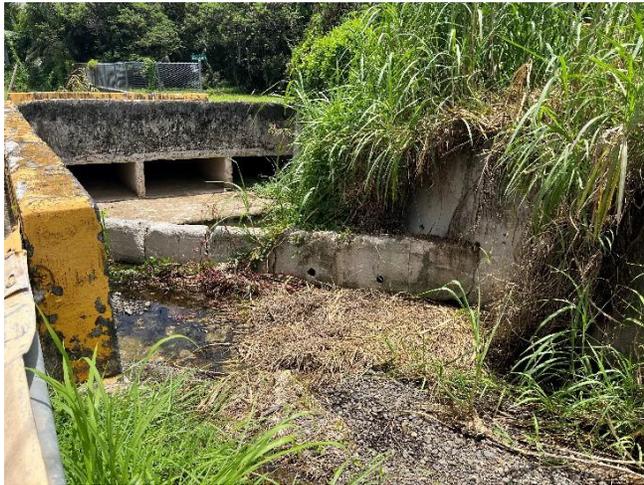
Photo Caption: Looking at culverts just upstream of the downstream 90-degree bend.

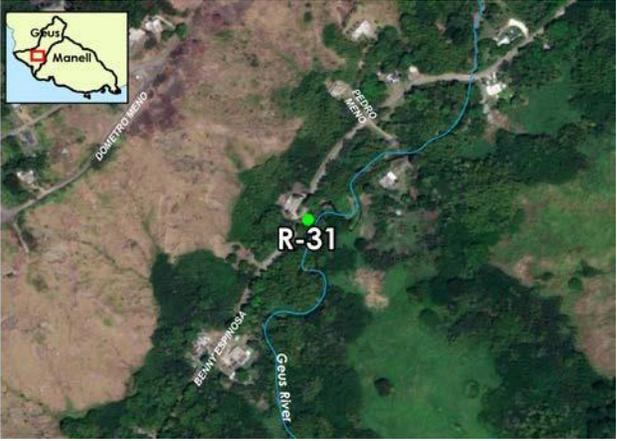
Site Name: Geus River Bamboo Site		ID#: R-31
DESCRIPTION		
Type of Project: Stream/Wetland Restoration	Preliminary Ranking: Medium	
Existing Conditions: Clumping bamboo falling into river.	Site Location:	
Proposed Solution: Clearing of bamboo.

Site Constraints: Difficult to access.	Other Notes:	
PHOTOS/SKETCHES

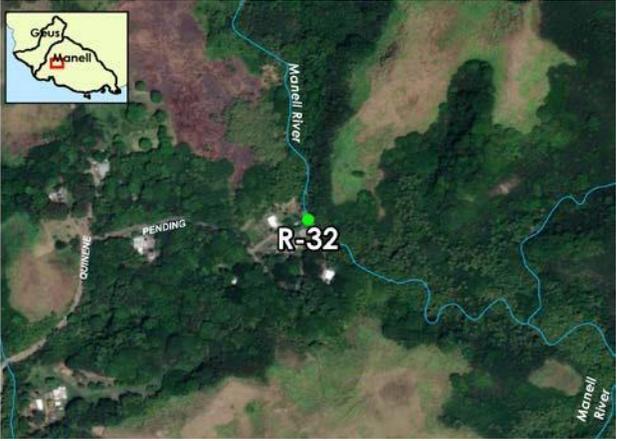
Site Name: Manell River Bamboo Removal **ID#: R-32**

DESCRIPTION	
Type of Project: Stream/Wetland Restoration	Preliminary Ranking: Unsure
Existing Conditions: Steep, bare bank. Invasive bamboo and vines. Previous bamboo treatments done.	Site Location:

Proposed Solution: Continued invasive mgmt, bank stabilization/revegetation	
Site Constraints: Access through private property. Commitment to invasive work.	Other Notes:

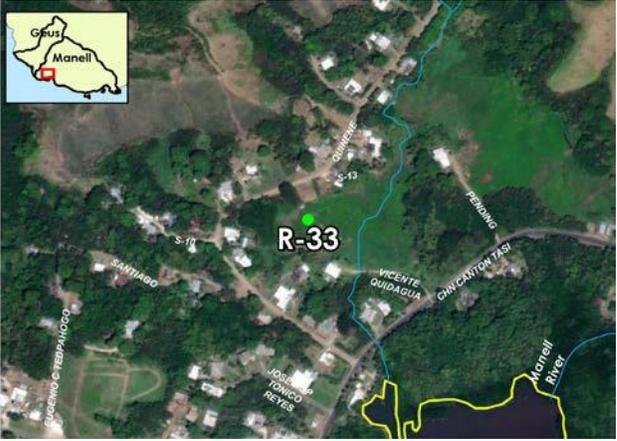
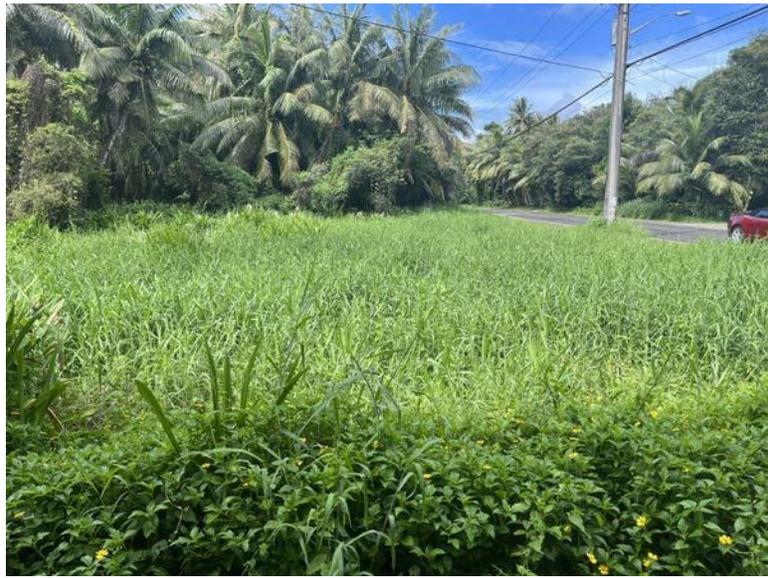
Site Name: Quinene Wetland Enhancement **ID#: R-33**

DESCRIPTION	
Type of Project: Stream/Wetland Restoration	Preliminary Ranking: Low
<p>Existing Conditions: Wetland area along Quinene adjacent to river. Several drainage paths converge at this location.</p>	<p>Site Location:</p>

Photo Caption: Existing wetland area along private driveway.

<p>Proposed Solution: Enhance and protect wetland from additional development/alteration. Provide better conveyance from steep slopes on mountain side of Quinene Rd to this area.</p>	
<p>Site Constraints: Private property.</p>	<p>Other Notes:</p>

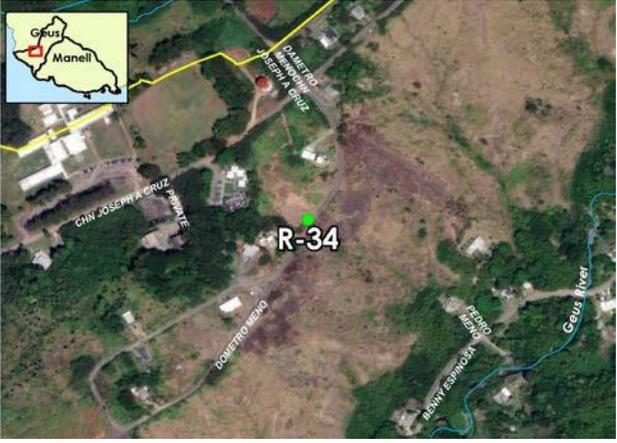
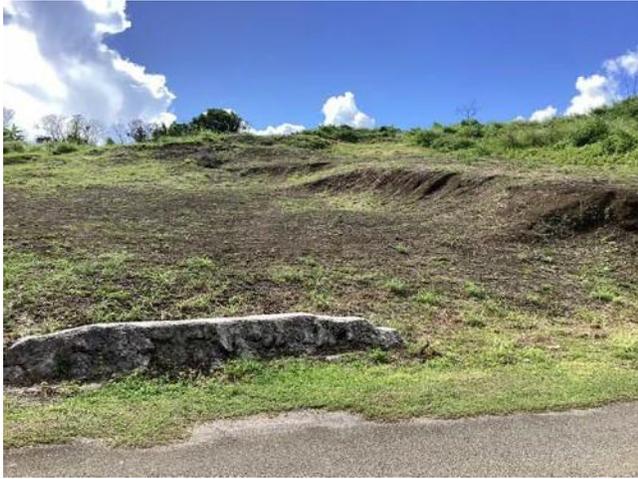
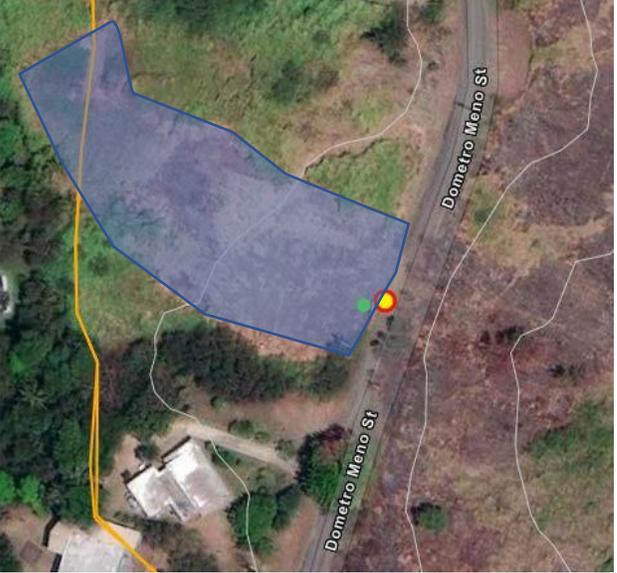
<p>Type of Project: Upland Revegetation</p>	<p>Preliminary Ranking: Medium</p>
<p>Existing Conditions: Culvert at bottom of slope and outlets down steep hill across the road. Potentially high erosion downhill of culvert; very steep. Steep hill with bare soil. Some short grass. Looks like a point of high sediment runoff.</p>	<p>Site Location:</p>

<p>Photo Caption: Looking toward upgradient end of culvert and bare sloped area.</p>	<p>Site Sketch: Approximate area to be revegetated.</p>
---	--

<p>Proposed Solution: Revegetate sloped area to stabilize slope and reduce sediment runoff.</p>

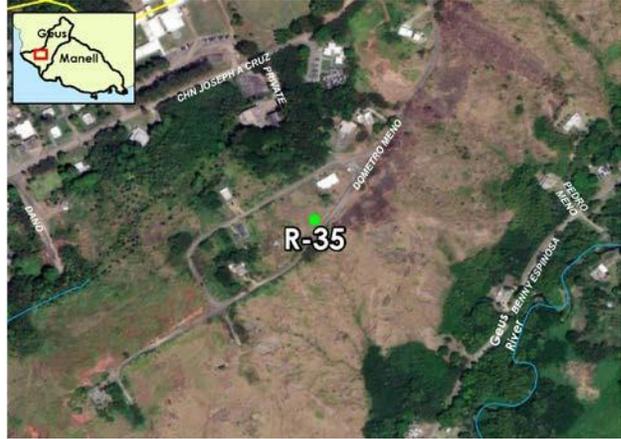
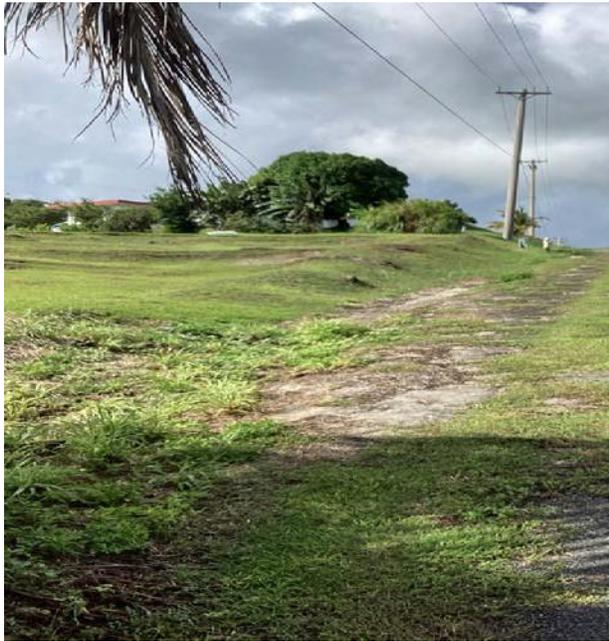
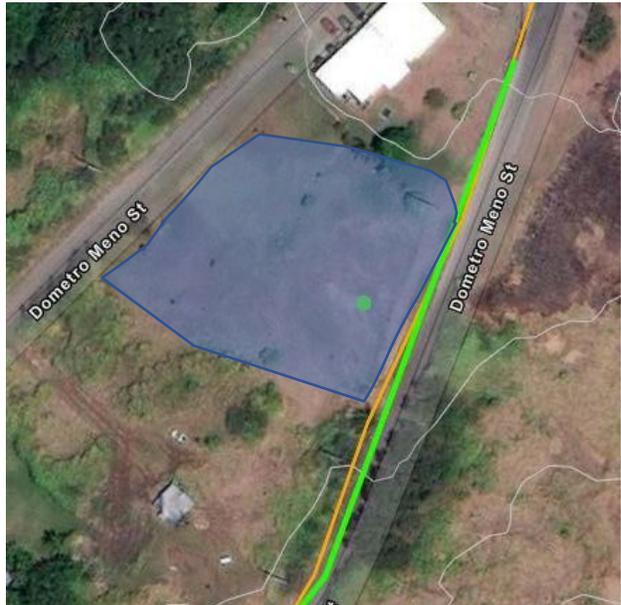
Existing Conditions: Bare soil and short grass on slope.

Site Sketch: Approximate area to be revegetated.

Proposed Solution: Revegetate slope.
