# GUAM COMPREHENSIVE STUDY SHORELINE INVENTORY

#### **GUAM SHORELINE INVENTORY**

U. S. Army Engineer District, Honolulu Building 230. Planning Branch Fort Shafter, Hawaii 96858 Contract No. DACW84-79-C-0024

Sea Engineering Services, Inc./
R. M. Towill Corporation
- A Joint Venture Honolulu, Hawaii

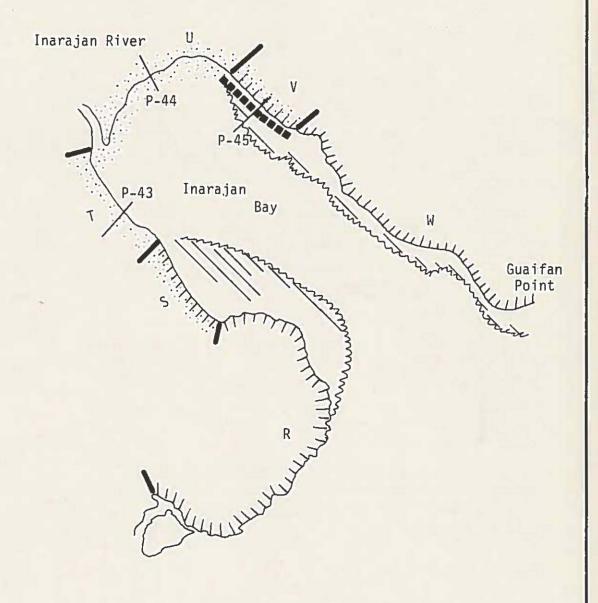
400 200 0 400 800 SCALE IN FEET FIGURE 8-7
INARAJAN BAY

- The beach material is 80 to 90 percent alluvial material and volcanic sand, with the remainder calcareous.
- There is a 160- to 200-foot wide grassy area between the beach and the highway. Two houses are located on the backshore berm, both set back 100 feet from the shoreline.
- Stable, no erosion.

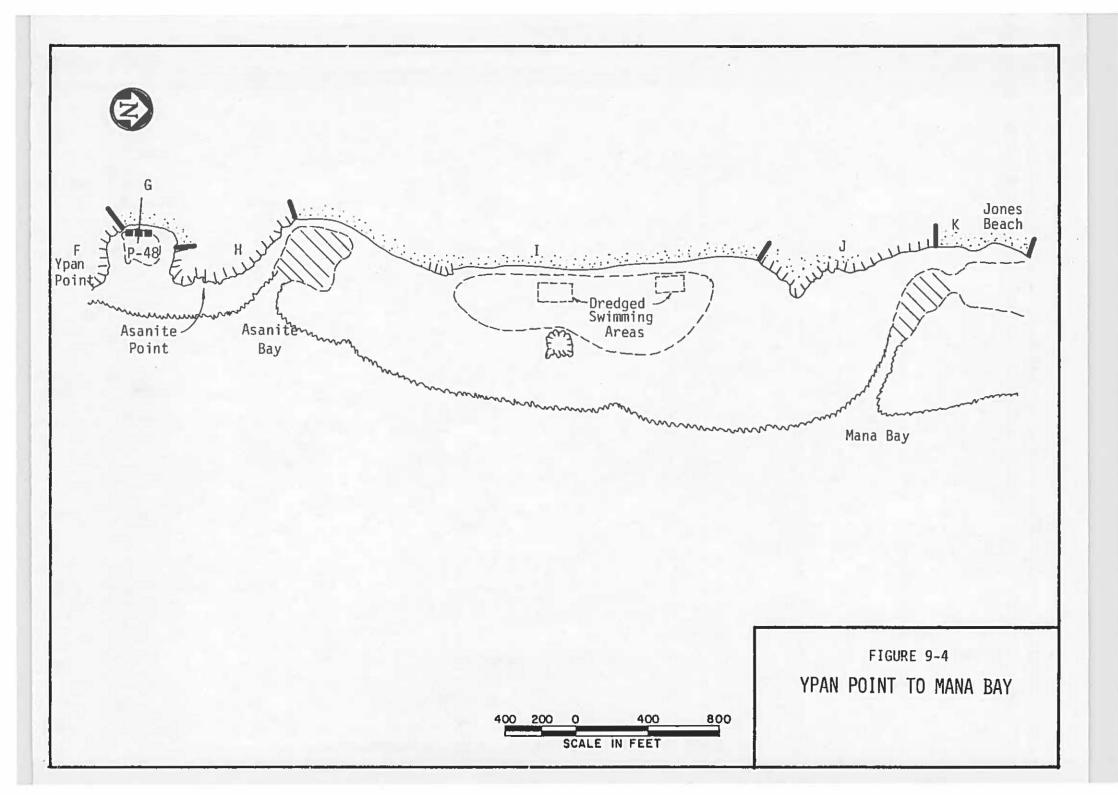
Eroding Scarp, Reach G

- The intertidal reef flat is 500 feet wide, with intermittent moat development as shown by Profile 48.
- Classification Intermediate erosion at south end. The beach is stable during normal conditions, but storm waves could result in erosion and potential undercutting of the highway.

Ypan Point	Reach G, Figure 9-4	Beach Just North of Point is Eroding at South End. A 2 to 3 Foot Scarp is 10 Feet From the Edge of Route	Intermediate	150 Feet	Investigate Shore Protec- tion Alterna- tives
			4, Storm Waves Could Undercut Highway

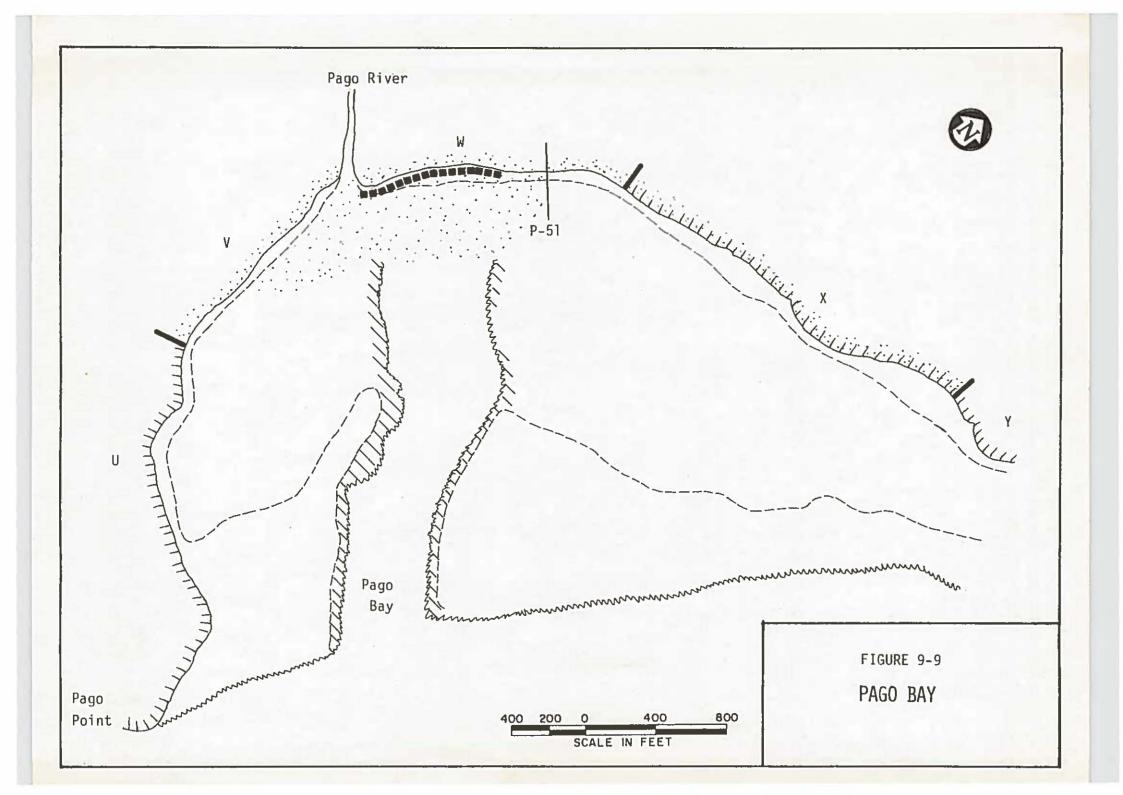
Typical View. Reach W

• The sand composition in Reaches V and W is indicative of predominant transport to the south, probably in response to the prevailing trade winds.

- The alluvial river delta fronts the south half of the beach, grading into the reef flat to the north. The reef flat off the north side of the beach is up to 2,500 feet wide.
- The 850-foot length of beach immediately north of the Pago River is subject to minor, ongoing erosion. A two-foot scarp has been cut into the backshore along this area. A remaining coconut tree on the beach foreshore indicates a beach recession of at least 25 feet in the recent past.
- There is no backshore development.

Location	Reference Map	<u>Problem</u>	Classification	Affected Length (ft)	Recommended Action
Pago Bay	Reach W, Figure 9-9	Beach Section Just North of Pago River is Eroding, With a 2-Foot Scarp Cut into Backsho There are Indications the Beach Recession ma be Steady and Ongoing	re. that	850 Feet	Monitor
