# **COASTAL ENVIRONMENTAL DAMAGE**

## **A PRELIMINARY SURVEY OF IMPACTS OF TYPHOON CHATA'AN ON GUAM'S NATURAL ENVIRONMENT**

**Coordinated by  
THE GUAM BUREAU OF STATISTICS AND PLANS  
Assisted by  
DEPARTMENT OF LAND MANAGEMENT,  
DEPARTMENT OF AGRICULTURE,  
THE GUAM ENVIRONMENTAL PROTECTION AGENCY,  
and  
THE CHAMORRO LAND TRUST COMMISSION**

**JULY, 2002**

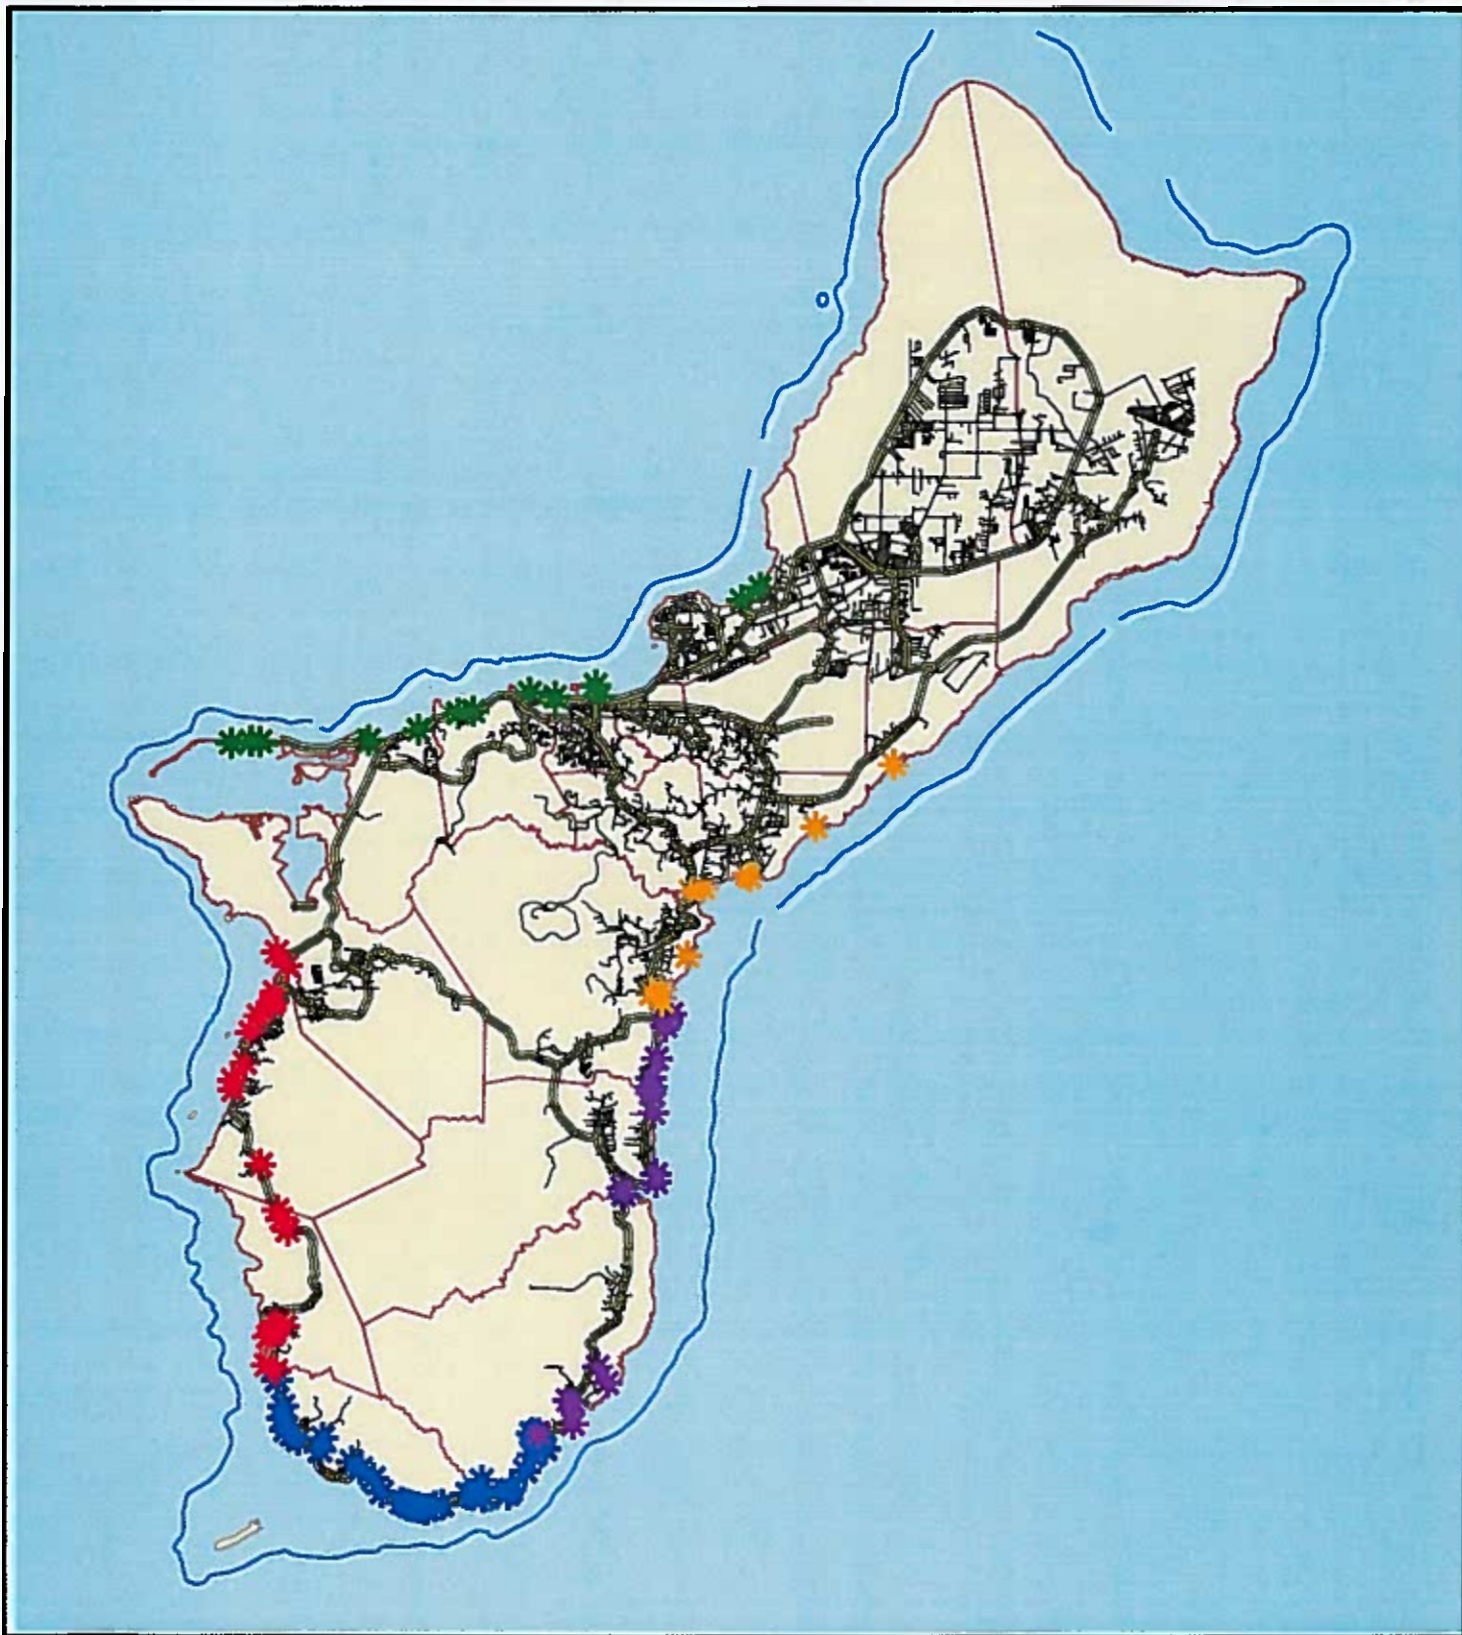
# Typhoon Chata'an Coastal Damage Sites

The five teams reported on 175 sites. Locations of each of the sites are shown in the appended six maps. The sites were broken down into five categories, of which, 75 sites were beach or shore, 30 sites were river areas, 35 sites were inland, 1 site was reef, and 34 sites were under the infrastructure category, which includes bridge, drain, road, or seawall. In the beach/shore category, 49 of the 75 sites had evidence of erosion. In the river category, 25 of the 30 sites had evidence of erosion. In the inland category, 31 of the 35 sites had evidence of erosion. In the reef category, the reef site had evidence of erosion. And finally, in the infrastructure category, 28 of the 34 sites had evidence of erosion. In total, 134 of the 175 sites had evidence of erosion. (Please see Table I.)

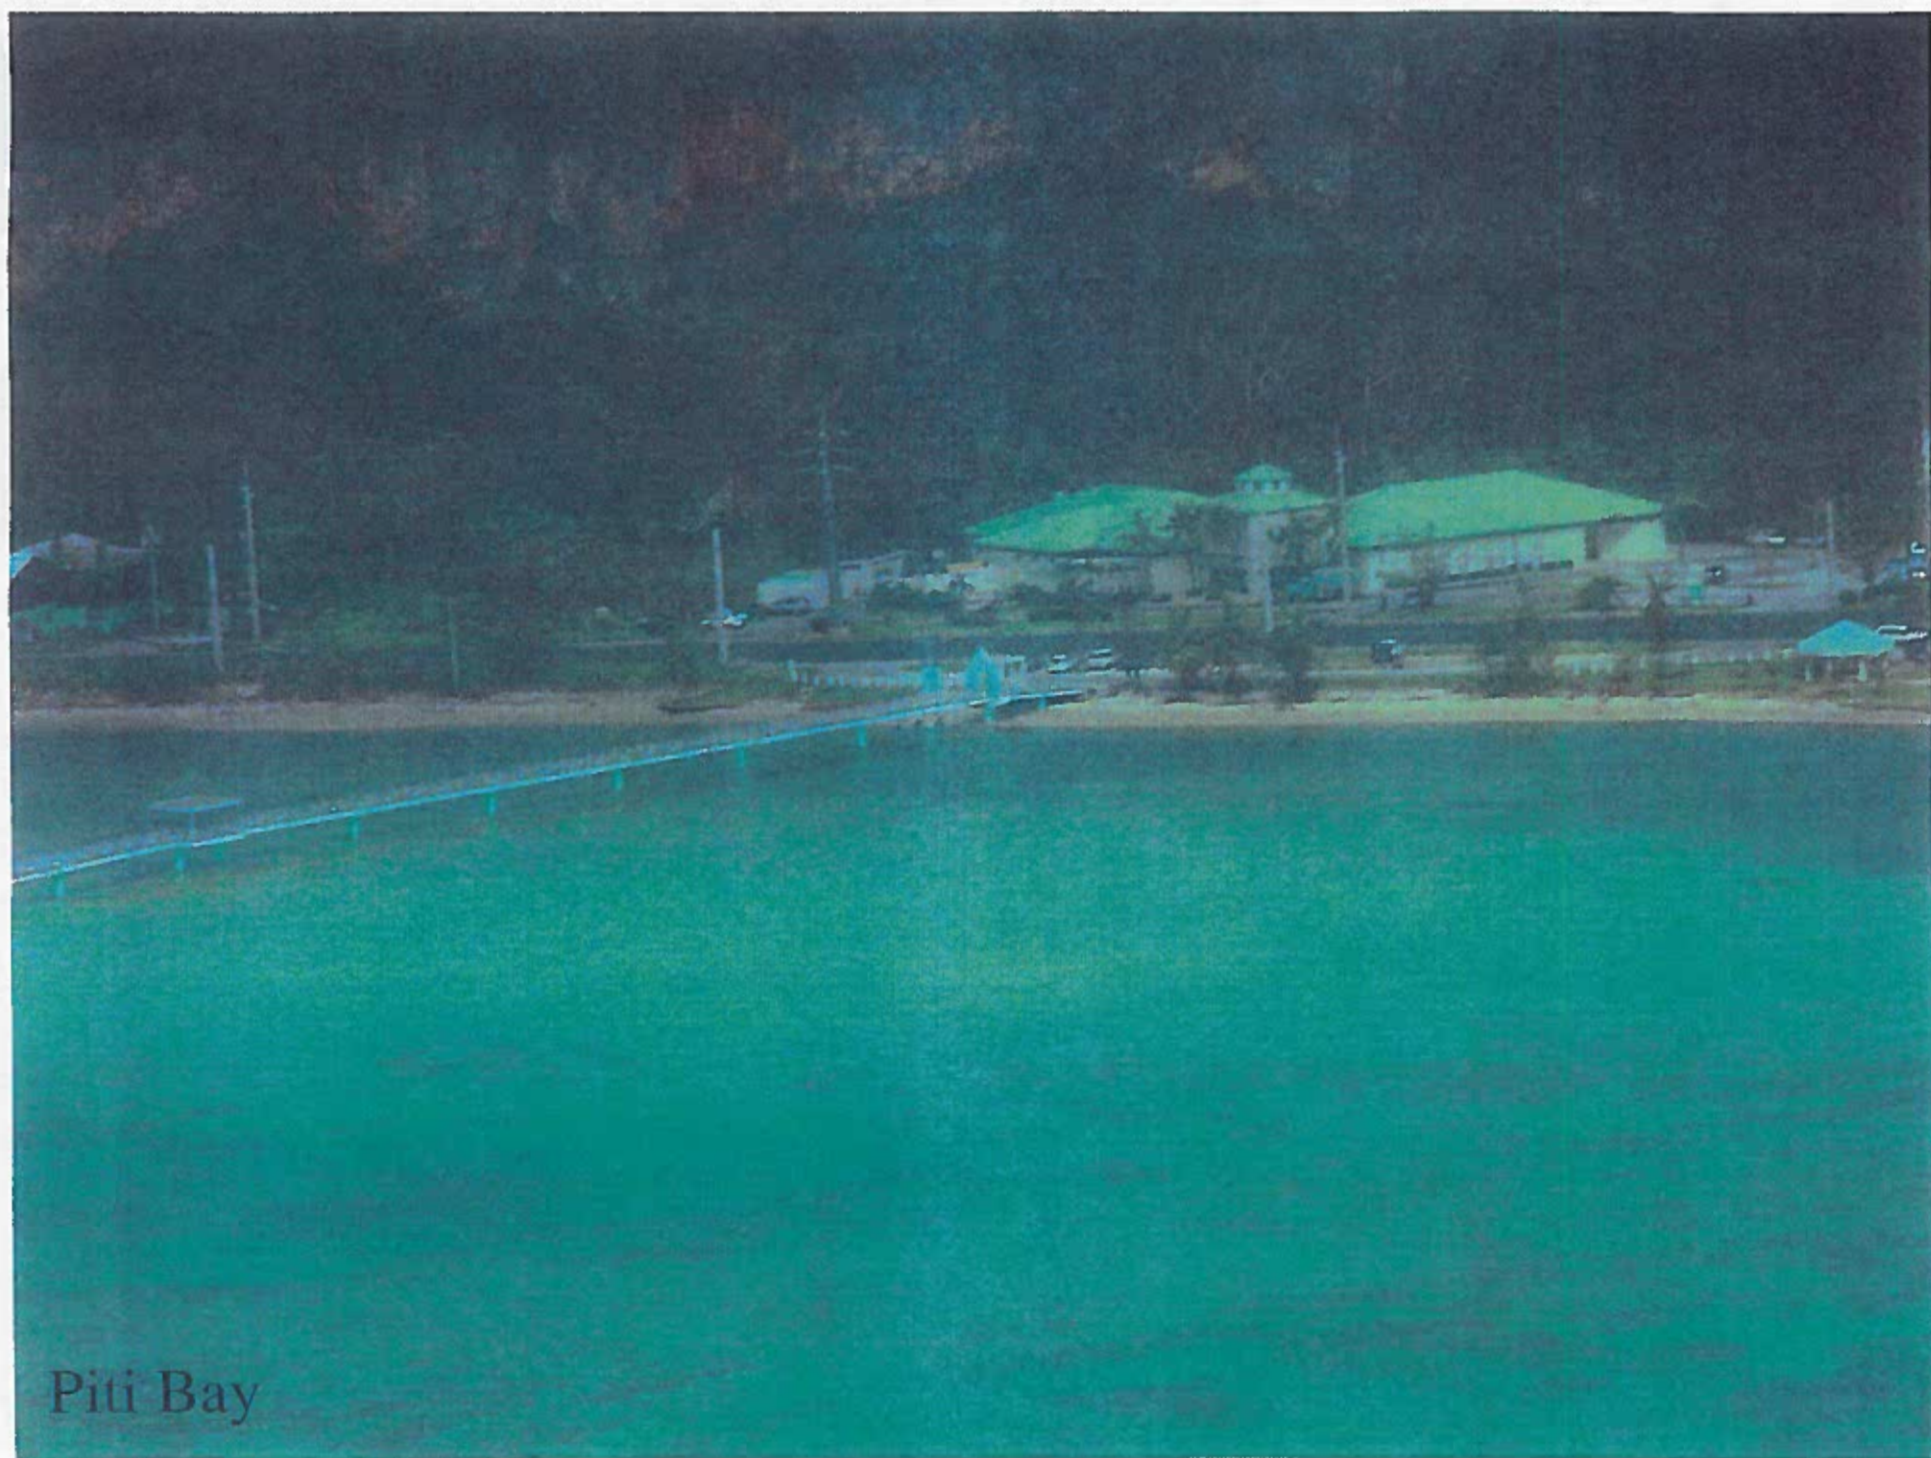
Talofofo Bay

Aerial Assessment: The aerial survey that was done brought back 131 digital photographs of Guam's coastline and river mouths, debris sites and evidence of erosion. Many of the southern river mouths showed low to no turbidity, as shown in appended photo of Talofofo Bay. However, there were indications of erosion up-river and along the riverbanks. The rivers also showed debris around the bridges causing flooding in the vicinity. Evidence of this is in the Village of Merizo where several rivers overflowed their banks and flowed into several residences. It should be noted that the aerial assessment was done on July 16<sup>th</sup>, over ten days after the typhoon. Many riverbanks were cleared and the river mouths and bays had time for particles to settle. The photo of Piti Bay, appended, indicates how quickly clarity had returned to coastal waters by July 16. In contrast, Fena Reservoir remained muddy and turbid as shown in the appended photo.
