**AN EVALUATION OF NEARSHORE SEDIMENT  
CONTAMINATION  
DUNGCA'S BEACH, EAST AGANA BAY, GUAM**

Prepared For  
First Living Service (USA), Inc.

Prepared by  
Pacific Basin Environmental Consultants, Inc.

August 1991

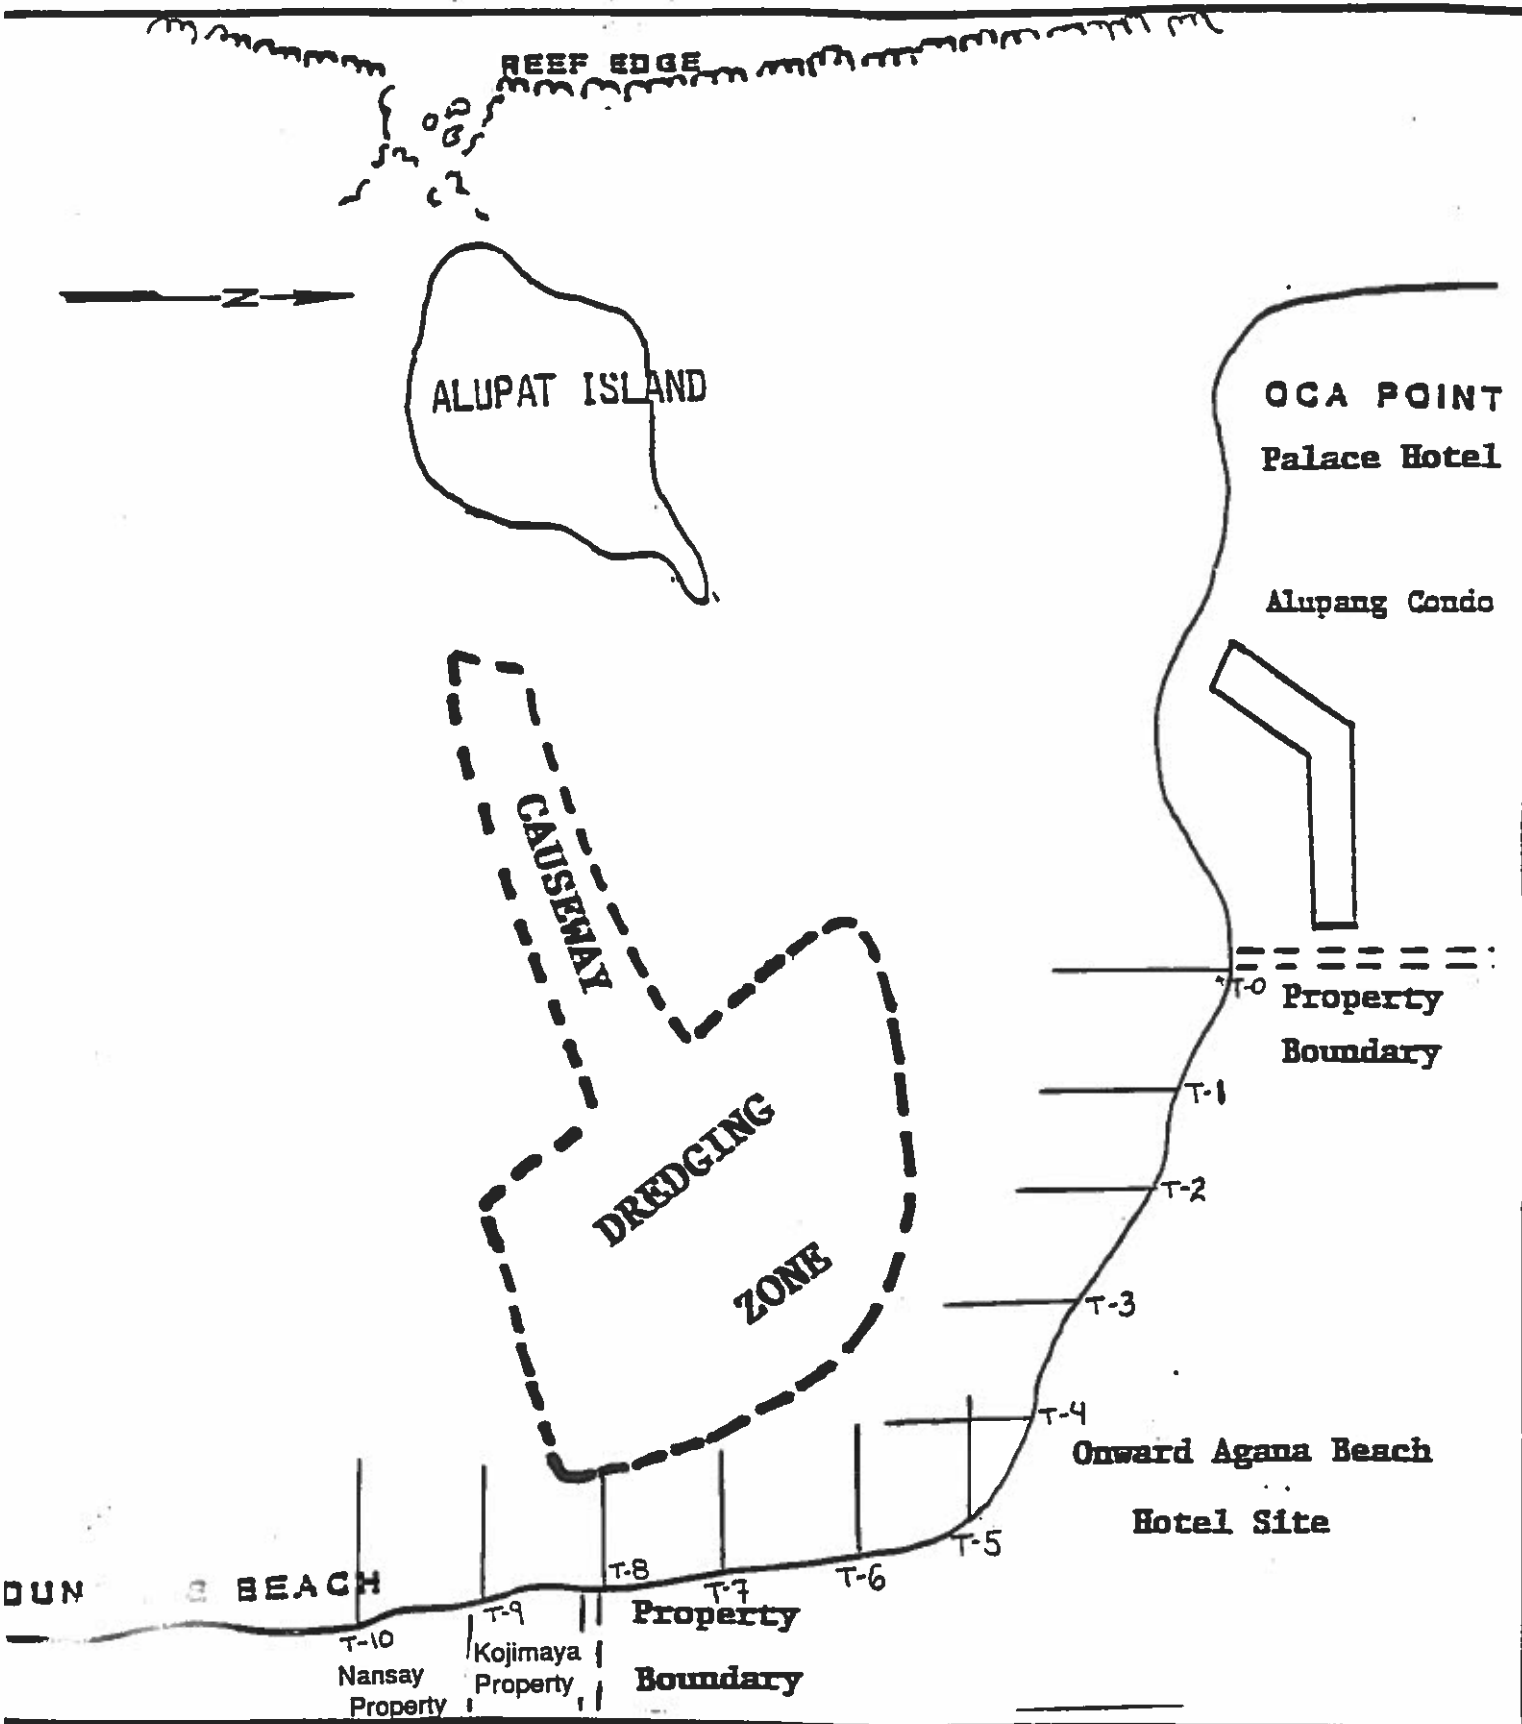
Figure 3. Project site showing approximate loaction of survey transect lines. (Transect lines are labeled T-1, T-2,etc.)

A baseline transect was established at the High Water Line along the beach fronting the Onward Agana Beach Hotel property. Eleven transects (T-0 thru T-10) were run 100 feet apart perpendicular to the shoreline (Figure 3). Each transect extended 100 ft out from the shoreline. Substrate composition along each transect was recorded and samples were taken of representative substrate types. A soil probe was used to determine depth to pavement along each transect. These data were used to compile a profile of the substrate type by sub-area in the area (Figure 4) and to estimate the volume of polluted material that should be removed from this area.
