A MARINE SURVEY  
FOR THE PROPOSED  
MERIZO MARINA

ROBERT S. JONES AND RICHARD H. RANDALL

February 15, 1973

University of Guam  
The Marine Laboratory  
Environmental Survey Report

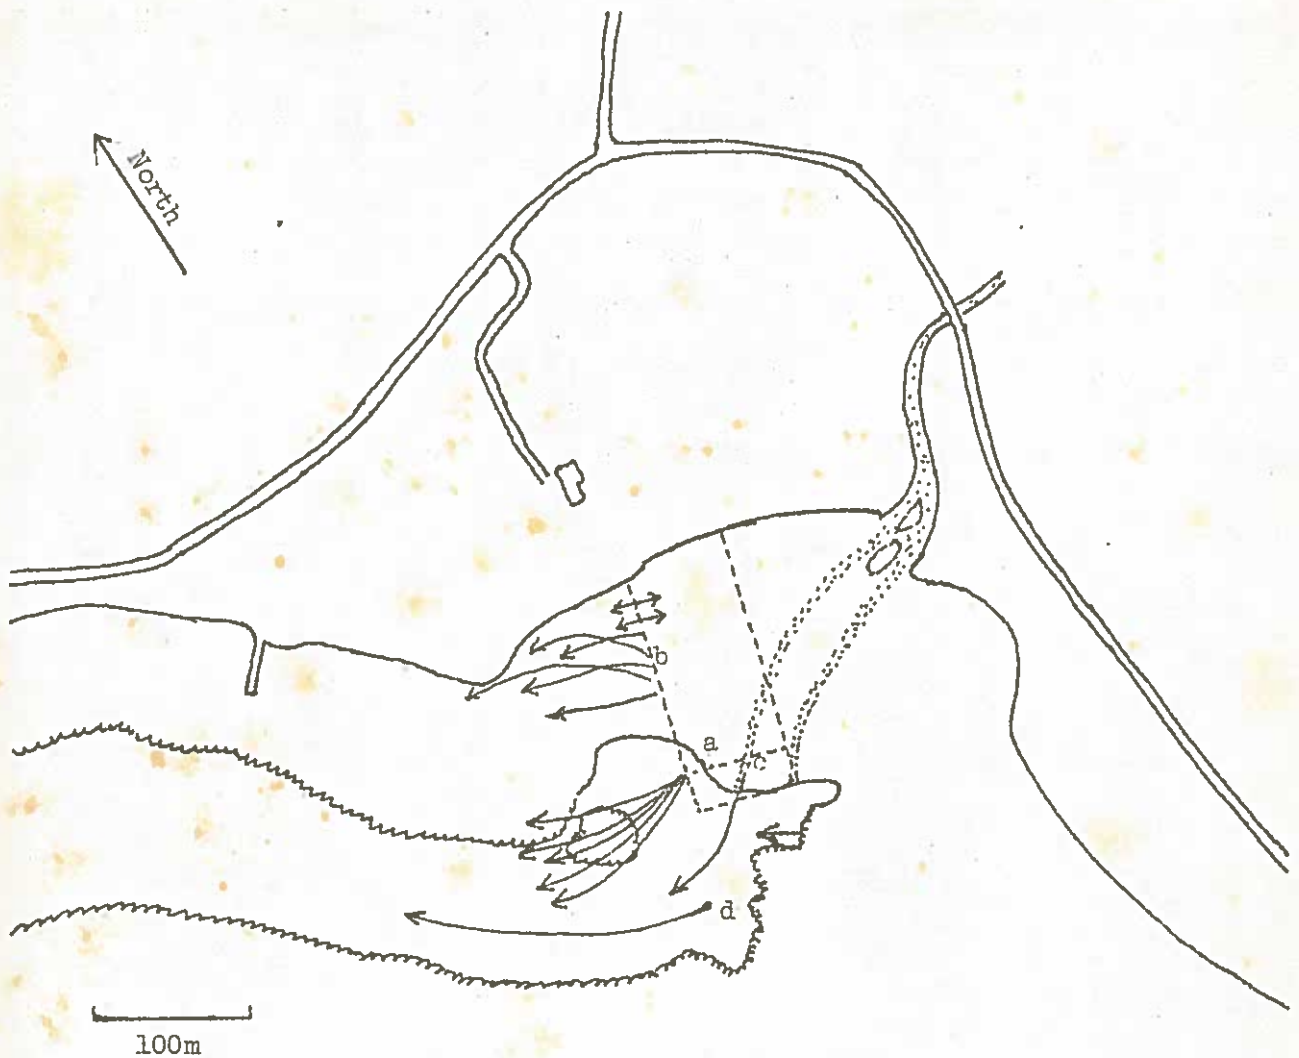
Figure 10. Current Map.

- (a) Primary sample point.
- (b) Series of stations along west boundary at 10m intervals.
- (c) This station was taken in the river channel at a minus tide.
- (d) Two releases in Mamaon Channel.

It should be pointed out that a picture of the current patterns in the study area is based on very few samples. The data taken are shown on Figure 10 and in Table 3. The current sweeps through the study area from east to west. This condition predominates at all stands of the tide. All of the water flowing through the study area eventually enters Mamaon Channel and moves westward to the Philippine Sea. These data are in agreement with a similar study conducted by Randall and Jones (1972), in an area along Mamaon Channel and farther to the west. On January 13 we encountered a weak west wind which is rare in the study area. The result of this wind was a reduction in current velocity (Table 3). During flood tides and strong west winds, there may be a current reversal in Mamaon Channel and water may then sweep from west to east across the study area.

Figure 10 shows that the construction area will block the present tidal channels of the Geus River. This will deflect the flow around the end of the east causeway into Mamaon Channel. Some accretion of material can be expected along the east side of the east causeway. The deflection of silt into Mamaon Channel may ease the present amount of sedimentation of the mud flats and the coral rich channel margins west of the construction site. This might well result in a richer marine community in the present mud flat area similar to that up current from the mouth of the Geus River.
