**Nearshore Currents and Coral Reef  
Ecology of the West Coast of  
Guam, Mariana Islands**

| Technical Report. 4 Feb. - 3 Mar. 1971 and 19 Aug. - 15 Sept. 1971 | | | |
| Howard D. Huddell, J. Craig Willett, and Gregory Marchand | | | |
| b. PROJECT NO 122/21 | | SP-259 | |

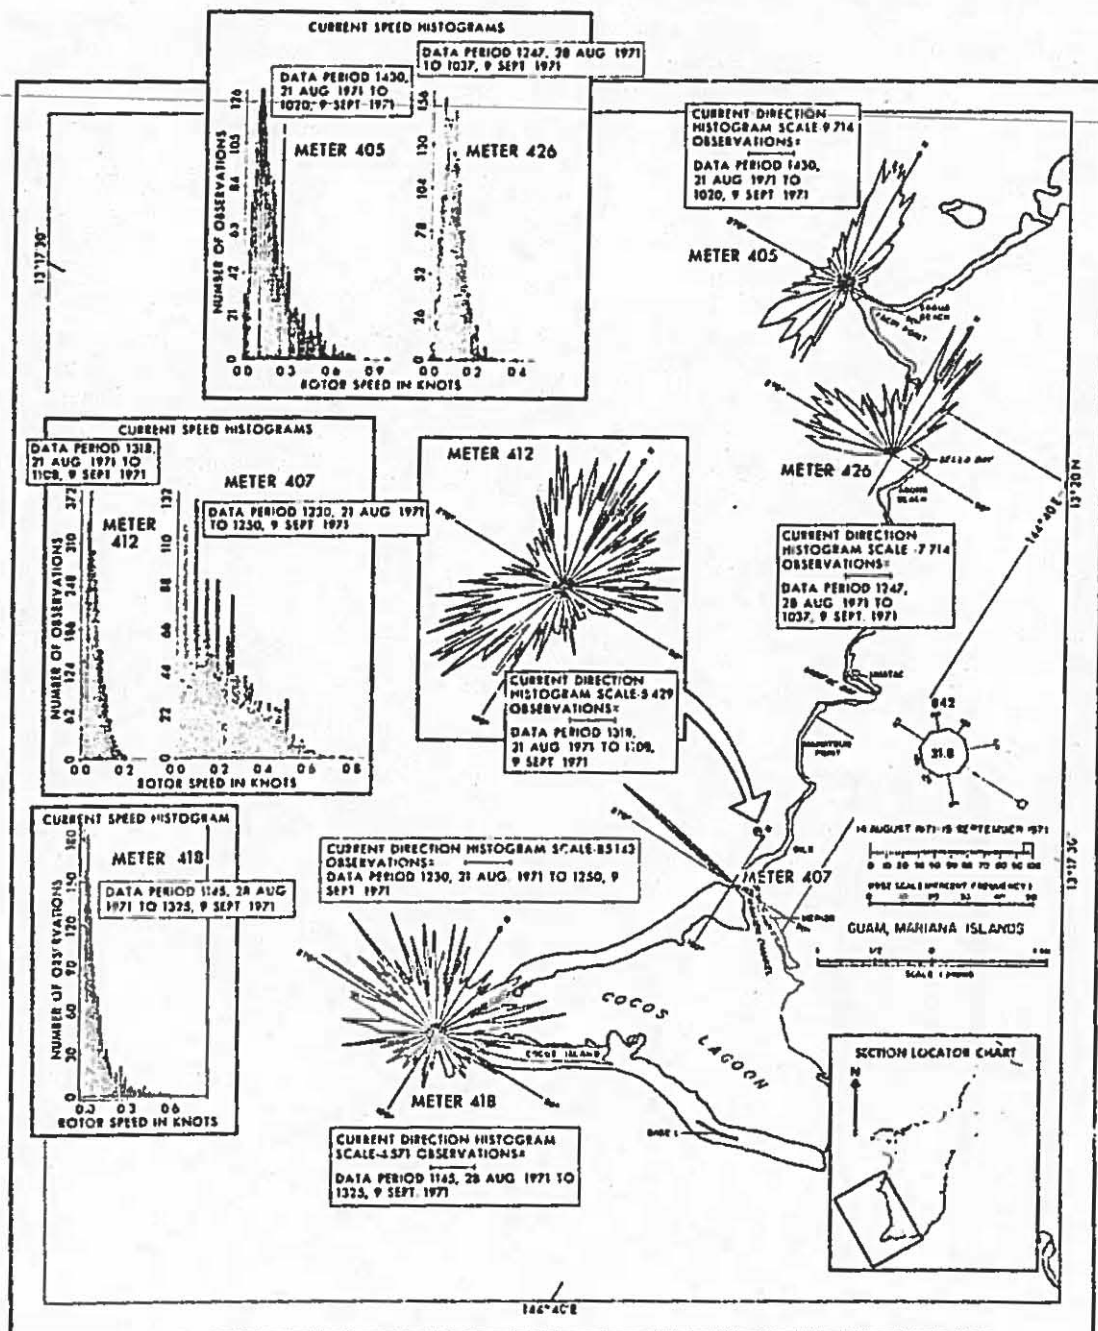
Figure 7. Current speed histograms and current direction histograms for the Bile Section in summer including meters #405, #426, #412, #407, and #418 and a wind rose for the data period.

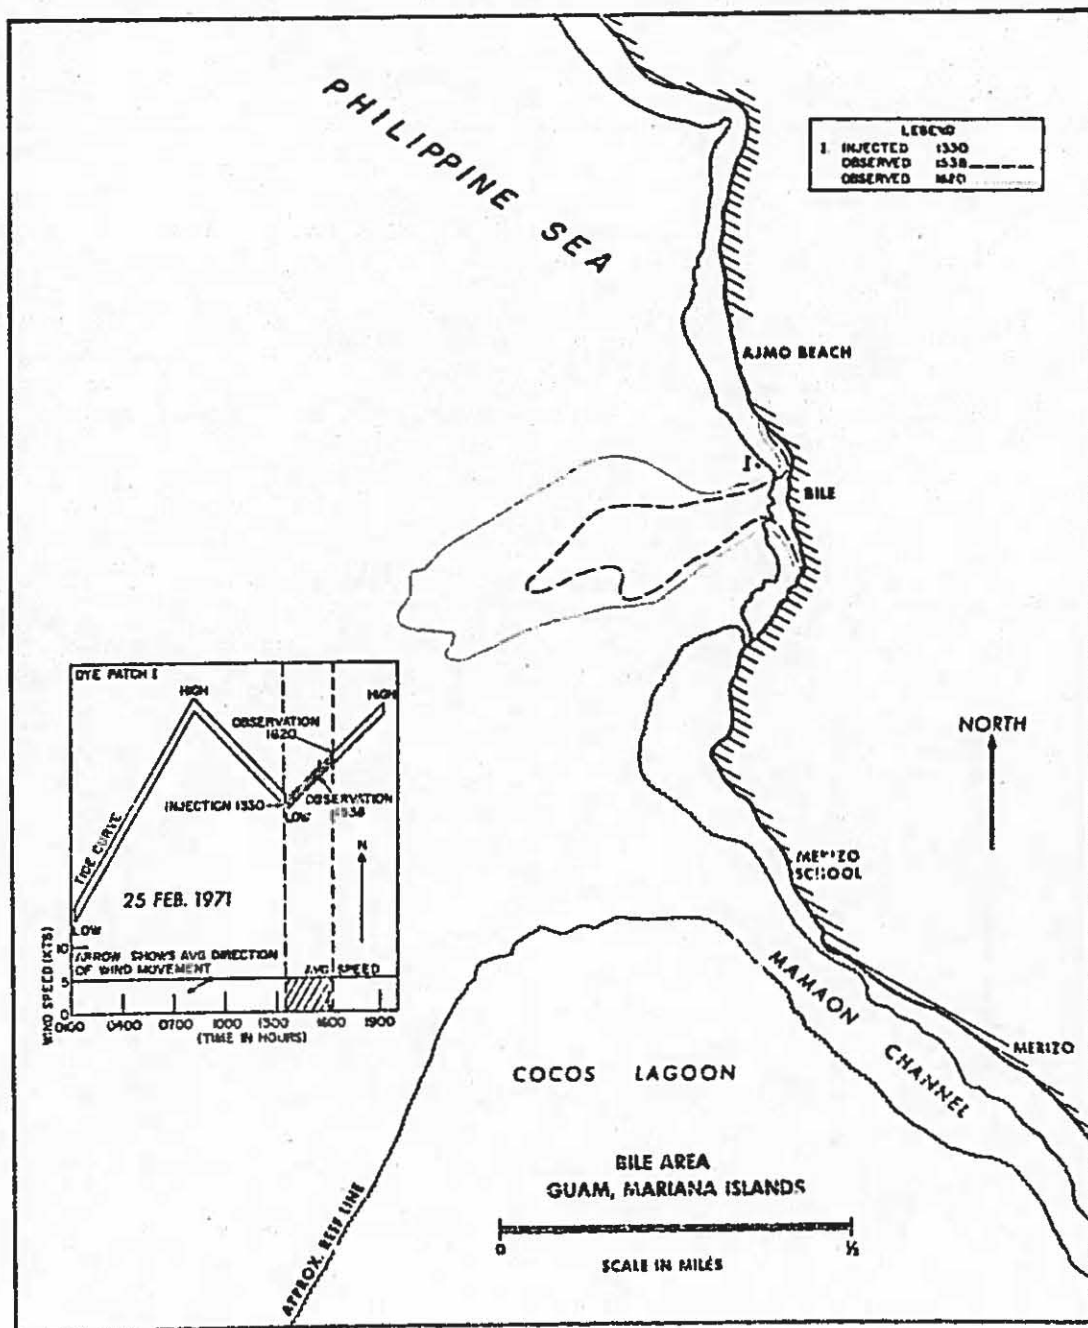
Figure 11. Dye movement at Bile Bay on 25 February 1971, P.M.

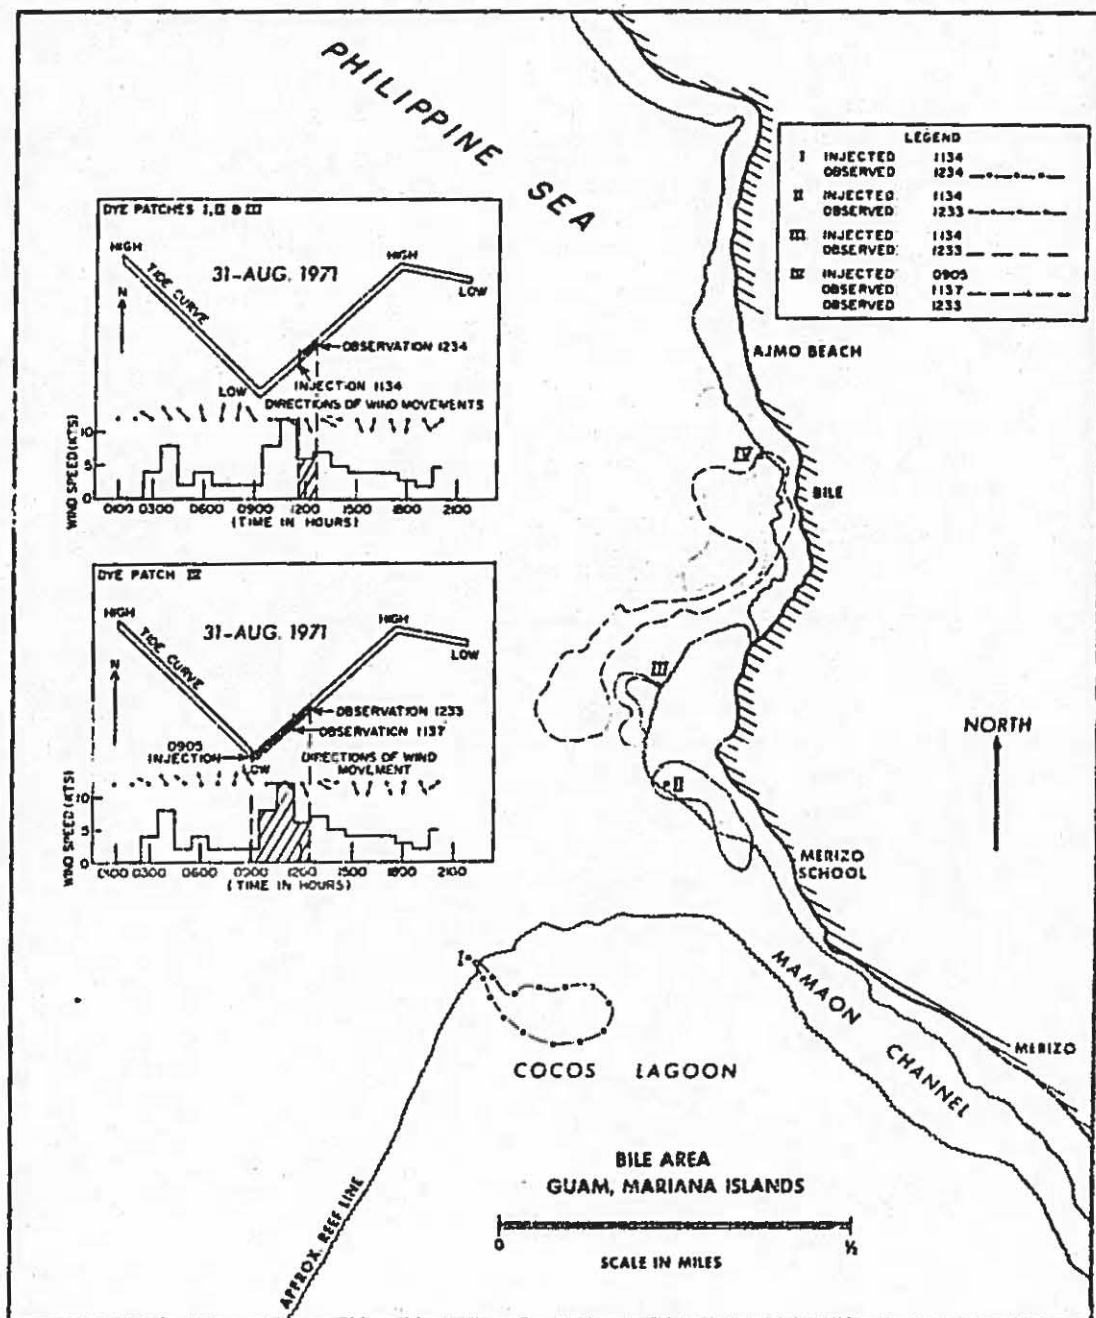
Figure 17. Dye movement at Bile Bay on 31 August 1971.

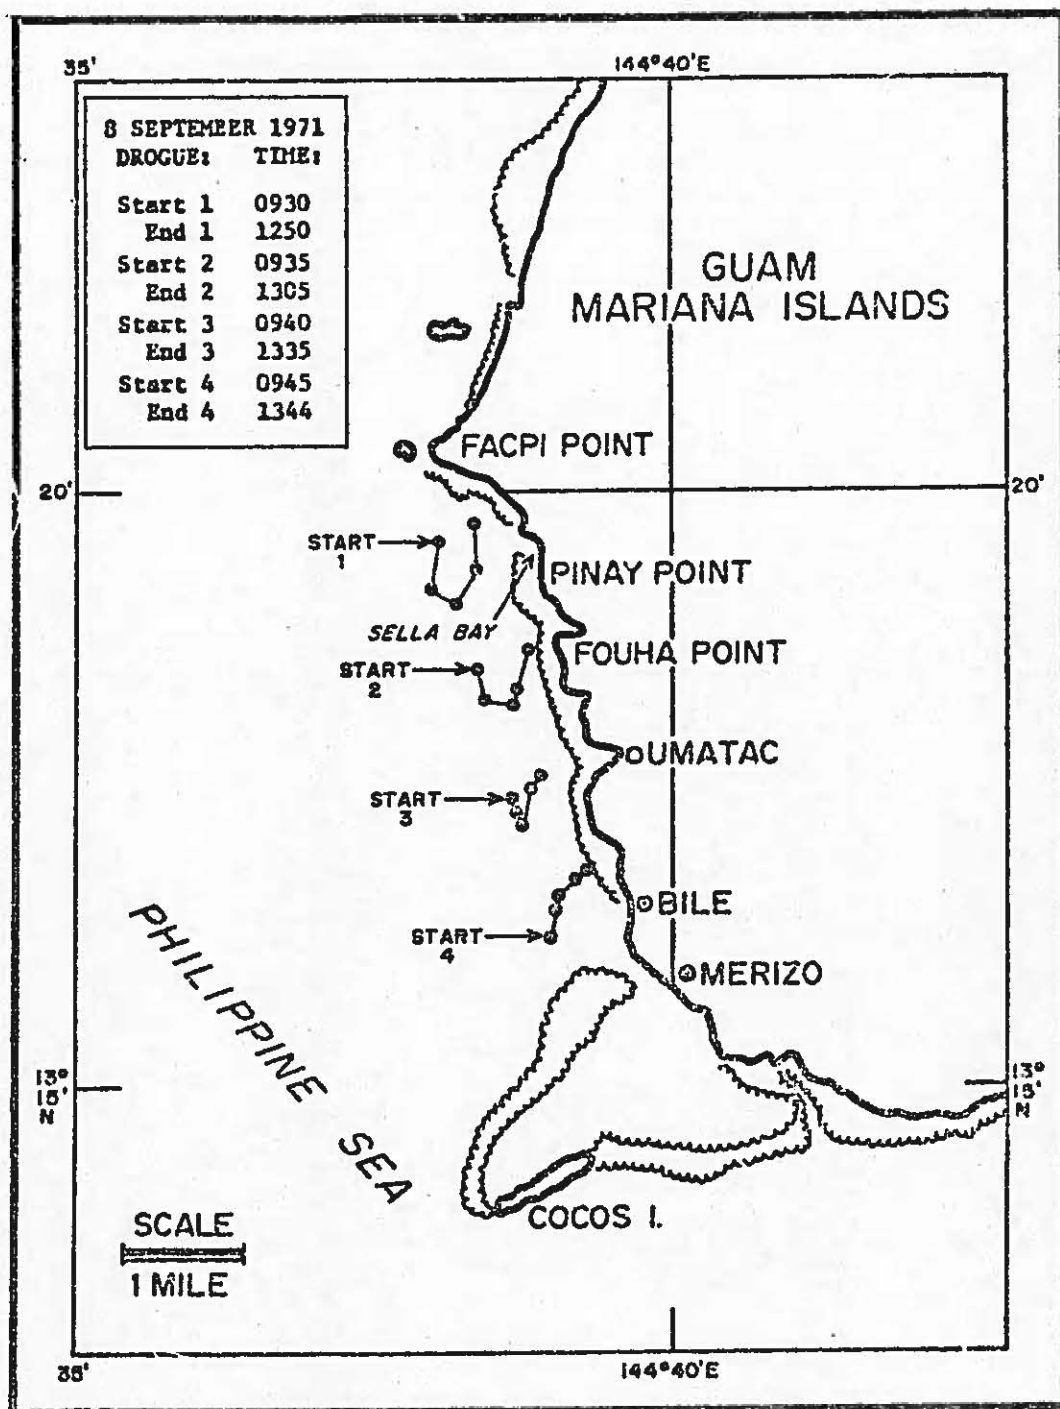
Figure 33. Drogue observations in Bile Section, 8 September 1971.

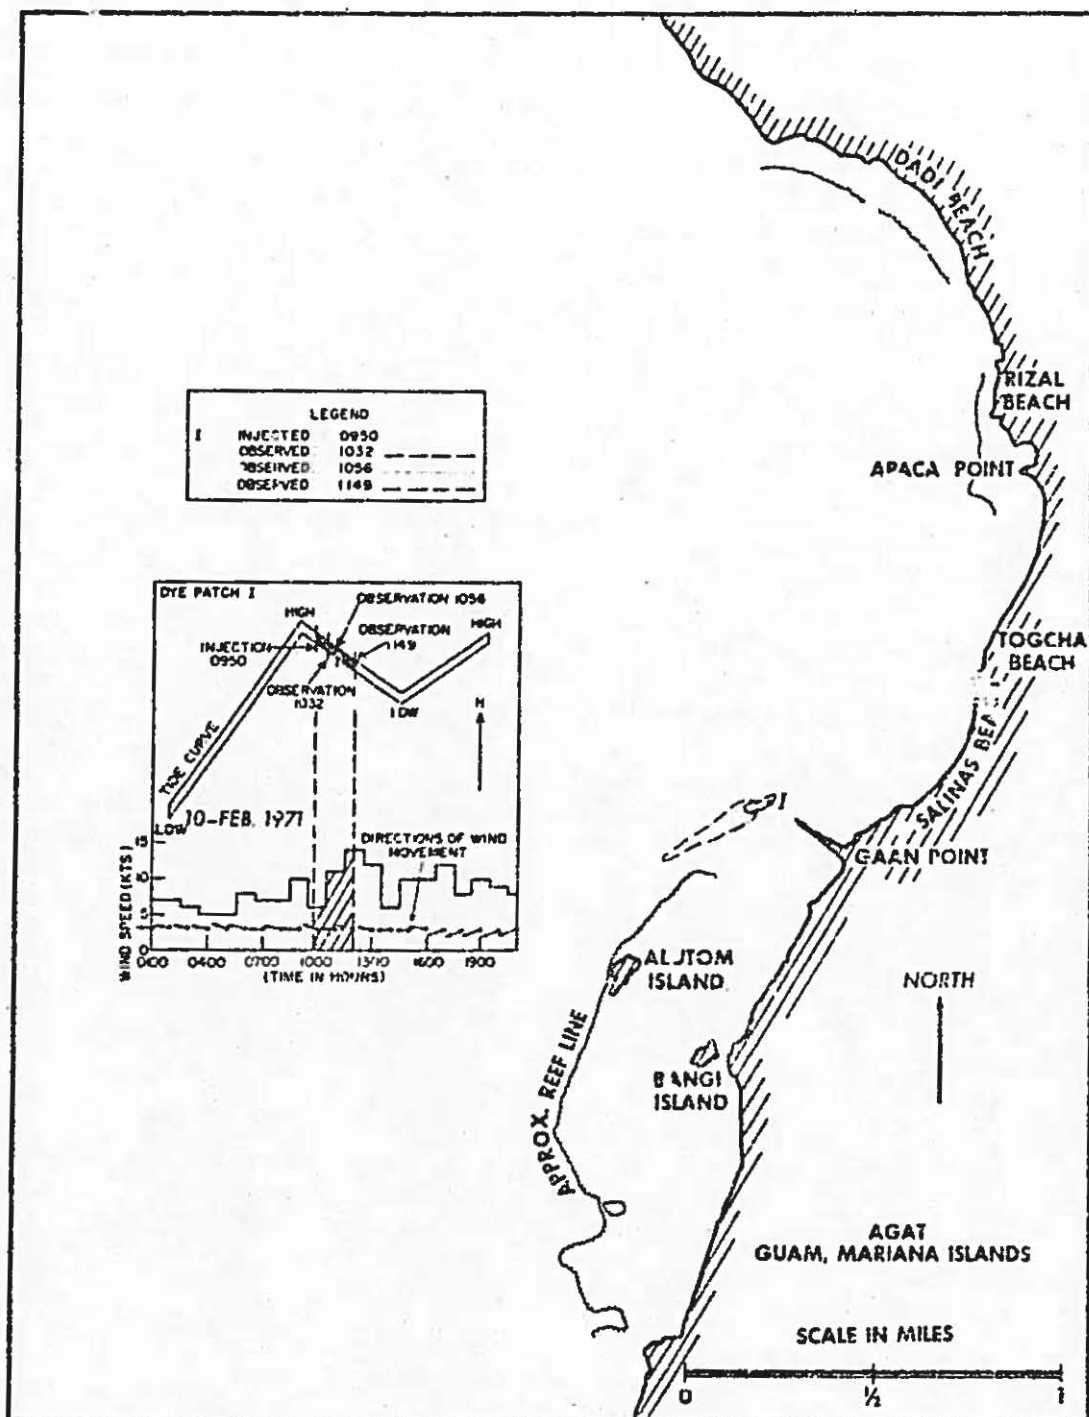
Figure 37. Dye movement at Agat Bay on 10 February 1971, A.M.

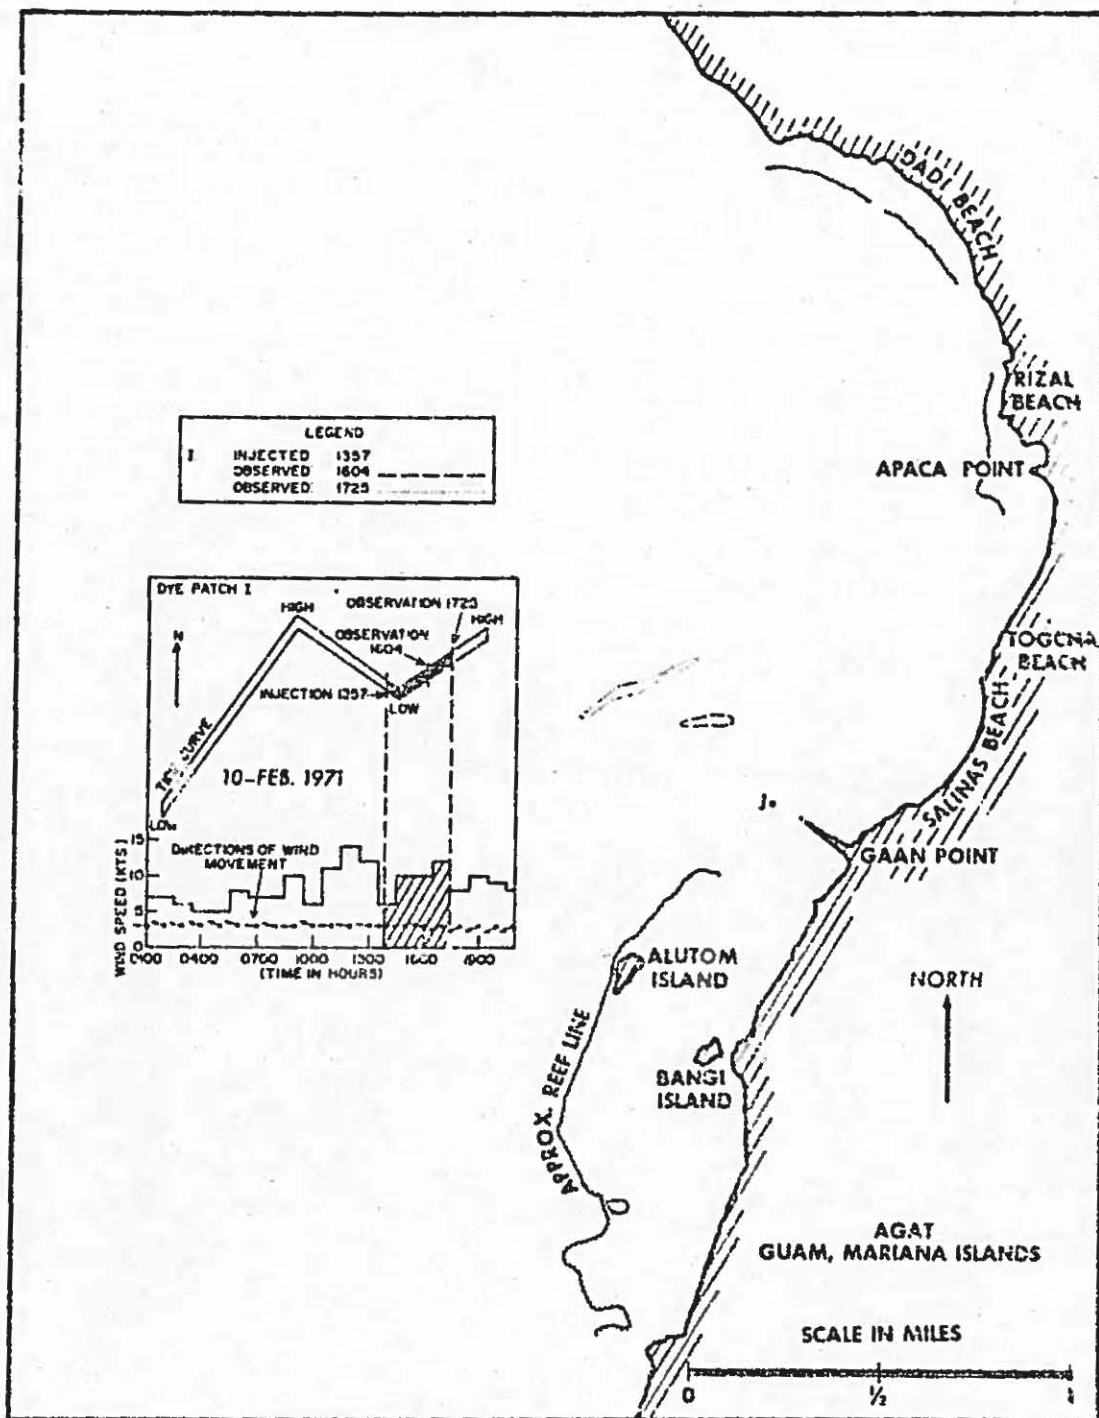
Figure 38. Dye movement at Agat Bay on 10 February 1971, P.M.

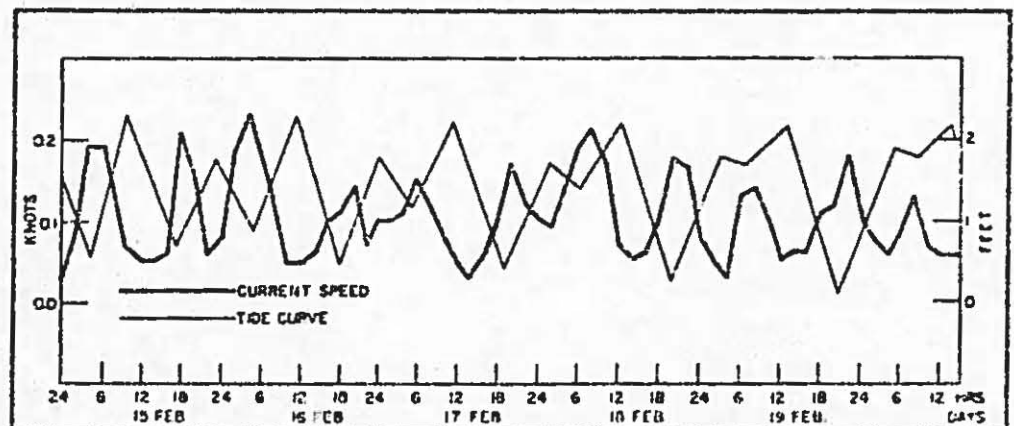
Figure 47. Current speeds versus tides from meter #323, 0000, 15 February to 1400, 20 February 1971.

Current meters were installed at Lantapalo Point during both winter and summer field surveys. They were placed on a bottom stand in 65 feet (19.8 meters) of water 200 feet (61 meters) from an outfall which dumps sewage over a cliff into the water. Data from meter #323, installed during the winter field survey, are presented in figures 34, 47, and 48. Most of the currents observed flowed toward the west; however, the direction histogram shows a secondary peak toward the southeast. Current speeds were strongly influenced by tides. The highest current speeds occurred 1 to 2 hours after each low tide. Currents were westerly during the peak flows changing to southeasterly after each high tide when speeds were least.

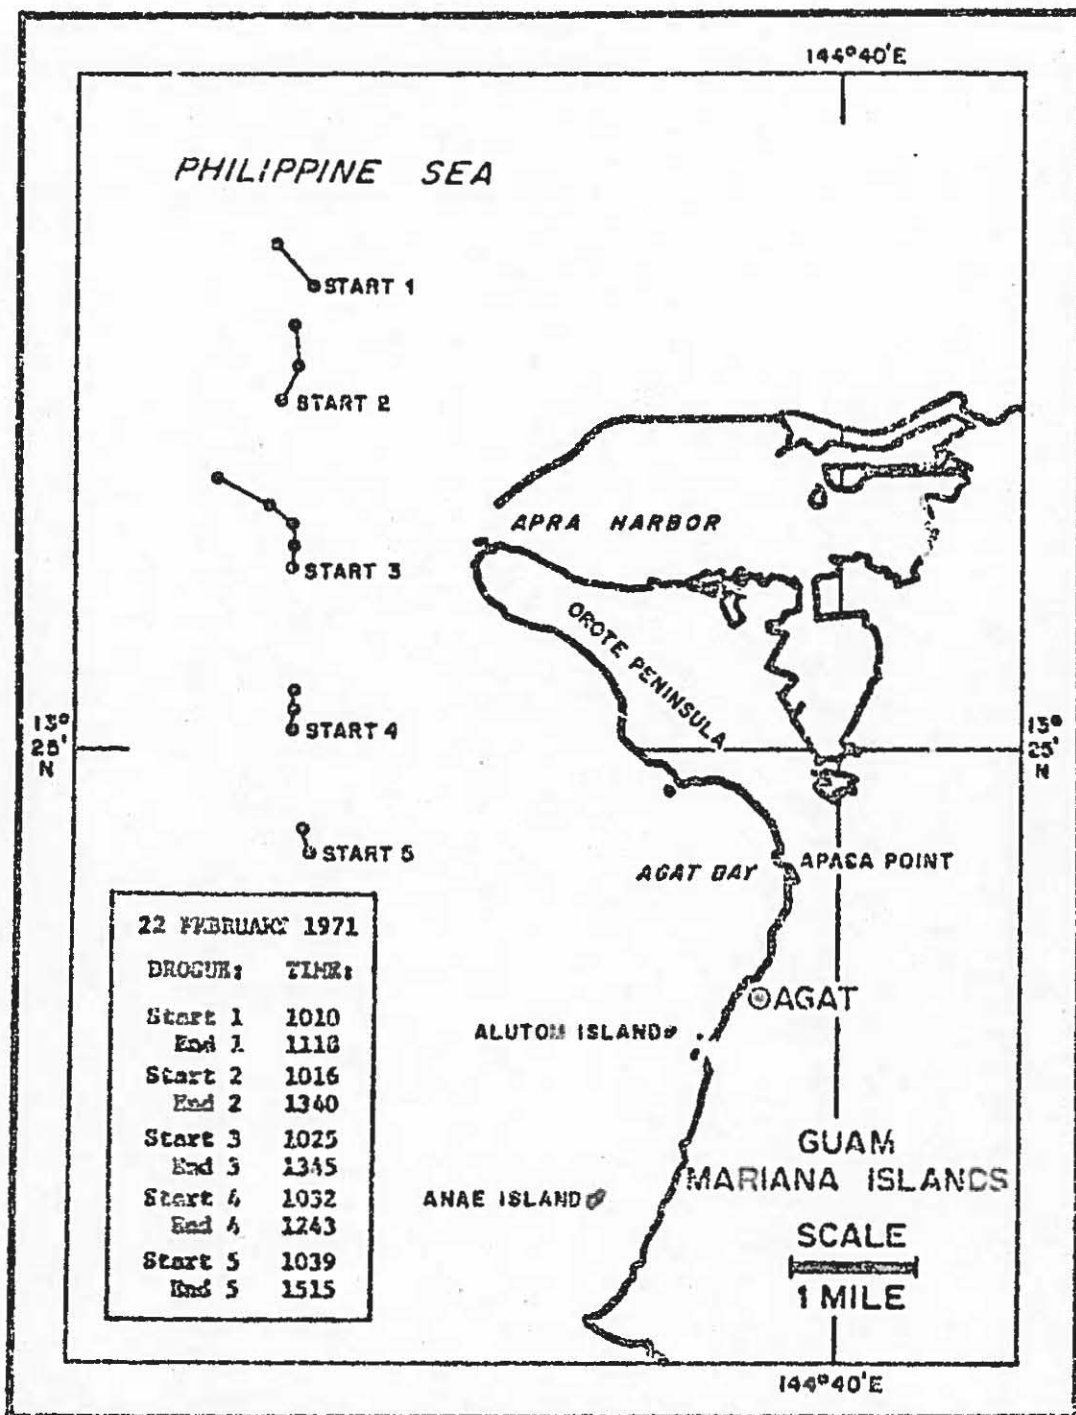
Figure 55. Drogue observations in Agat Section, 22 February 1971.

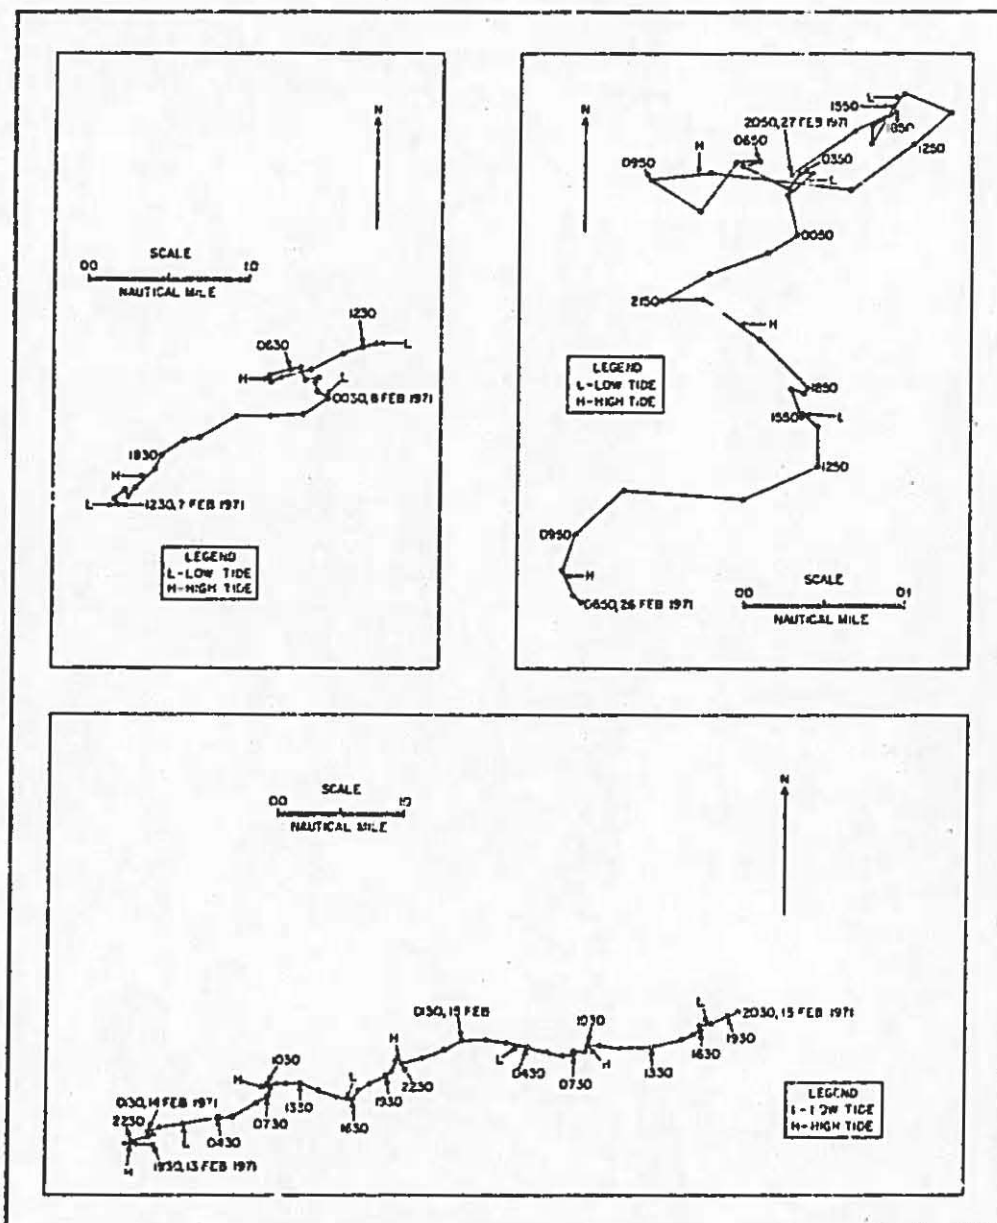
Figure 76. Progressive vector diagrams of current from meter #103, 1230, 7 February to 1330, 8 February; 0650, 26 February to 2050, 27 February; and 1930, 13 February to 2030, 15 February 1971.

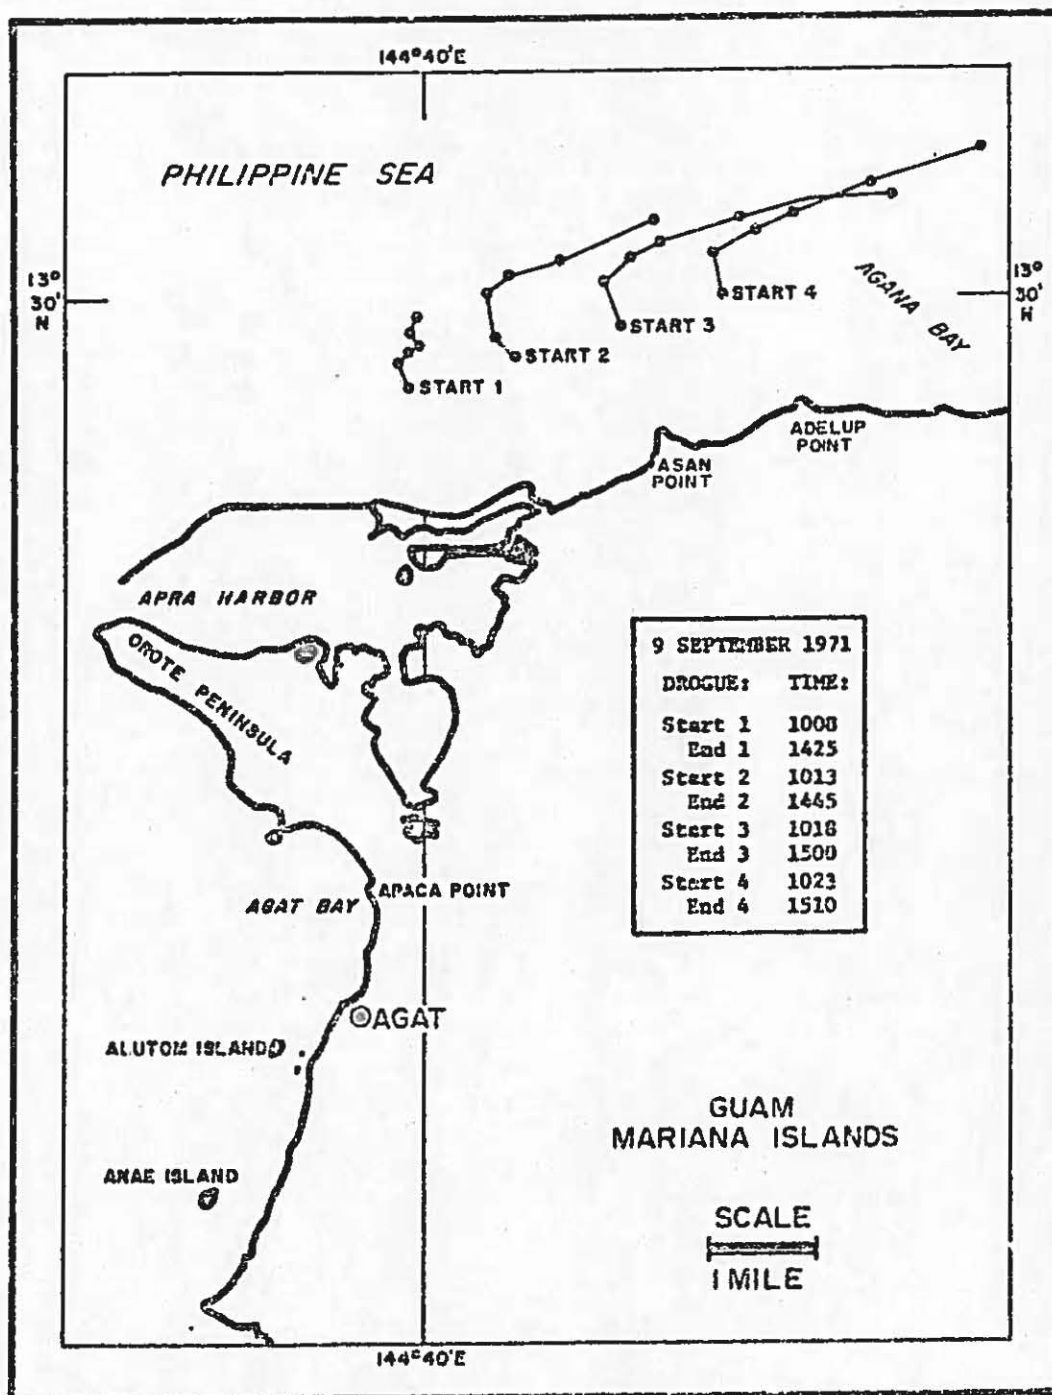
Figure 86. Drogue observations in Agaña Section, 9 September 1971.

One drogue tracking operation was conducted in this vicinity during the summer survey (fig. 86). After initial movement toward the north, the drogues turned and travelled rapidly toward the east. This flow pattern apparently was a result of currents caused by strong westerly winds which began early on 9 September.

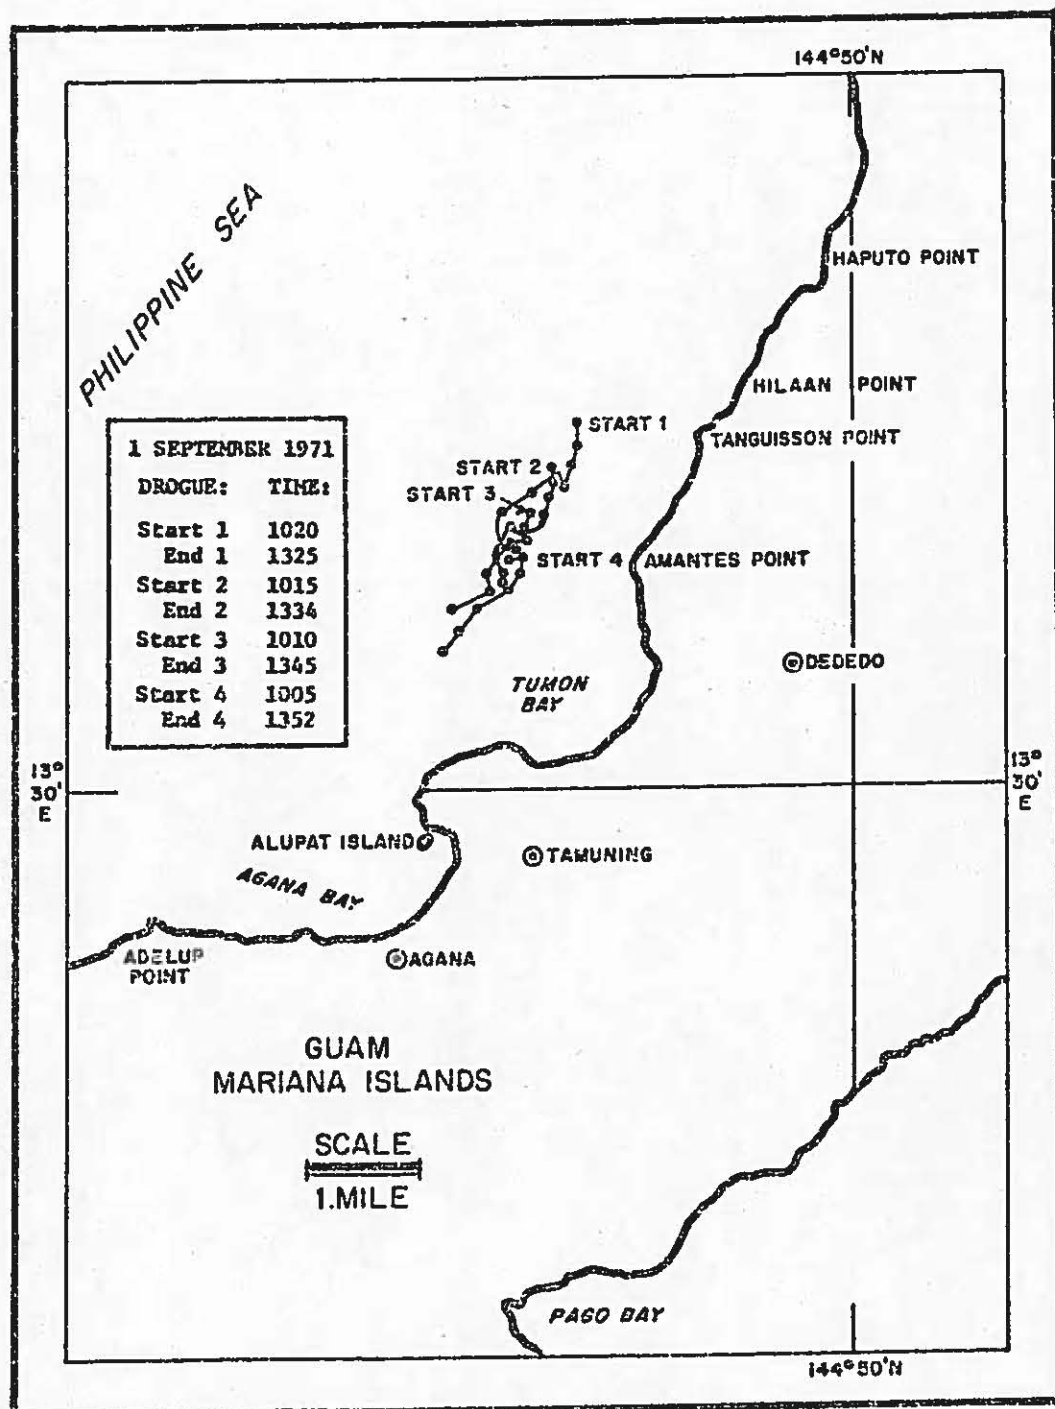
Figure 105. Drogue observations in Tumon Section, 1 September 1971.

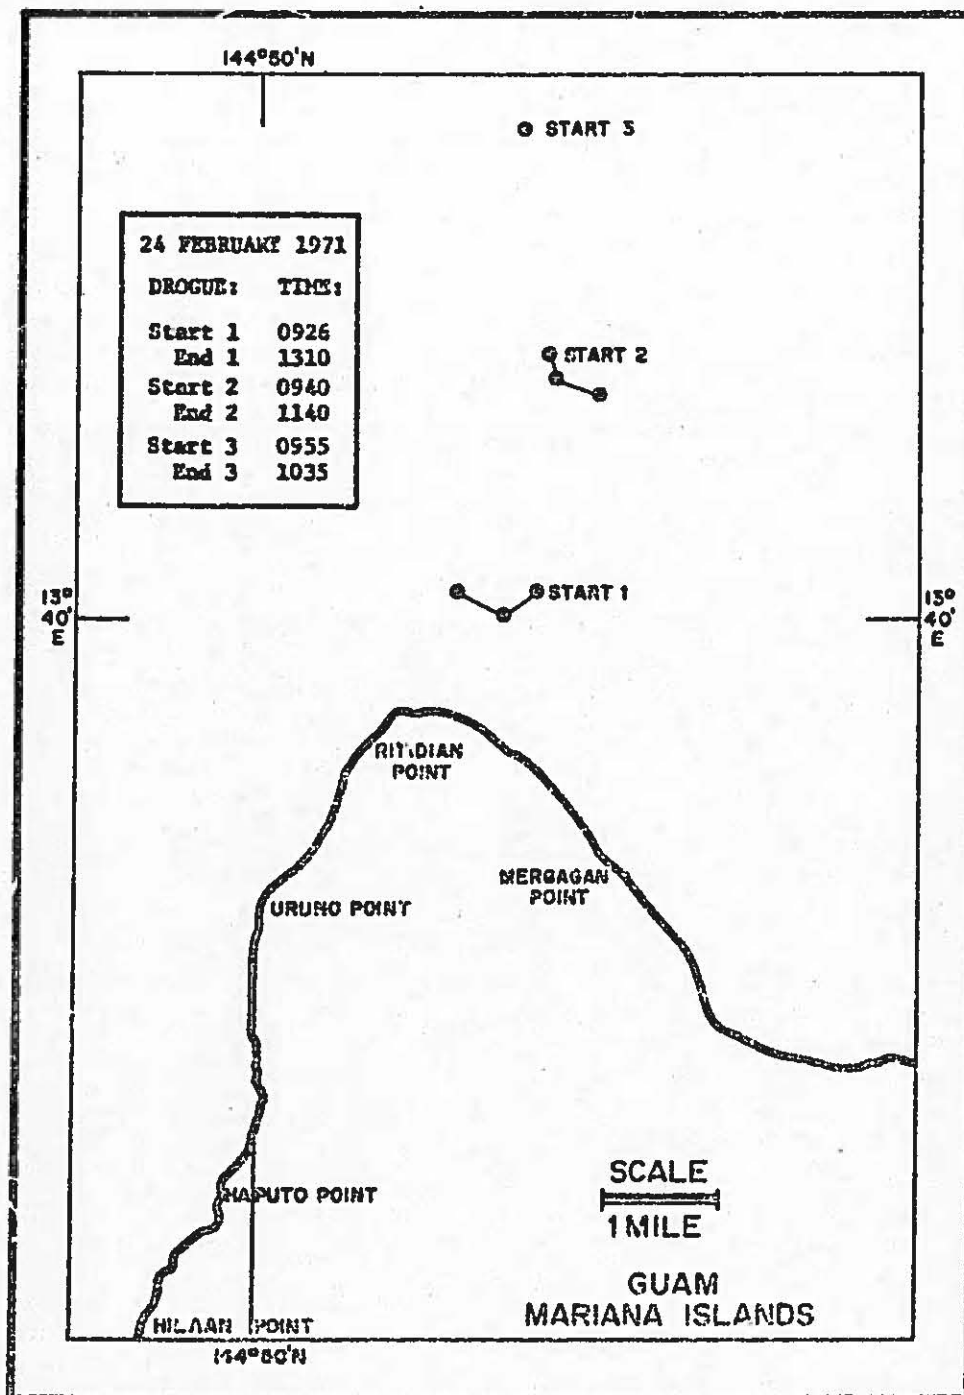
Figure 111. Drogue observations in Ritidian Section, 24 February 1971.

Surface drogues were tracked north of Ritidian Point during February and August (figures 111 and 112). During February surface currents appeared to be relatively weaker; no movement at all was observed 5 miles (8 km) north of the point. Currents within a mile of Ritidian Point showed a more easterly component during both winter and summer than the currents further from shore.

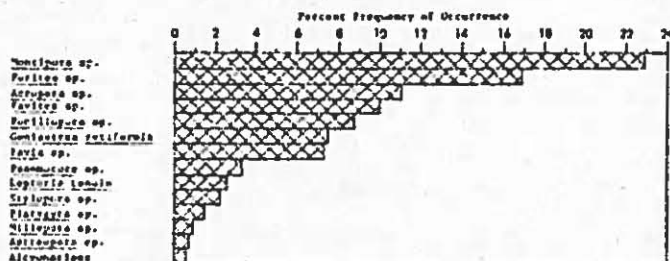
Figure 113. Frequency of occurrence of coral in quadrats on the first terrace of the reef front (quadrats 1 and 3).

Figure 113 is a composite frequency histogram of corals in quadrats 1 and 3 located on the first terrace, and figure 114 is a composite frequency histogram of corals in quadrats 2, 4, and 5 located on the slope to the second terrace.

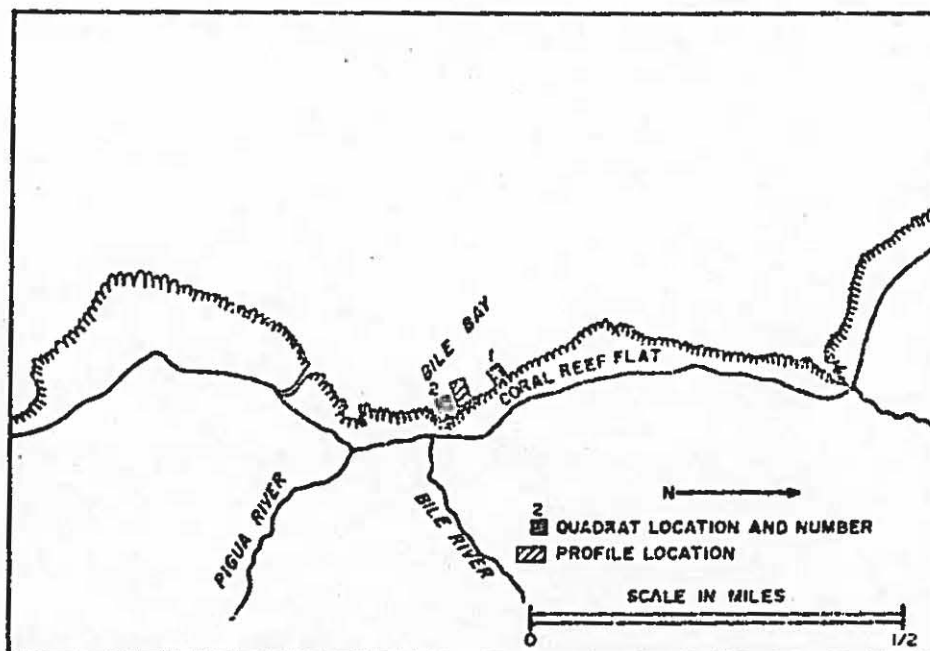
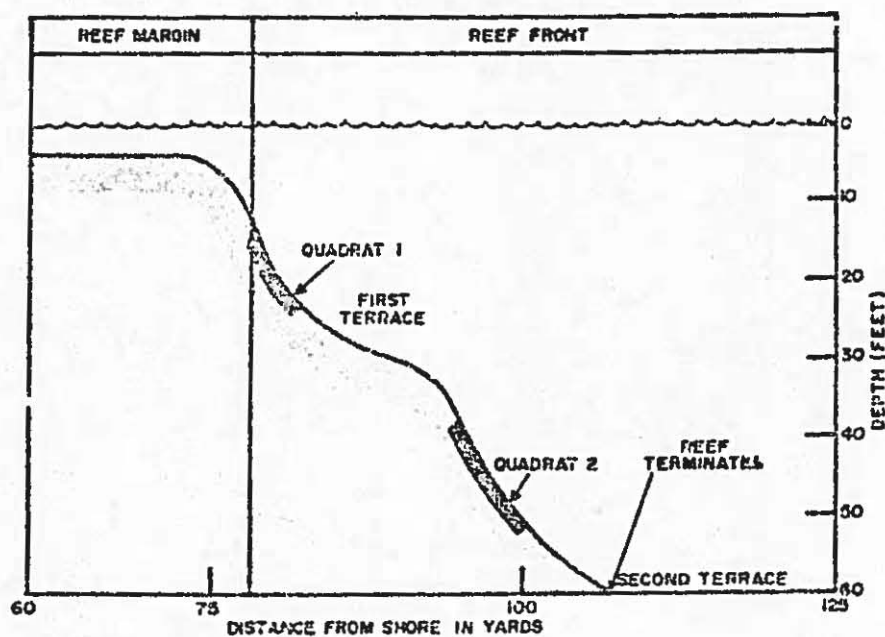
Figure 115. Area chart and reef profile for Bile Bay ecological study.

Bile Bay lies in a protected location on the southwestern coast of the island. Sheltered inland by mountains and facing southwest, the bay receives few strong winds and is not subject to strong currents. Two streams, the Bile and Pigua, empty into the bay and physically divide it into three parts. Both streams flow through sparsely populated regions, and they are used by inhabitants for some waste removal. The streams are generally low volume; however, after heavy rains large sediment plumes extend into the bay. The streams have caused an impact sufficient to inhibit coral growth in their direct path of flow, and in adjacent areas they restrict coral growth to genera with some tolerance to silting. Figure 115 presents a profile and chart of the Bile Bay ecological study area.

The reef at Bile Bay is a narrow fringe 110 yards (100.6 meters) wide. The reef begins at the shore vegetation line and at its seaward limit it meets a sand and silt bottom at the 60-foot (18.3-meter) depth. The reef of the bay center, modified by the outflow of the streams, is narrow and broken by channels; whereas, the reef at each end of the bay is broader and more uniform.

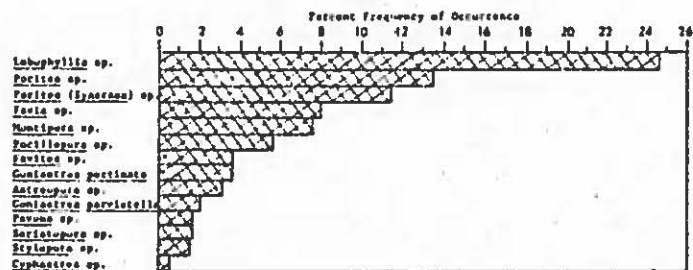
Figure 119. Frequency of occurrence of coral in quadrat 2, Bile Bay.

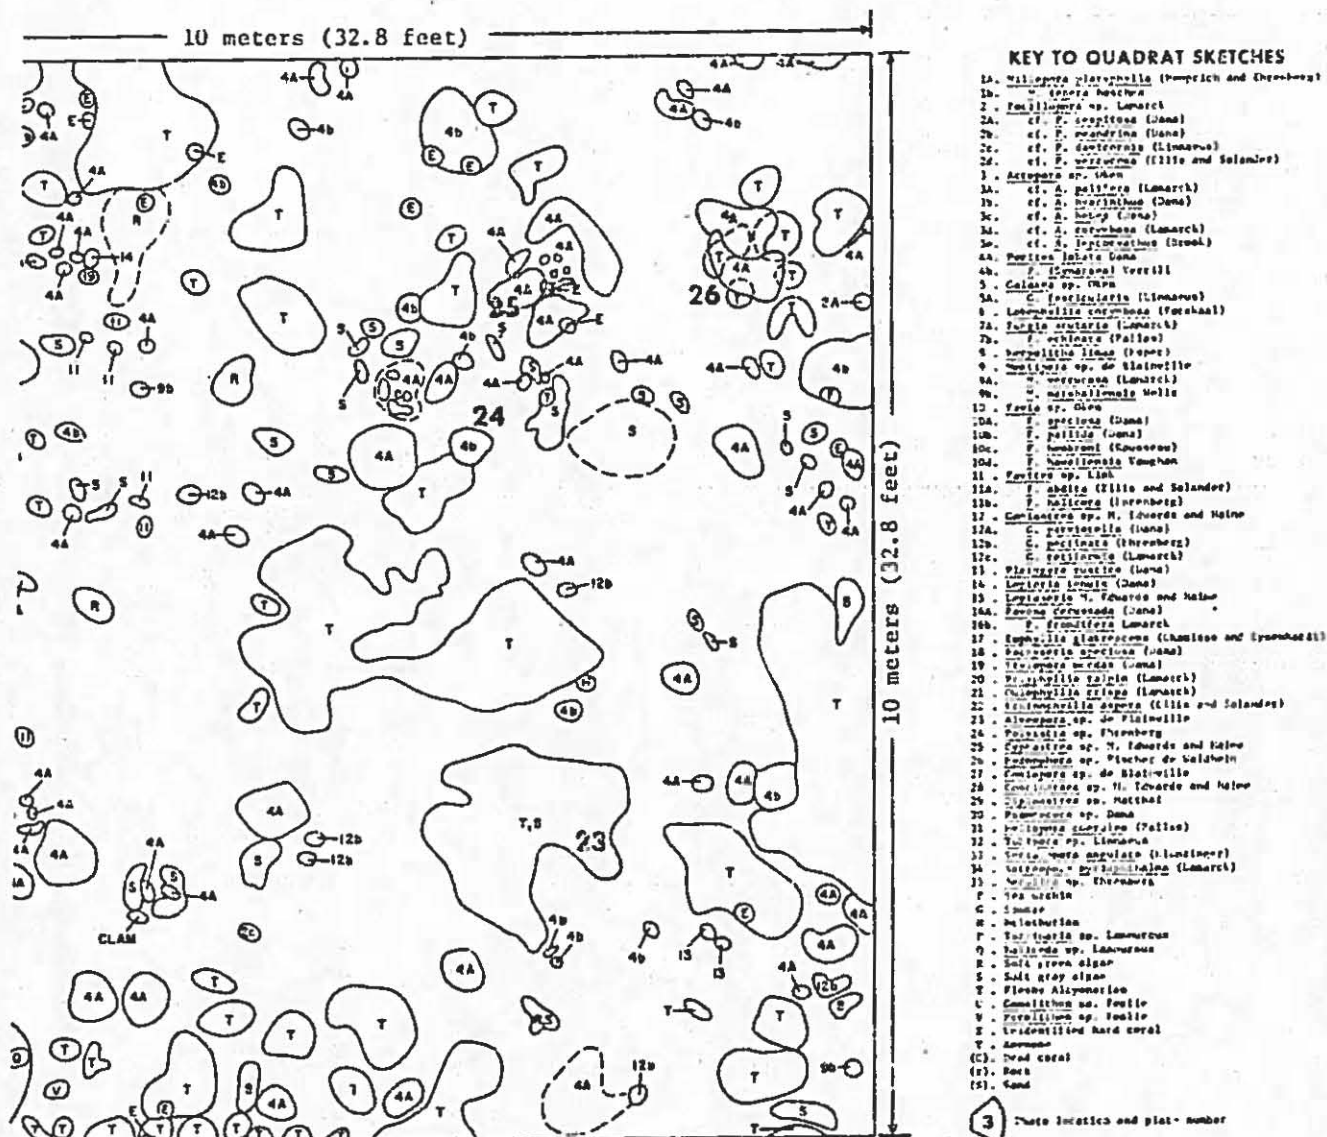
132. Species distribution chart, quadrat 7, Piti Bay.

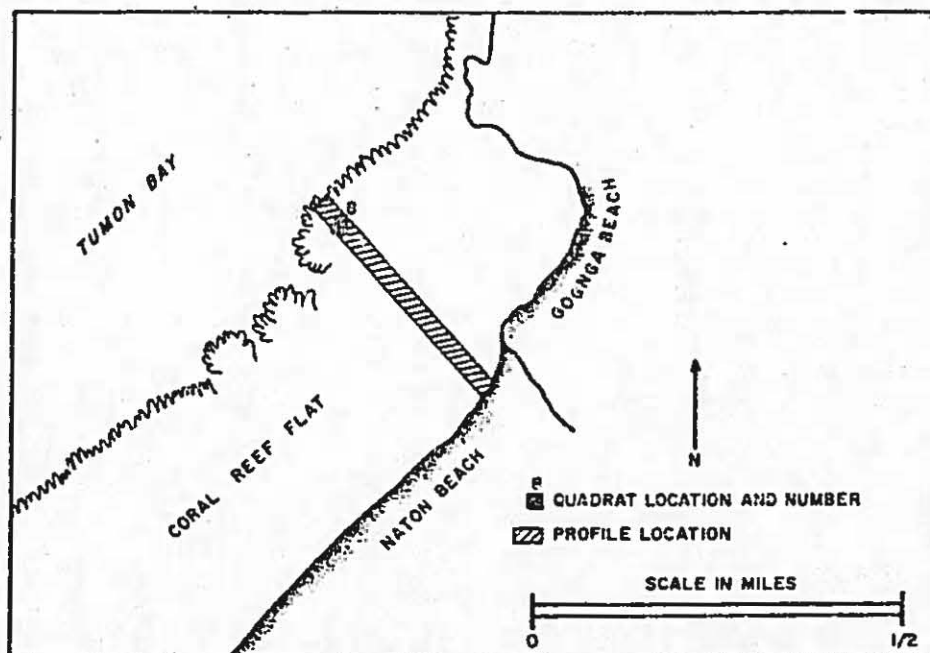
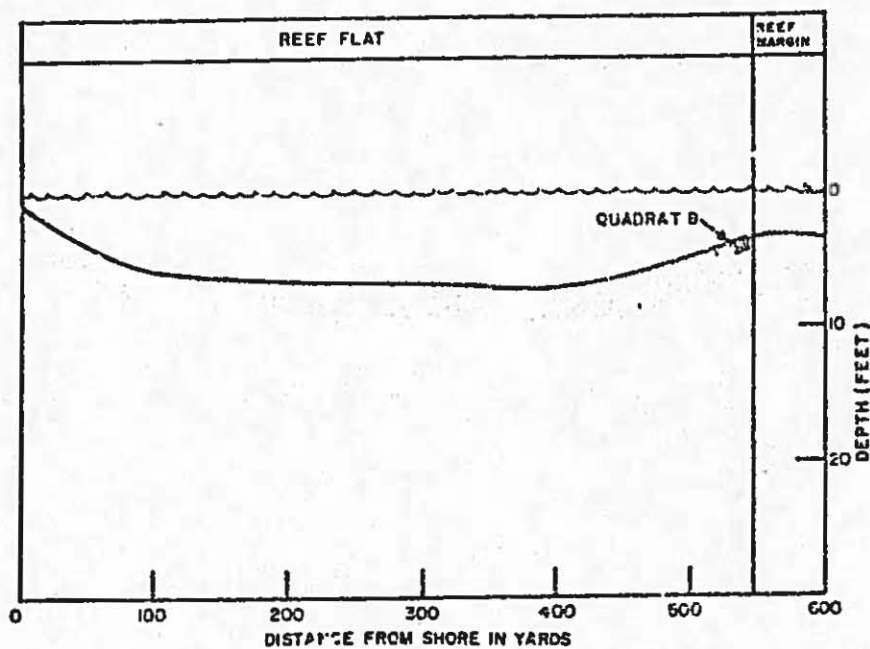
Figure 134. Area chart and reef profile for Tumon Bay ecological study.

Three days of observations were made of the fringing reef at Tumon. The reef front had been decimated by the starfish, Acanthaster (crown-of-thorns), and presented an ugly view of dead coral buttresses and pillars. This reef sector now appears to be in an early stage of redevelopment with sponges, algae, the coral Galaxea, and the hydroid Millepora being predominant. The reef flat extends 550 yards (503 meters) from the shore to the algal ridge and encompasses the following zones: (1) beach sand and marine grass (0-100 yards (0-91.4 meters)); (2) sand, and coral of the genera Coniastrea, Porites, and Acropora (100-350 yards (91.4-320 meters)); and (3) sand, rock, and coral of the genera Pocillopora, Acropora, and Porites (350-550 yards (320-503 meters)). A similar traverse was run by Tracey et al. (op. cit.) before the starfish infestation, and comparison of data indicates the reef flat did not suffer
