# Nearshore Currents and Coral Reef Ecology of the West Coast of Guam, Mariana Islands

NEARSHORE CURRENTS AND CORAL REEF ECOLOGY OF THE WEST COAST OF GUAM, MARIANA ISLANDS

HOWARD D. HUDDELL J. CRAIG WILLETT GREGORY MARCHAND

NAVAL OCEANOGRAPHIC OFFICE WASHINGTON, D.C. 20373

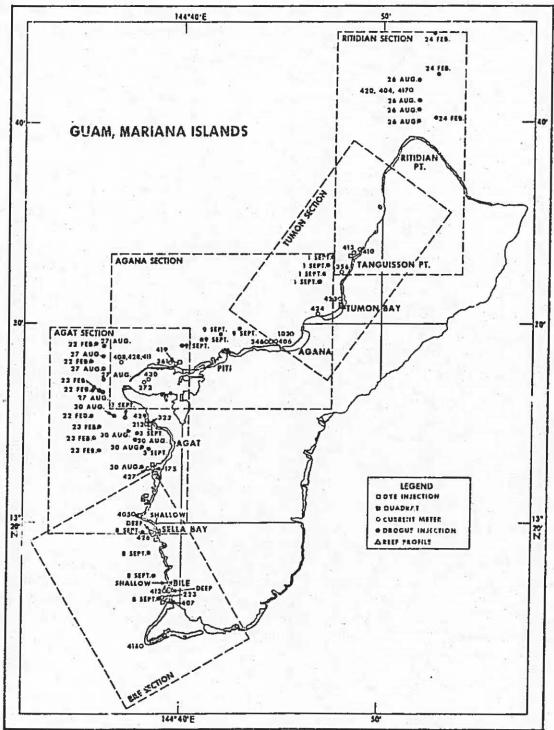
Figure 1. Summary of survey operations conducted during two field investigations February - March 1971 and August - September 1971.

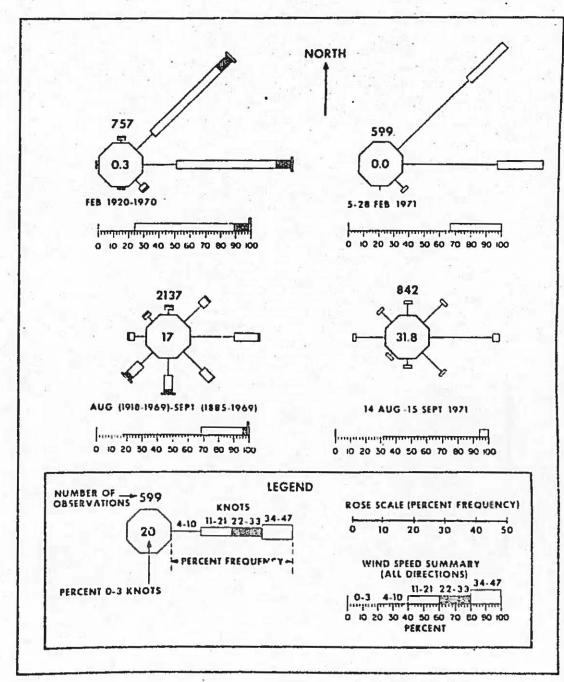
Figure 3. Wind roses of historical data and 1971 data.

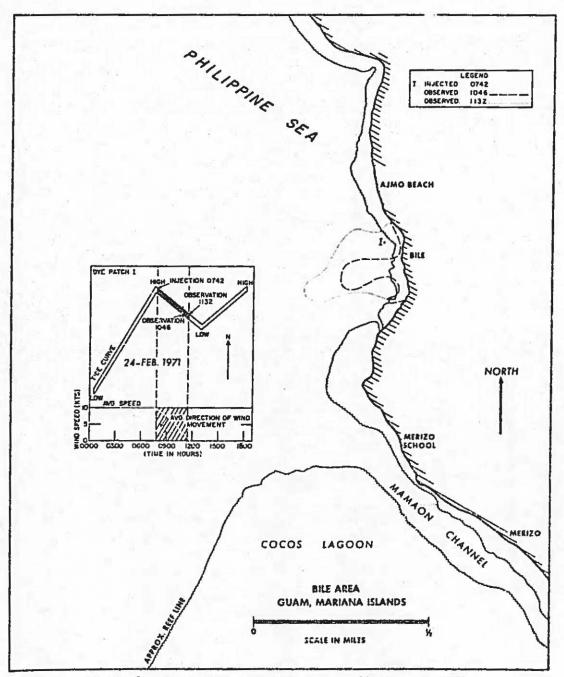
Figure 9. Dye movement at Bile Bay on 24 February 1971.

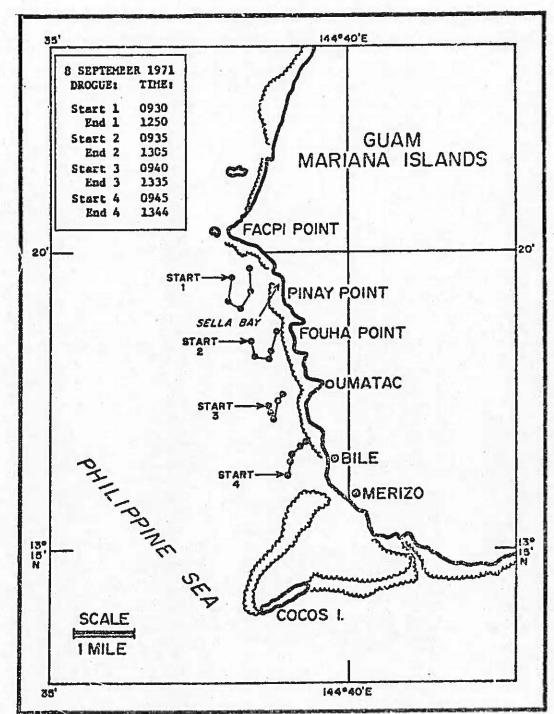
Figure 33. Drogue observations in Bile Section, 8 September 1971.

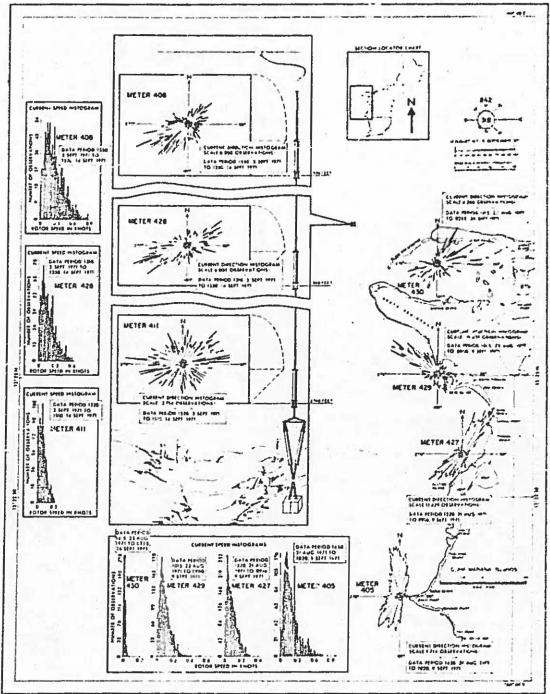
Figure 36. Current speed histograms and current direction histograms for the Agat Section in summer including meters #408, #428, #411, #405, #427, #429, and #430 and a wind rose for the data period.

A similar situation existed during the number field survey as shown in the data from meter #429 (figs. 36 and 49). Peak speeds occurred during rising tide and lower speeds were recorded during obb. Speeds were generally higher during the summer, reaching a maximum of 0.55 knot (.275 m/sec). Currents flowed northwest during flood and were variably southeast and northwest during ebb.

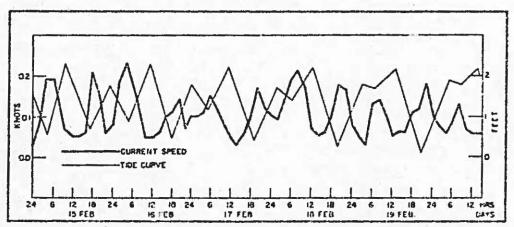
Figure 47. Current speeds versus tides from meter #323, 0000, 15 February to 1460, 20 February 1971.

Current meters were installed at lastspalo Point during toth winter and summer field surveys. They were placed on a bottom stand in 65 feet (19.8 meters) of water 200 feet (61 meters) from an outfall which dumps sewage over a cliff into the water. Data from meter #323, installed during the winter field survey, are presented in figures 34, 47, and 48. Most of the currents observed flowed toward the west; however, the direction histogram shows a secondary peak toward the southeast. Current speeds were strongly influenced by tides. The highest current speeds occurred 1 to 2 hours after each low tide. Currents were westerly during the peak flows changing to southeasterly after each high tide when speeds were least.

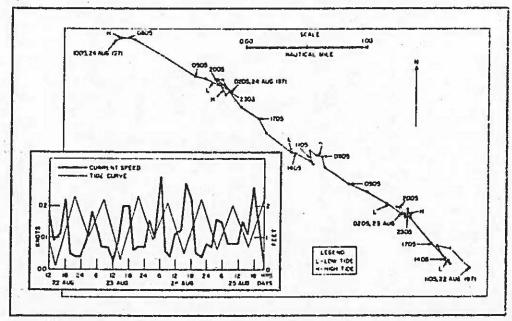
Figure 49. Progressive vector diagram of current from meter #429, 1105, 22 August to 1005, 24 August 1971, and current speeds versus tides from 1200, 22 August to 2000, 25 August 1971.

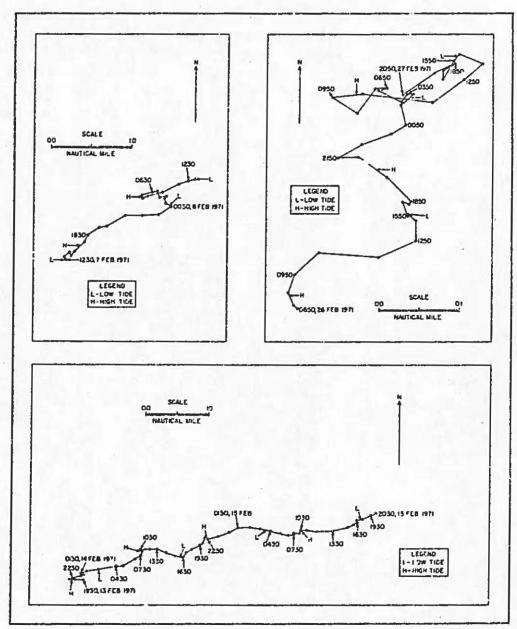
Figure 76. Progressive vector diagrams of current from meter #103, 1230, 7 February to 1330, 8 February; 0650, 26 February to 2050, 27 February; and 1930, 13 February to 2030, 15 February 1971.

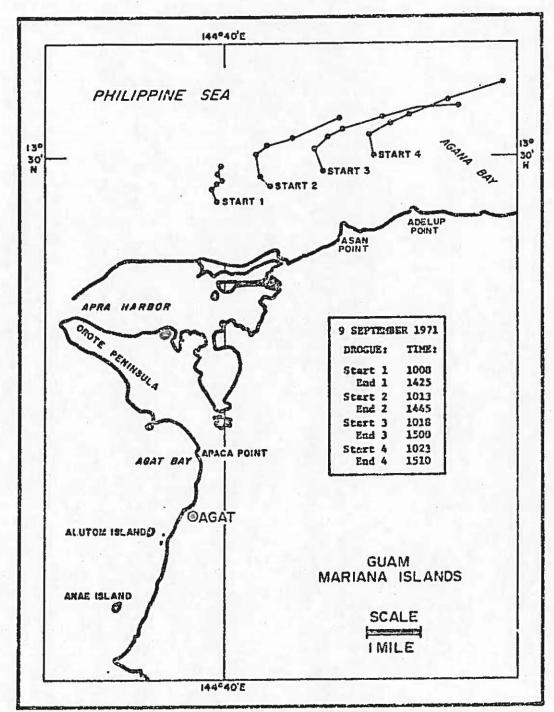
Figure 86. Drogue observations in Agama Section, 9 September 1971.

One drogue tracking operation was conducted in this vicinity during the summer survey (fig. 86). After initial movement toward the north, the drogues turned and travelled rapidly toward the east. This flow pattern apparently was a result of currents caused by strong westerly winds which began early on 9 September.

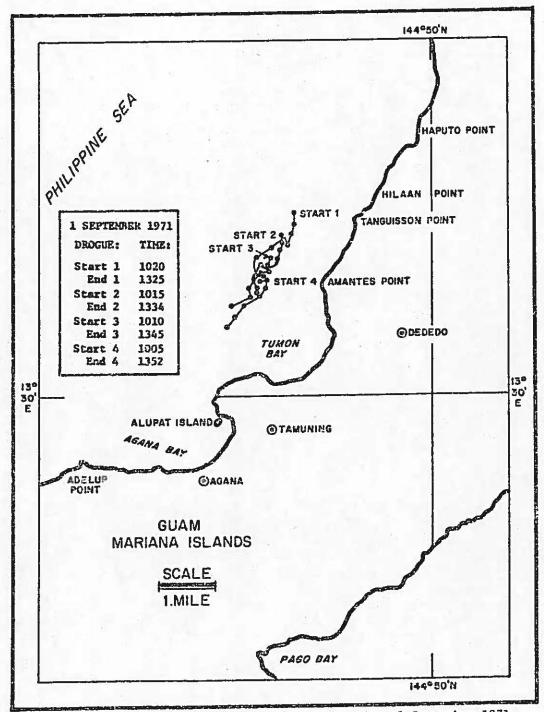
Figure 105. Drogue observations in Tumon Section, 1 September 1971.

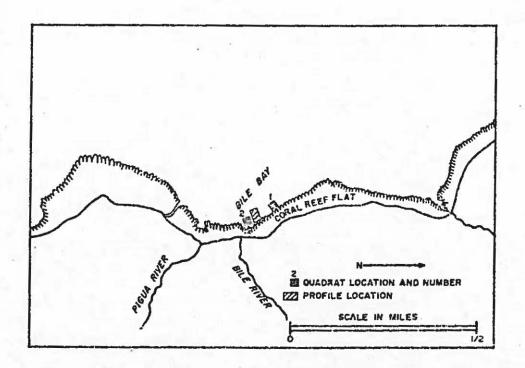
Figure 115. Area chart and reef profile for Bile Bay ecological study.

Bile Bay lies in a protected location on the southwestern coast of the island. Sheltered inland by mountains and facing southwest, the bay receives few strong winds and is not subject to strong currents. Two streams, the Bile and Pigua, empty into the bay and physically divide it into three parts. Both streams flow through sparsely populated regions, and they are used by inhabitants for some waste removal. The streams are generally low volume; however, after heavy rains large sediment plumes extend into the bay. The streams have caused an impact sufficient to inhibit coral growth in their direct path of flow, and in adjacent areas they restrict coral growth to genera with some tolerance to silting. Figure 115 presents a profile and chart of the Bile Eay ecological study area.

The reef at Bile Bay is a narrow fringe 110 yards (100.6 meters) wide. The reef begins at the shore vegetation line and at its seaward limit it meets a sand and silt bottom at the 60-foot (18.3-meter) depth. The reef of the bay center, modified by the outflow of the streams, is narrow and broken by channels; whereas, the reef at each end of the bay is broader and more uniform.

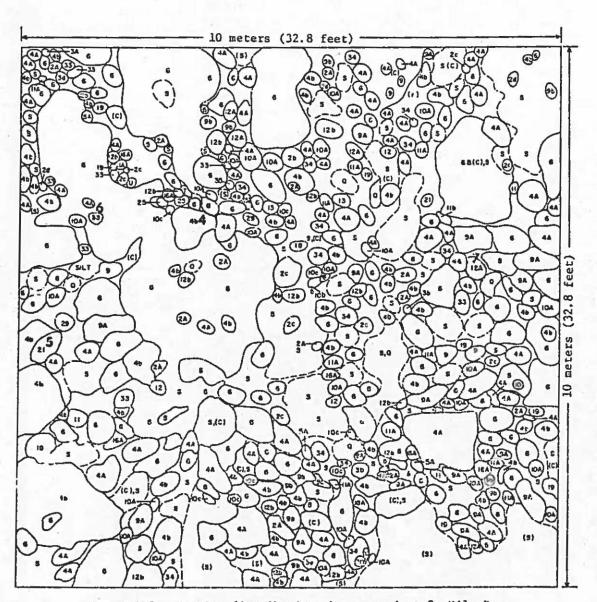
Figure 118. Species distribution chart, quadrat 2, Bilo Bay.

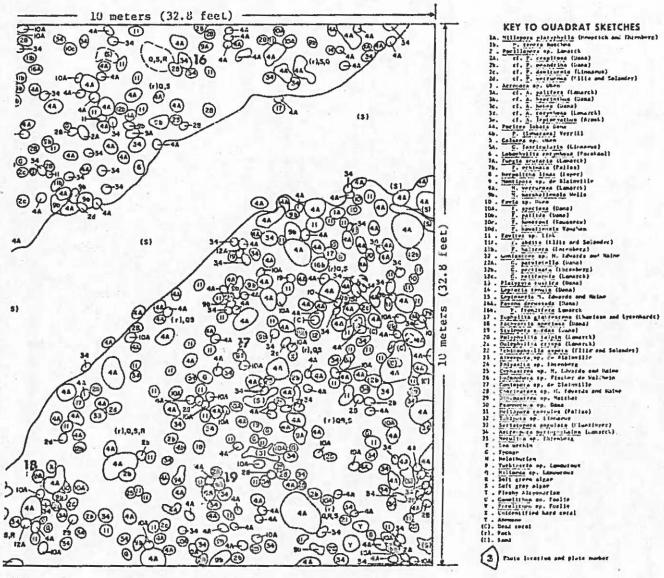
126. Species distribution chart, quadrat 5, Anae Island.

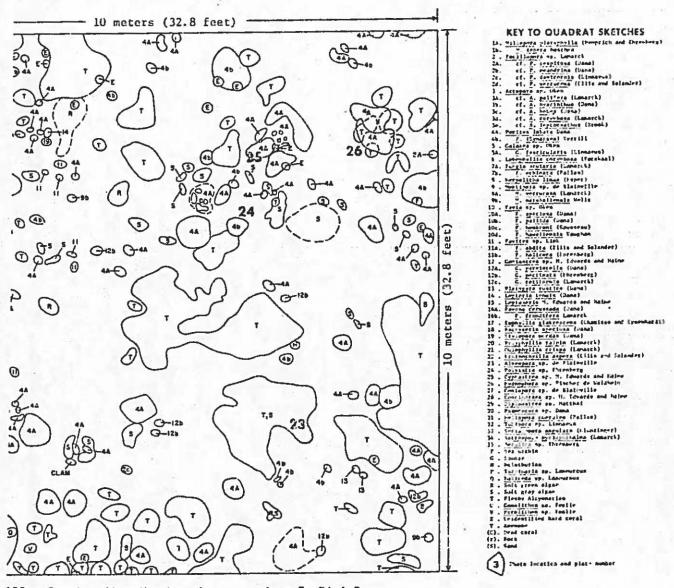
132. Species distribution chart, quadrat 7, Piti Bay.

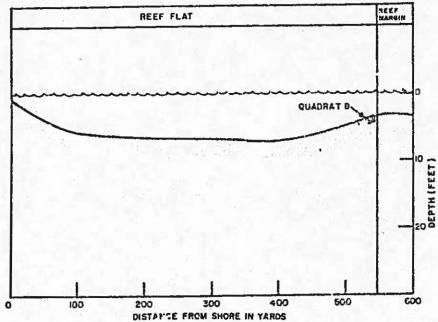
Figure 134. Area chart and reef profile for Tumon Bay ecological study.

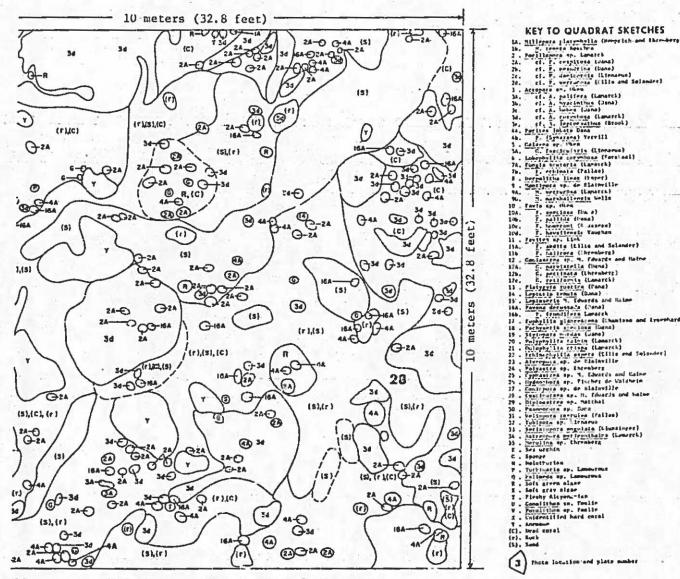
35. Species distribution chart, quadrat 8, Tumon Bay.

Quadrat 8, located in the <u>Pocillopora</u>, <u>Acropora</u>, and <u>Porites</u> zone, is covered by 6 inches to 2 feet (15.24 centimeters to .6 meter) of water depending on the tide. Much of the bottom is covered by sand and loose coral, especially around the <u>Acropora</u> thickets. Figure 135 presents the species distribution in the quadrat. The population consisted of 226 sessile organisms of nine genera with <u>Pocillopora</u>, <u>Acropora</u>, <u>Porites</u>, and <u>Pavona</u> occurring most frequently (fig. 136).
