BIOLOGICAL IMPACT CAUSED BY CHANGES ON A TROPICAL  
REEF

UNIVERSITY OF GUAM

EPA-600/3-76-027

A biological study is conducted on a fringing coral reef adjacent to a thermoelectric power plant on Guam, before and after release of plant effluent. The before study shows corals of the reef front, submarine terrace, and seaward slope to be devastated because of a recent infestation by the crown-of-thorns starfish, Acanthaster planci (L.). The reef margin is found to comprise a rich and diverse coral reef community, presumably spared from Acanthaster attack by strong wave surge. The reef flat is naturally depauperate due to frequent exposure at low tide.

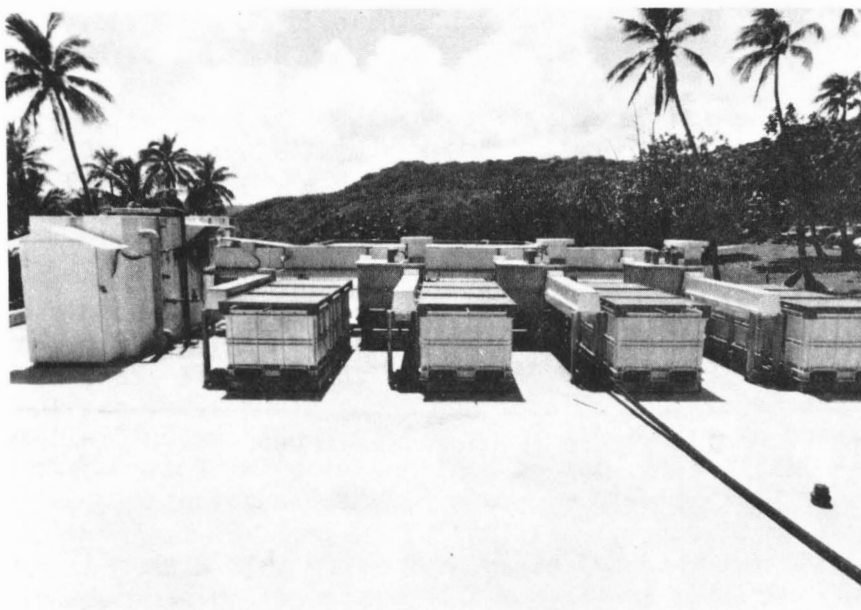
Figure 30 Thermal simulation device

Corals were acclimated for one to two weeks prior to introduction to the simulator (Fig. 31). The corals were placed in pans of fresh seawater and floated in the experimental tanks until they reached the experimental temperature (two to three hours). They were then arranged in rows within the tanks. The tanks were set up in replicates of three for each experimental temperature (Fig. 30). The rows of coral specimens were alternated between tanks to avoid bias in placement. Coralla were placed on inverted specimen jars to prevent bacterial contamination that often
